**SIX MONTH SURVEILLANCE  
HOMOGENEOUS ACBM RECORDS**

School: Bidwell Junior High School

RE: Final Close-Out Documentation for Asbestos/Hazardous Materials Related Work at  
Bidwell Junior High School Located at 2376 North Avenue in Chico, CA 95926

This report presents results of asbestos inspection of Building A (Classrooms 108, 109, 208, 209, and other offices) and Building C (Classrooms 206 and 207) located at Bidwell Jr. High School by Hazard Management Services, Inc. (HMS, Inc.). The onsite work was completed between November 14 and 30, 2005, which included a review of the existing US EPA AHERA report, and a review of all building materials in the rooms that will be impacted by the planned renovation project. The inspection was very limited in scope and included only those areas within the two buildings indicated on the drawings that will be affected by the project. The inspection was conducted to comply with U.S. EPA NESHAP requirements for a pre-renovation asbestos survey.

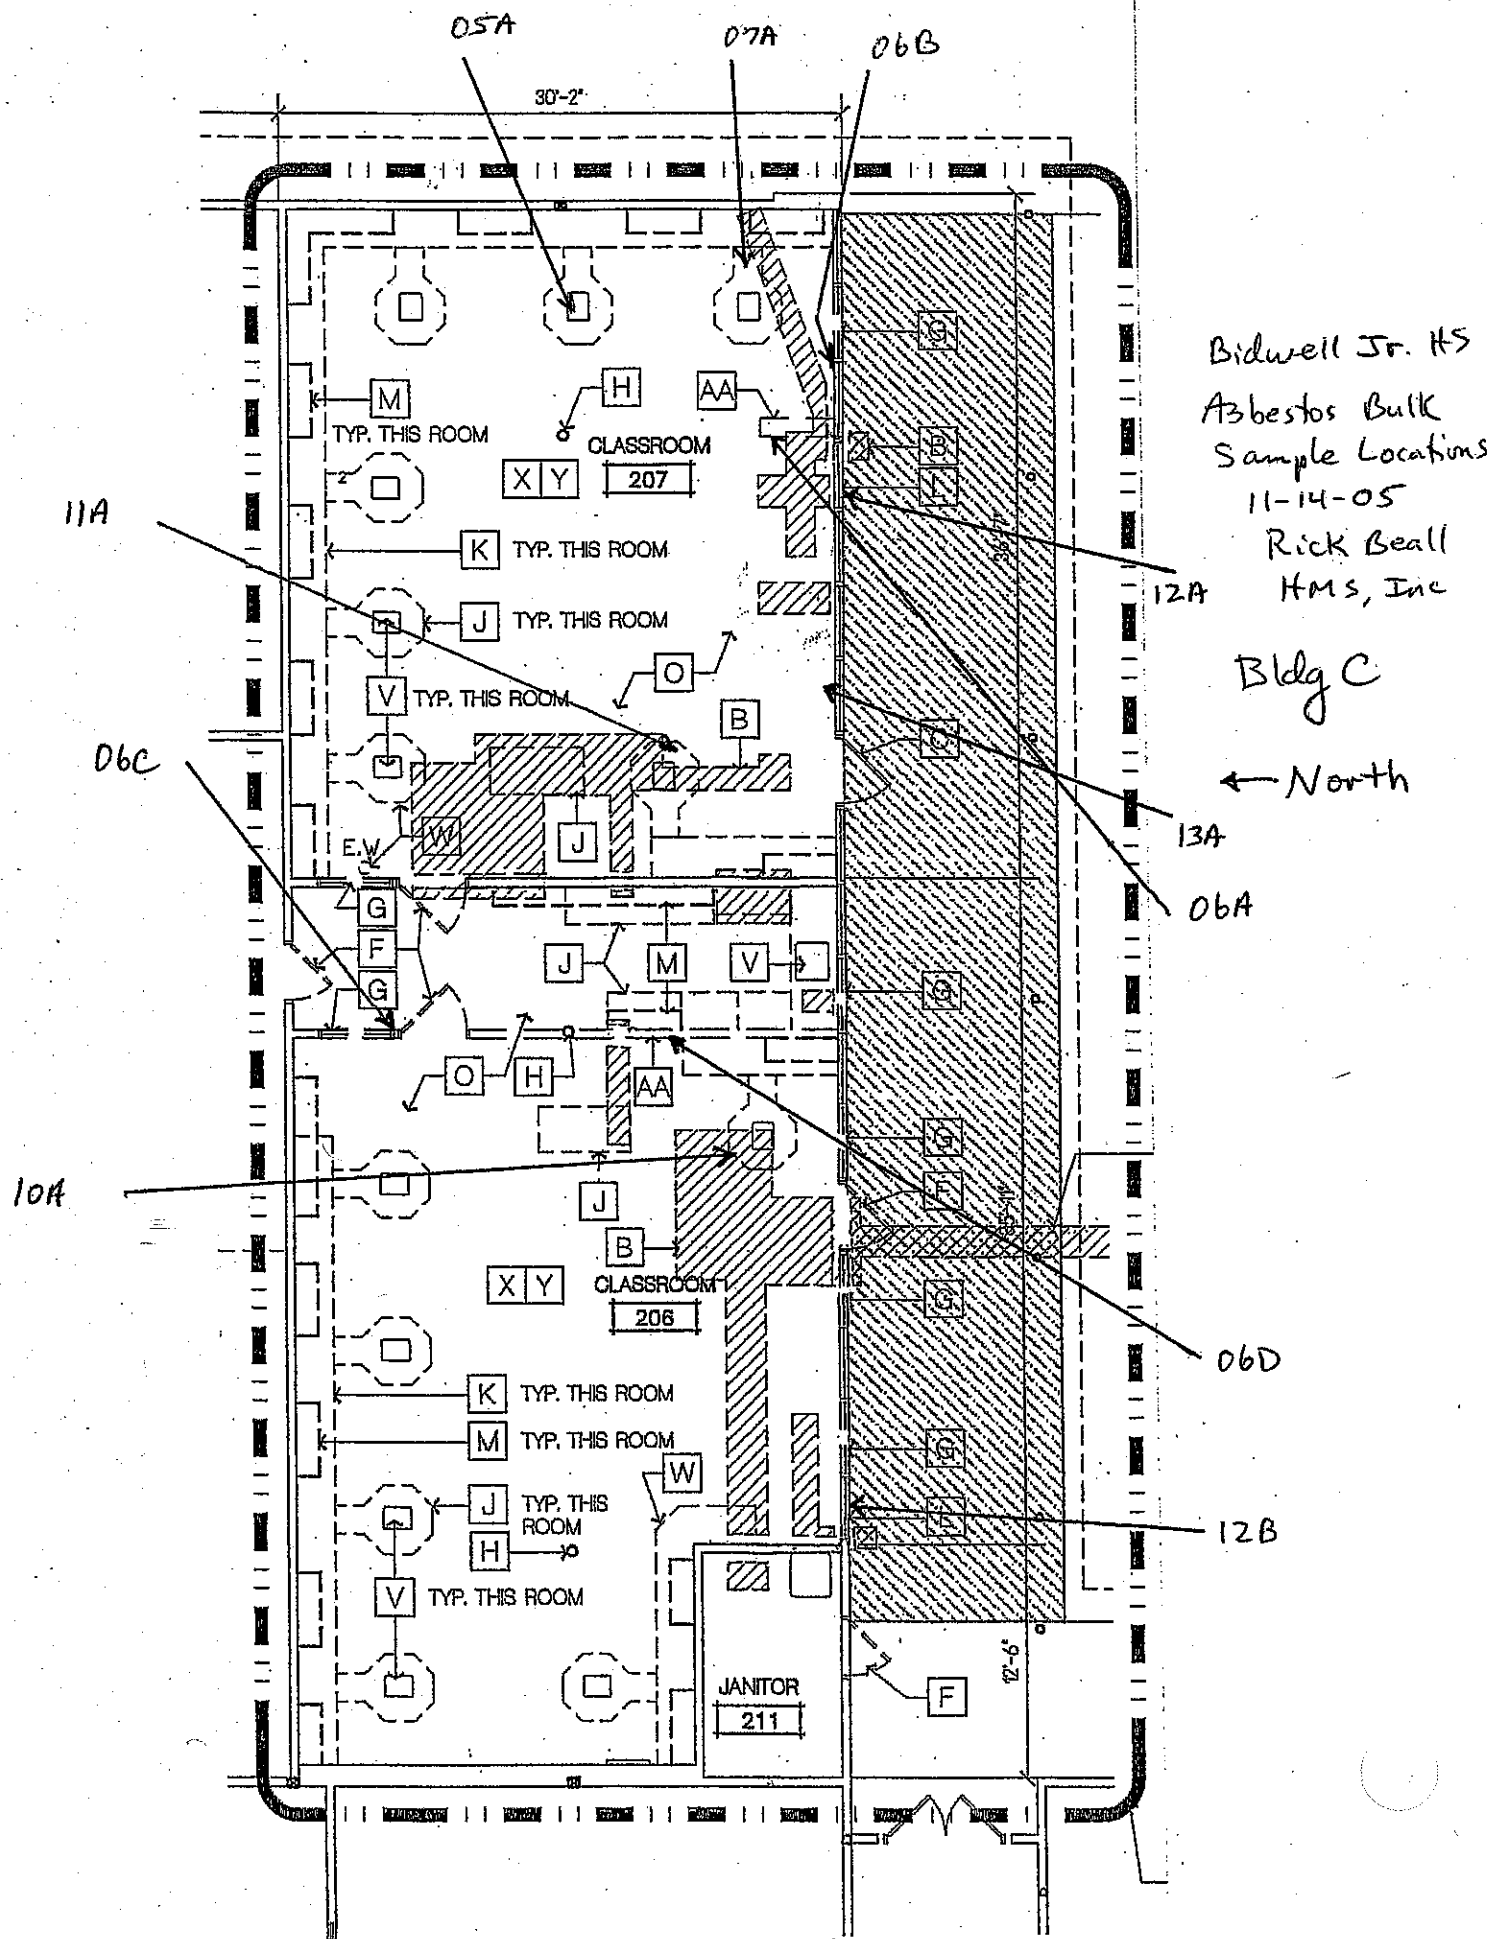
Bidwell Jr. HS  
 Asbestos Bulk  
 Sample Locations  
 11-14-05  
 Rick Beall  
 HMS, Inc

SAMPLE #	RESULTS	MATERIAL DESCRIPTION/LOCATION
HMS-R1823-08A	1-5% CHRYSOTILE (In VFT) 1-5% CHRYSOTILE (In Mastic)	9" VFT and Black Mastic in Room Between Classrooms 108 & 208 at Doorway to Classroom 109, Building A
HMS-R1823-09A	1-2% CHRYSOTILE (In VFT) 1-5% CHRYSOTILE (In Mastic)	12" VFT (Light Brown with Brown Streaks) & Black Mastic at West Side by Door Classroom 208, Building A
HMS-R1823-10A	<1% FIBROUS TREMOLITE	Brown Basecove Mastic, South East Side at Base of Wood Cabinet of Table Extension Classroom 206, Building C
HMS-R1823-11A	<1% FIBROUS TREMOLITE	Brown Basecove Mastic, West Side at Extension Wooden Table Base, Classroom 207, Building C
HMS-R1823-12A	NONE DETECTED	Exterior Stucco Below Register Grill at South Wall Classroom 207, Building C
HMS-R1823-12B	NONE DETECTED	Exterior Stucco Below Register Grill at South Wall Classroom 206, Building C
HMS-R1823-13A	NONE DETECTED	12" ACT, South Side of Classroom Near Door, Classroom 207, Building C

HMS-R1823-14A	1-2% CHRYSOTILE	Drywall Joint Compound at Metal Corner of Wall at Mezzanine by Ladder in Classroom 108, Building A
HMS-R1823-15A	NONE DETECTED (In Drywall) 1-2% CHRYSOTILE (Joint Compound) <1% CHRYSOTILE (Composite)	Drywall and Joint Compound North East Corner of Wall in Room 112 (Finish Room) in Building A
