# **Chico High School**

THREE-YEAR REINSPECTION

**THREE-YEAR REINSPECTION  
HOMOGENEOUS ACM RECORDS**

Date of Inspection: August 1, 2013

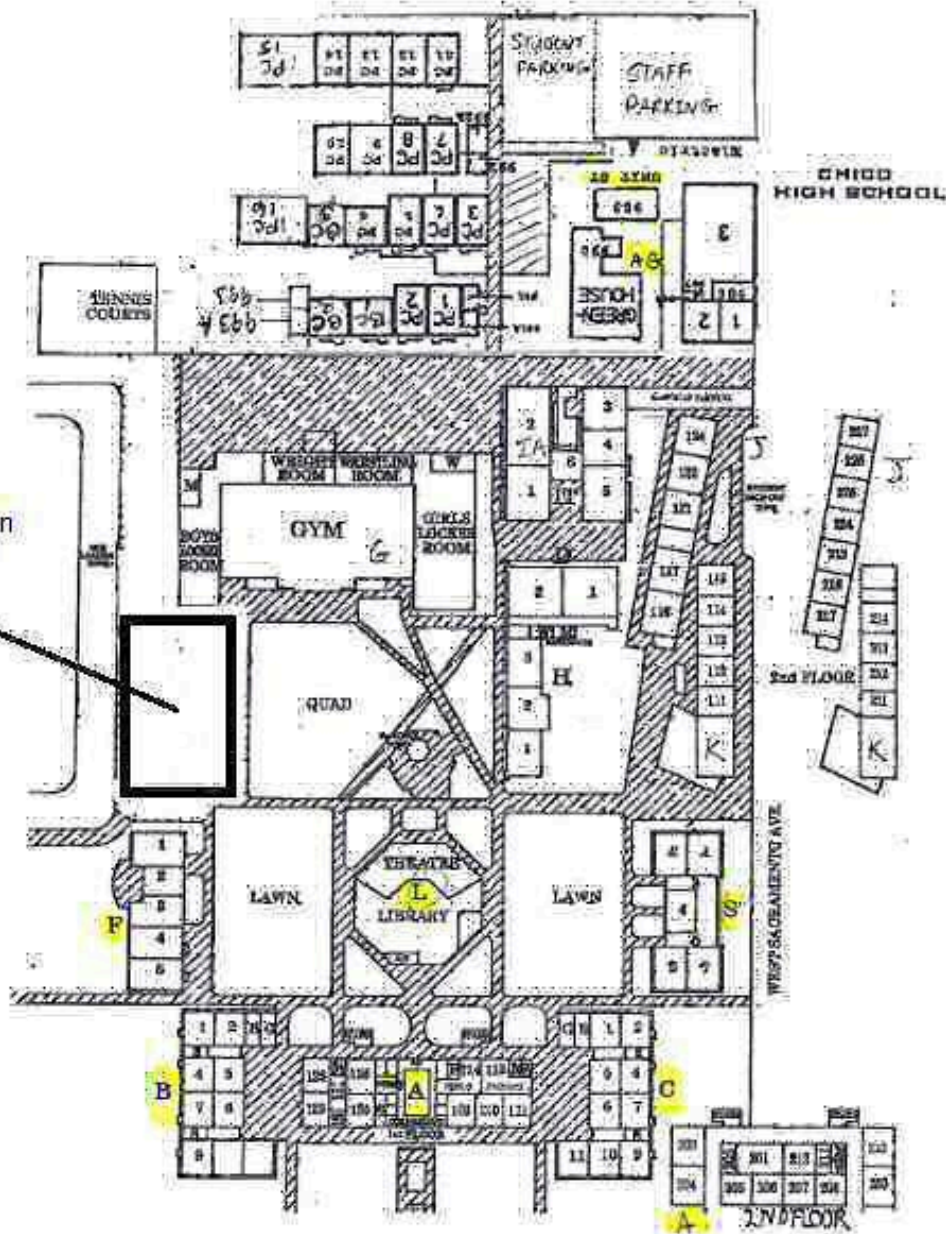
New Building  
Under Construction  
at Time of Survey
