INSPECTION DOCUMENTS

LEA: CHICO UNIFIED SCHOOL DISTRICT

SCHOOL: CHAPMAN ELEMENTARY SCHOOL

DATE OF INSPECTION: MARCH 31, 1988

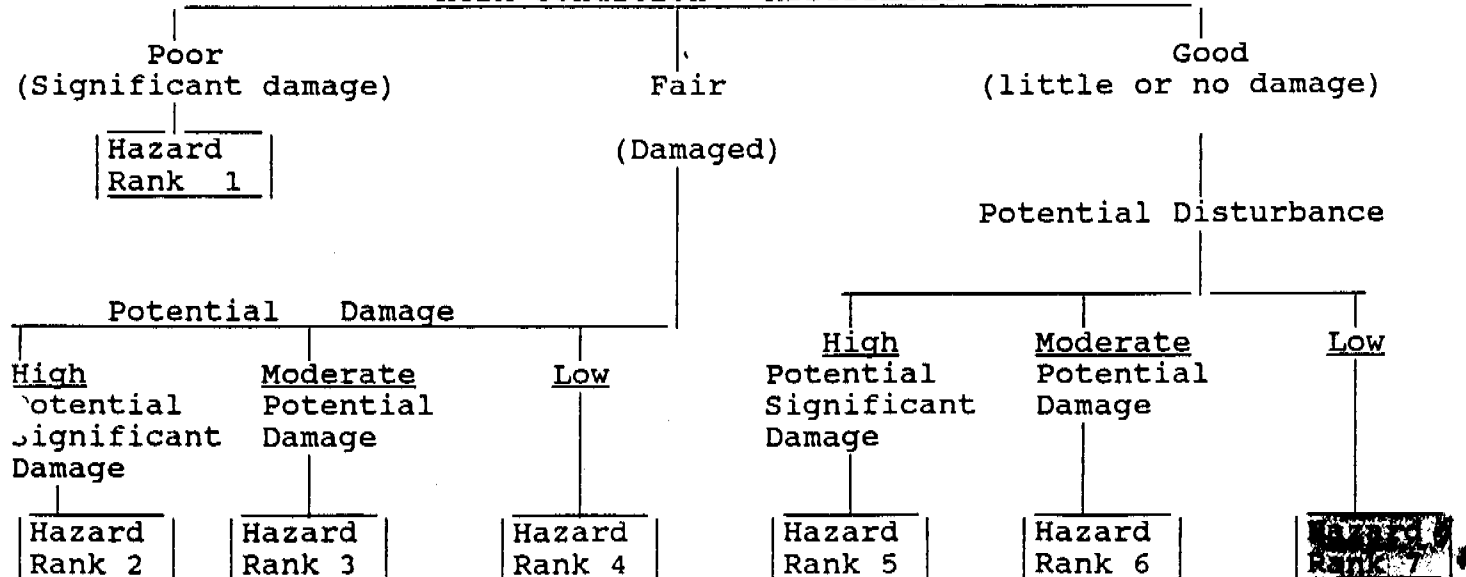
HMS-CPM-72

Material: Surfacing TSI Misc. % Asbestos 50-55

Description PL Straight (Large pipe 10")

DESCRIPTION: No Damage

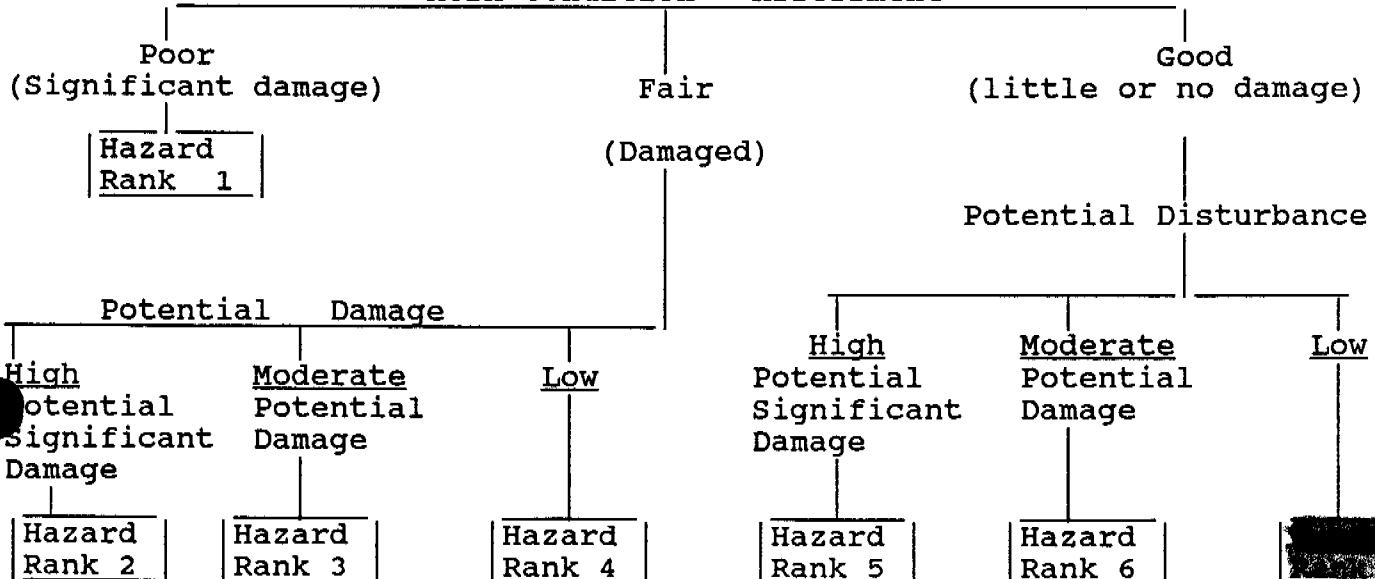
DISTRICT Chico UnifiedPage      of     SCHOOL Chapman ElementaryDate 3-31-88Building Unit GInspector     Location room # 3  
(functional area)HMS-CPM-03Material: Surfacing TST Misc.  
Description mudded joint% Asbestos 1-5Amount of Material (NF / F) 3 corners (ft<sup>2</sup>/lf) Assumed ACM: Y / N # of samples 1

DESCRIPTION: No damage

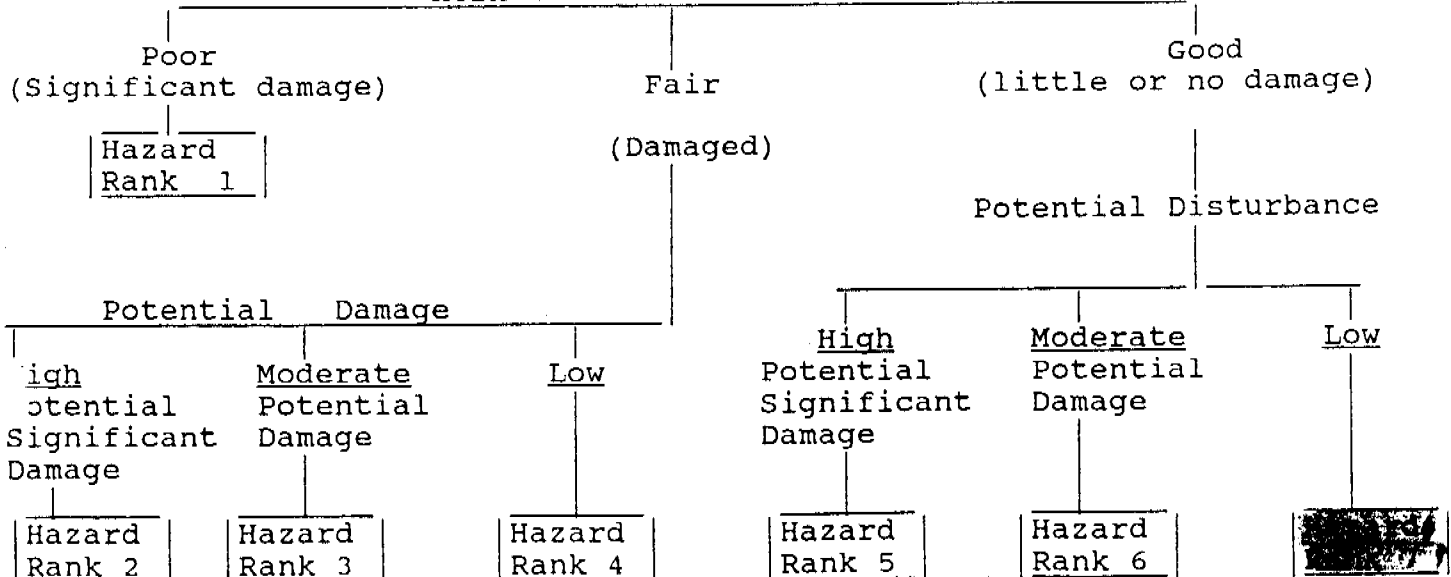
HMS-CPM-13 A, B, C, D, E  
~~F, G~~

Material: Surfacing TSI Misc. % Asbestos 1-5  
Description acoustic ceiling plaster

DESCRIPTION: No damage

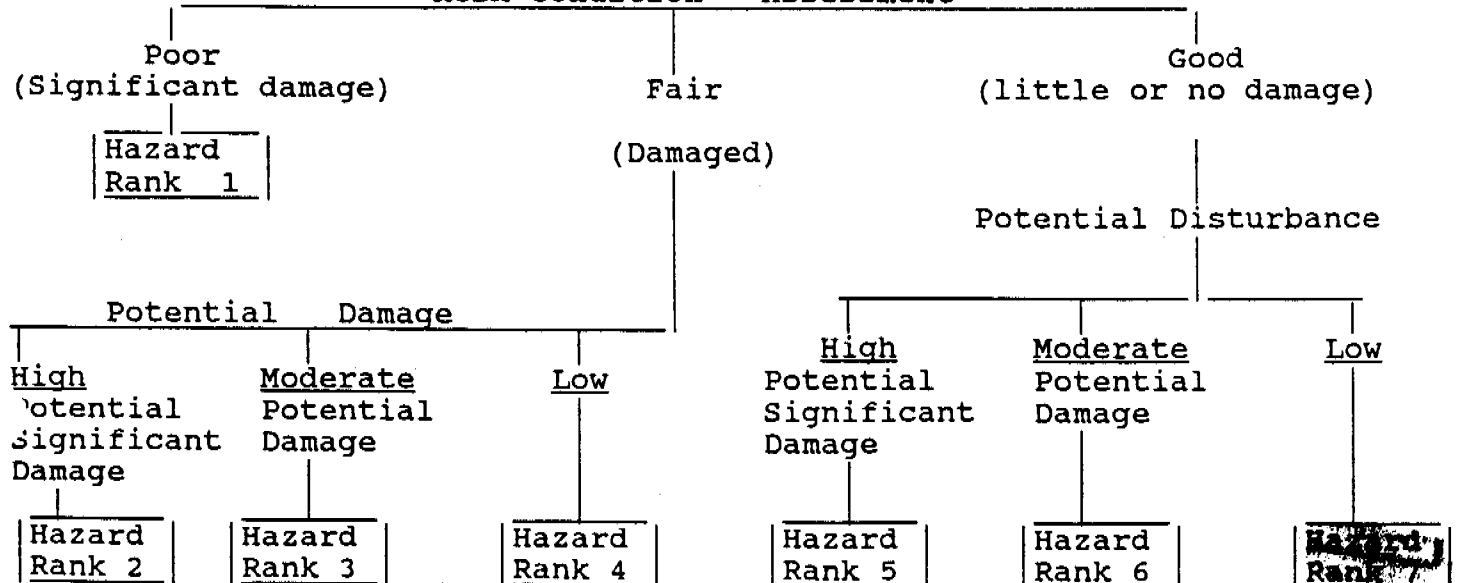
HMS-CPM-24

Material: Surfacing TSI Misc. % Asbestos 10-15

Description VFT 9"- Grey & Backing

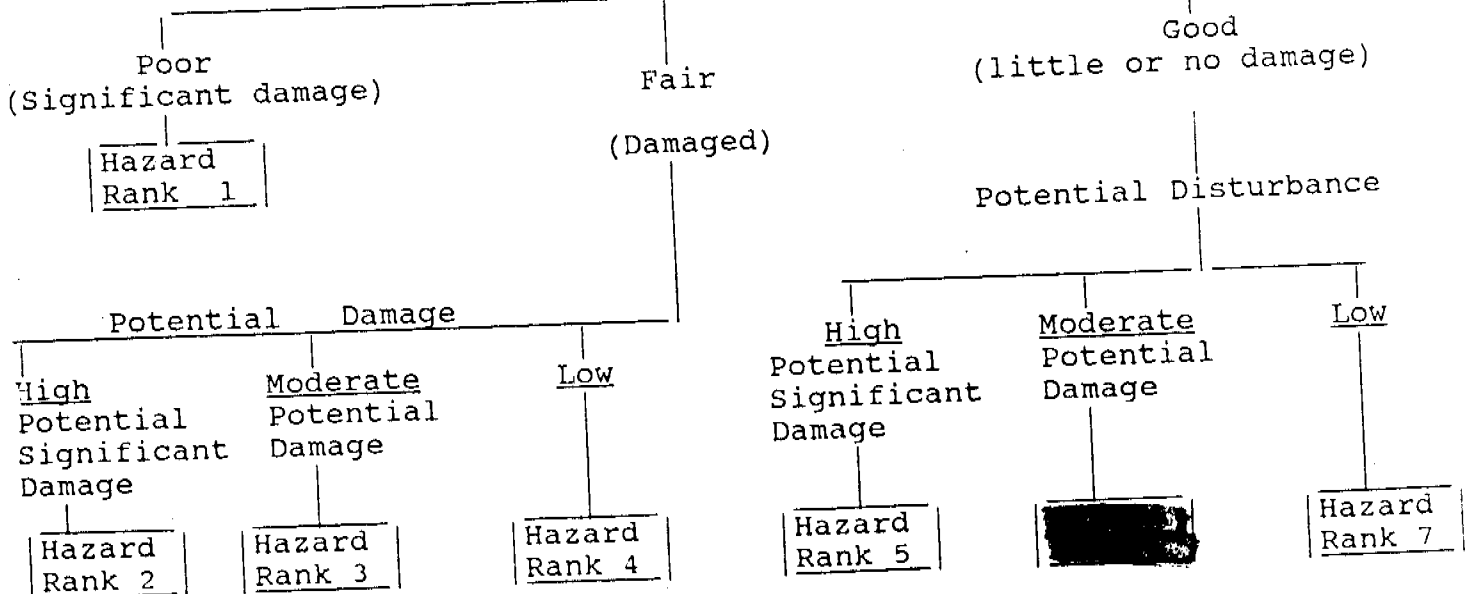
Material: surfacing TSI Misc. % Asbestos 1-5  
Description Hard Plaster Ceiling G-T  
Amount of Material (NF / F) 2400 (ft<sup>2</sup>/lf) Assumed ACM: Y / N # of samples 5

DESCRIPTION: Hole in Girls bathroom ceiling Unit D - room #16.  
from physical or water damage. Hole is 6" x 6"  
No friable edges

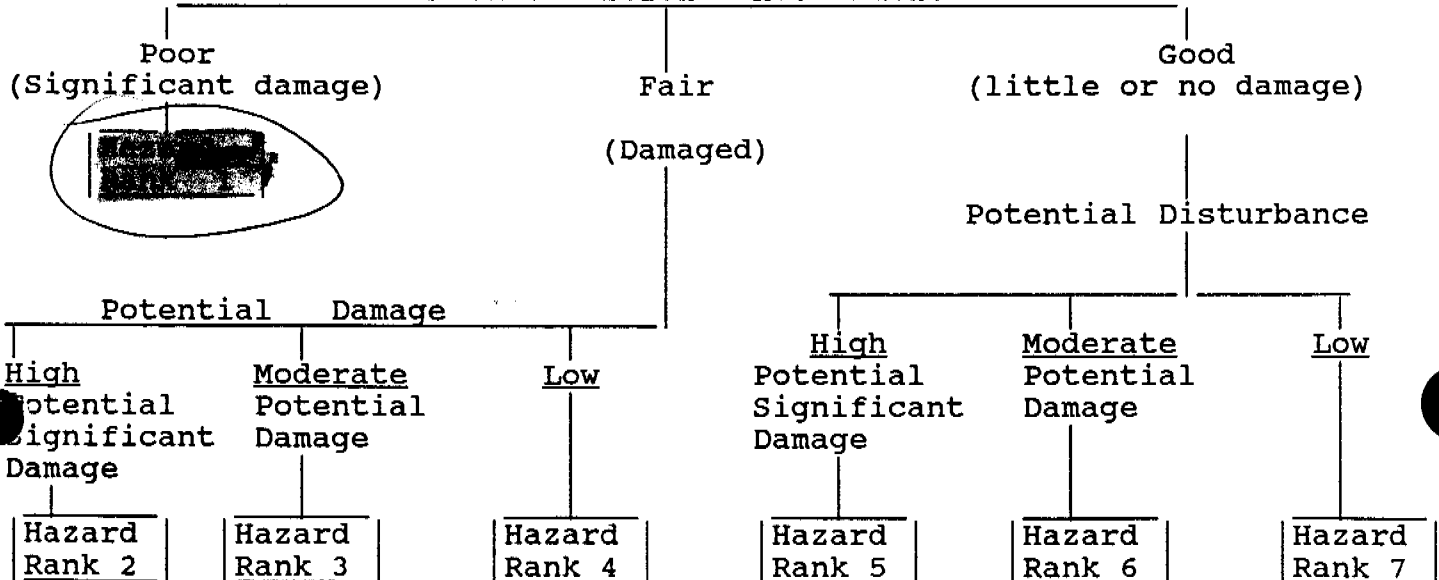
HMS-CPM-09abc

☐ GOOD     
 ☐ DAMAGED (Fair)     
 ☒ SIGNIFICANTLY DAMAGED (Poor)

☐ LOW     
 ☐ MODERATE (Potential for damage)     
 ☒ HIGH (Potential for significant damage)

Material: Surfacing TSI Misc.  
Description Debris% Asbestos C 75-80Amount of Material (NF / F) 0/5 (ft<sup>2</sup>/lf) Assumed ACM: Y / N # of samples 3CONDITION: % damaged: Extent of damage:  
0% <1% 1-10% 11-25% >25% none local distributedType damage: air; deterioration; water; physical; flaking

| RESPONSE ACTION | ESTIMATED COSTS |
|---|---|
| <input checked="" type="checkbox"/> E. REMOVAL _____ | \$ 1,350.00 |

| E. REMOVE DEBRIS AND 25 FEET OF AIRCELL PIPEWRAP ACCORDING TO OLA SPECS. | SCHEDULE | |

REMOVED 8/89
