06-133 Chico USD
Community Day School
Chico, CA

BULK ASBESTOS ANALYSIS REPORT

BULK ASBESTOS MATERIAL Analysis Request Form for Entek Consulting Group, Inc.

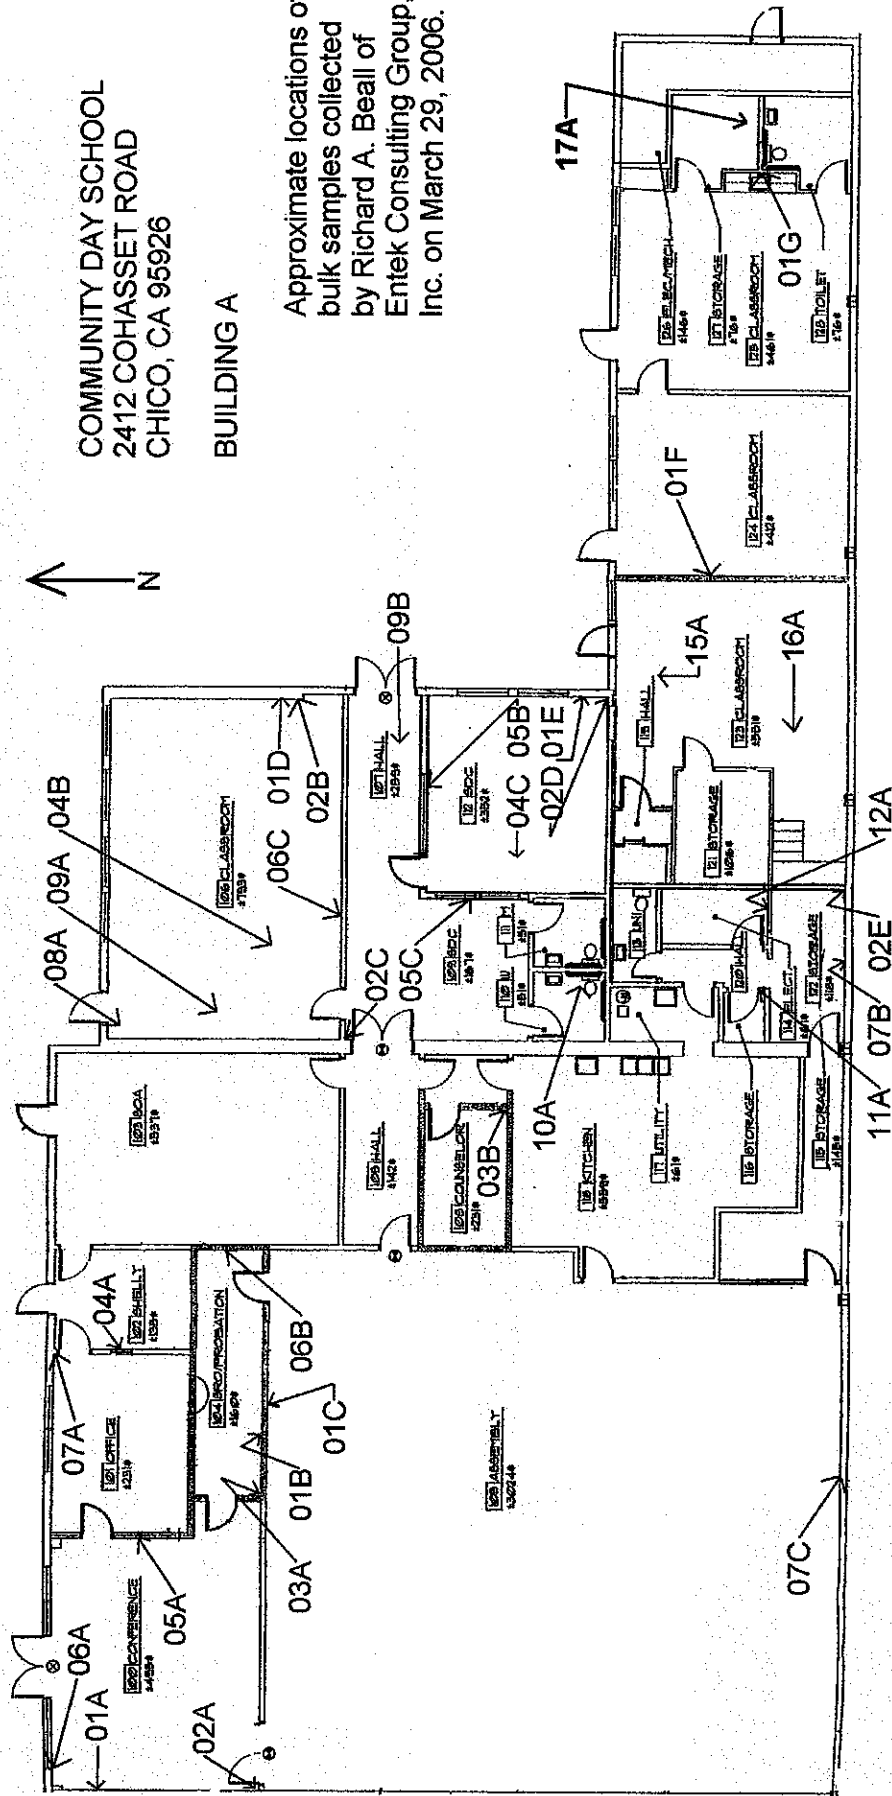
BUILDING A

Approximate locations of bulk
samples collected by Richard A
Beall of Entek Consulting Group,
Inc. on March 29, 2006

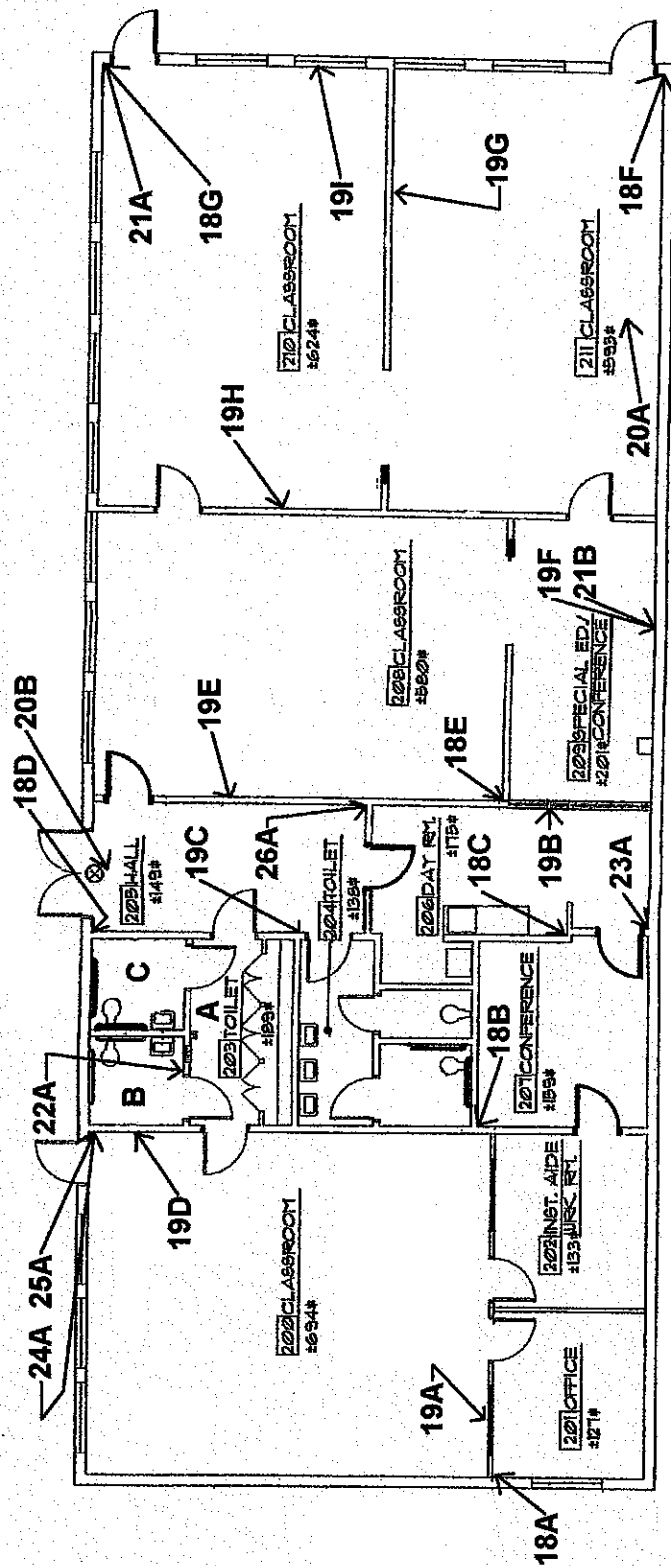
BUILDING B

Approximate locations of bulk
samples collected by Richard A.
Beall of Entek Consulting Group,
Inc. on March 29, 2006.
