Chico Junior High School  
Inspected 3/29/88

**PHYSICAL AND HAZARD ASSESSMENT OF FRIABLE  
ACBM OR FRIABLE ASSUMED ACBM (FORM C)  
(SEC. 763.93)**

| CHICO JUNIOR HIGH SCHOOL | | | 04 61424 6057137 | | |

## Inspection Form I-1

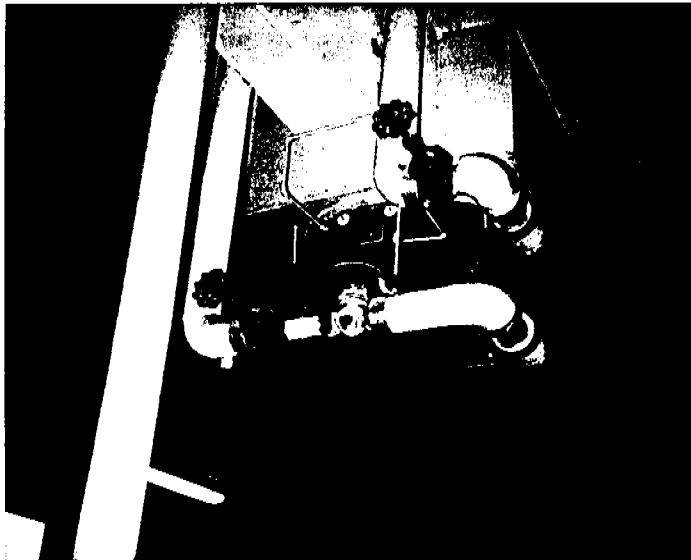
Mens locker room showing pipewrap directly in front of fan blower at ceiling level.
