**AIRBORNE FIBER ANALYSIS REPORT  
PHASE CONTRAST MICROSCOPY**

Client : Chico Unified School District  
Site : Chico Jr. High School

Client's  
Job ID : C1215 - Pipe "Wrap & Cut" Removal of Old System

**1998  
Asbestos Three Year Re-Inspection**

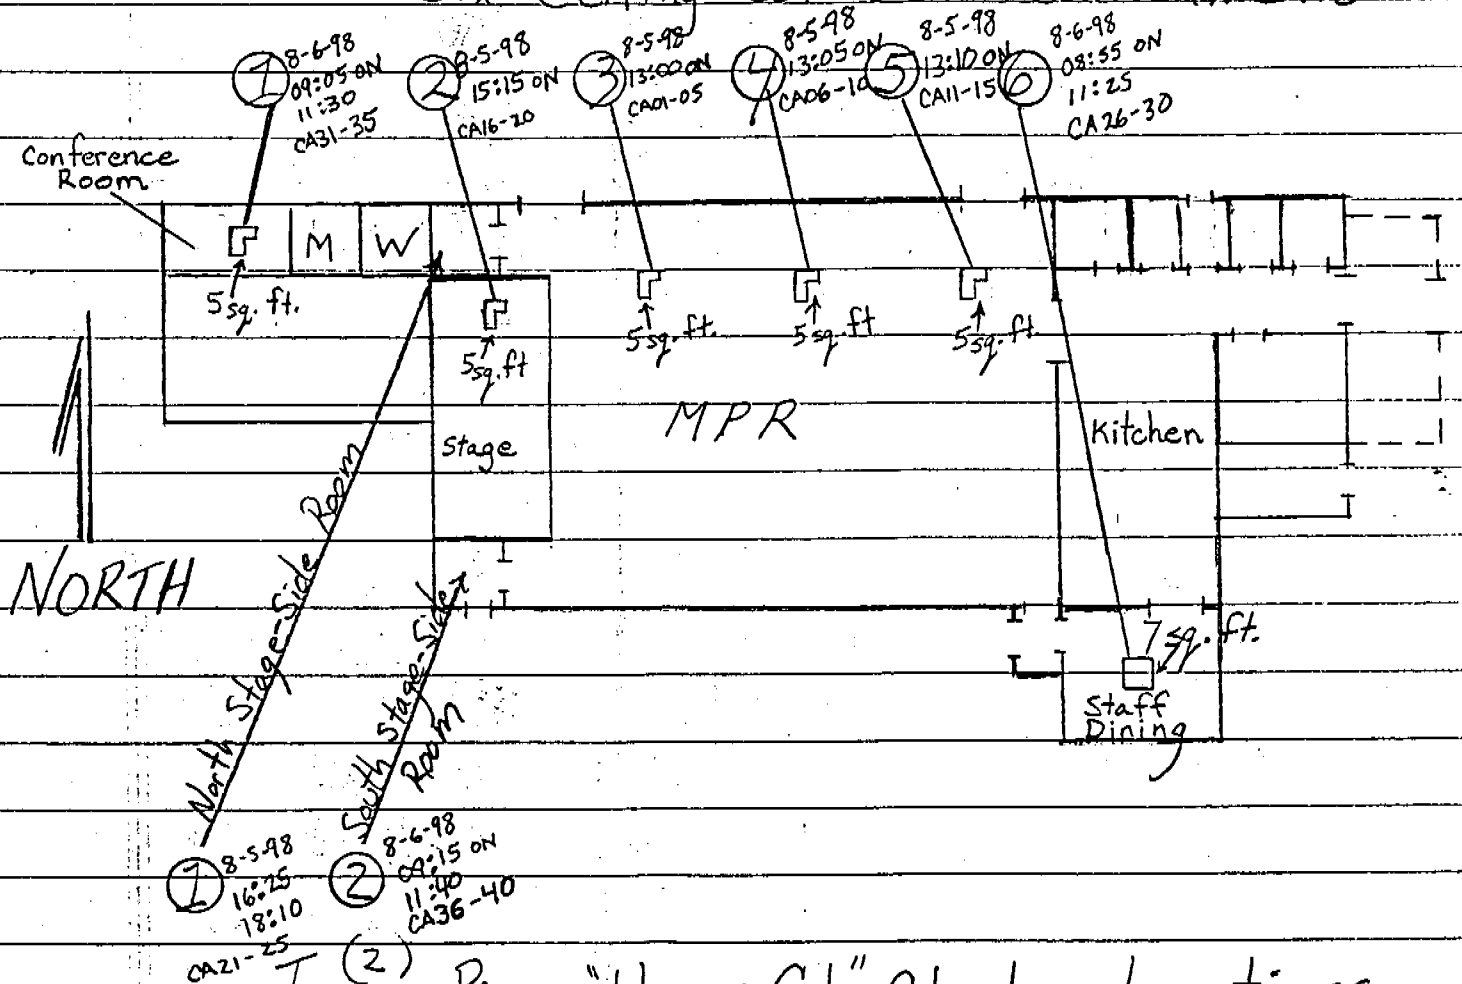
(6) Six Ceiling Cut Out Containments

(2) Two Pipe "Wrap & Cut" Glovebag Locations

Location 1: 2 pipes each 14' long, double wrapped, then cut at wall after removing pipewrap by glovebag, then disconnected at other end by loosening the threaded unions.

Location 2: Same - except 2 pipes each 6' long were removed.
