**SIX MONTH SURVEILLANCE
HOMOGENEOUS ACBM RECORDS**

Date of Inspection: 07/07/2006

District: Chico Unified School District

School: Chico Senior High School

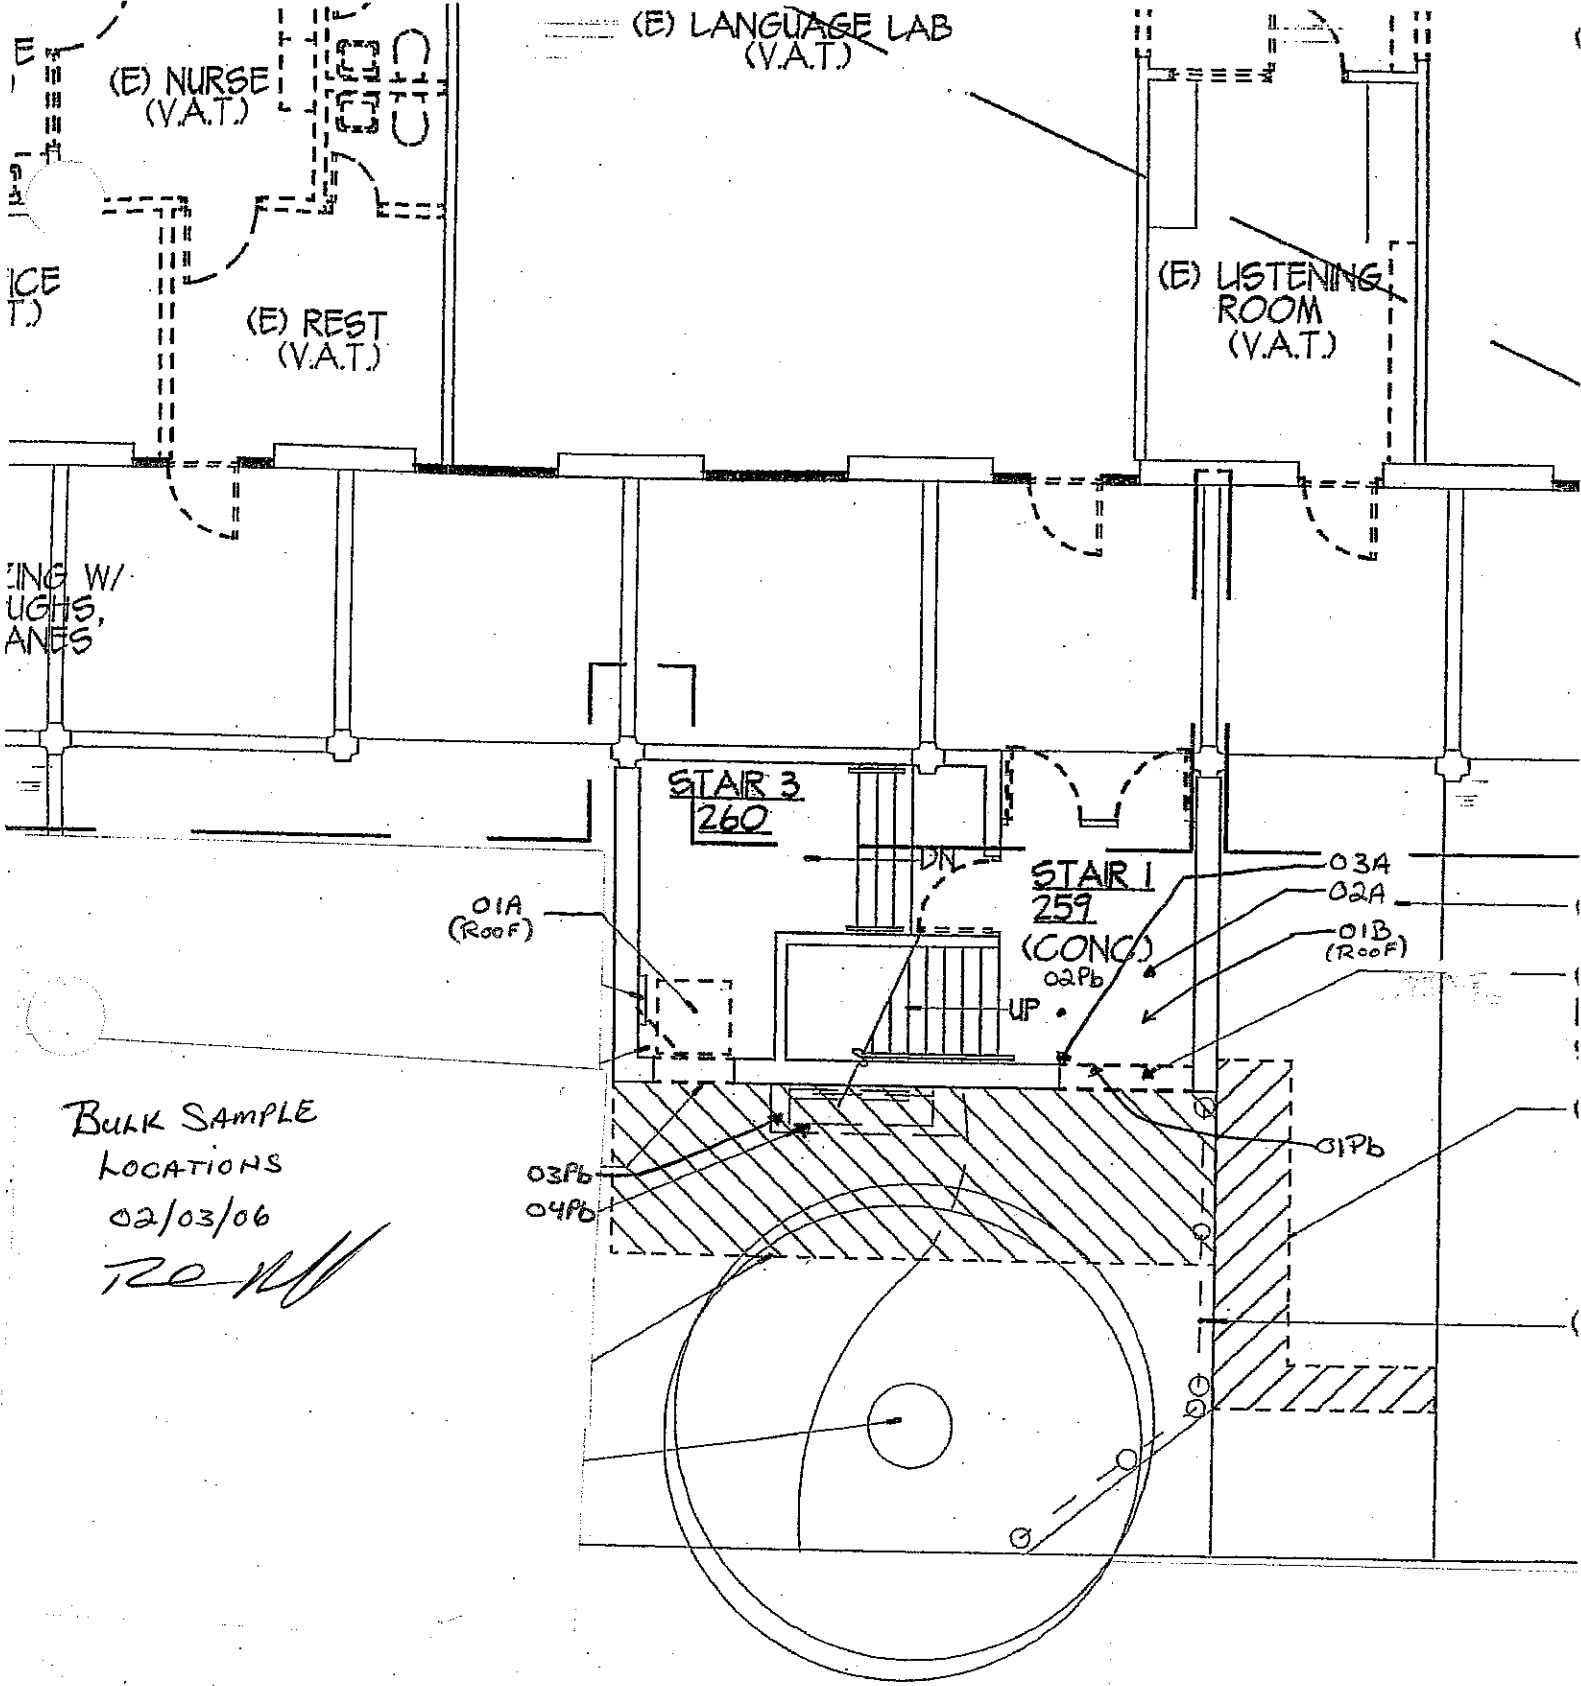
Bulk SAMPLE
 LOCATIONS
 02/03/06
re M

Stucco Ceiling Surfacing (Found on Stairway Ceiling)

Transite Panels (Found Under & Above Windows in the Stairway)

The Stucco Ceiling Surfacing material found to <1% asbestos during this investigation is regulated by Cal-OSHA as an ACCM, the transite panels are regulated as ACM. Therefore, notification, worker protection, and registration requirements would apply to disturbance of these materials.
