ENTEK CONSULTING GROUP, INC.

RE: Triennial AHERA Three-Year Reinspection

THREE-YEAR REINSPECTION

School: Loma Vista Elementary School

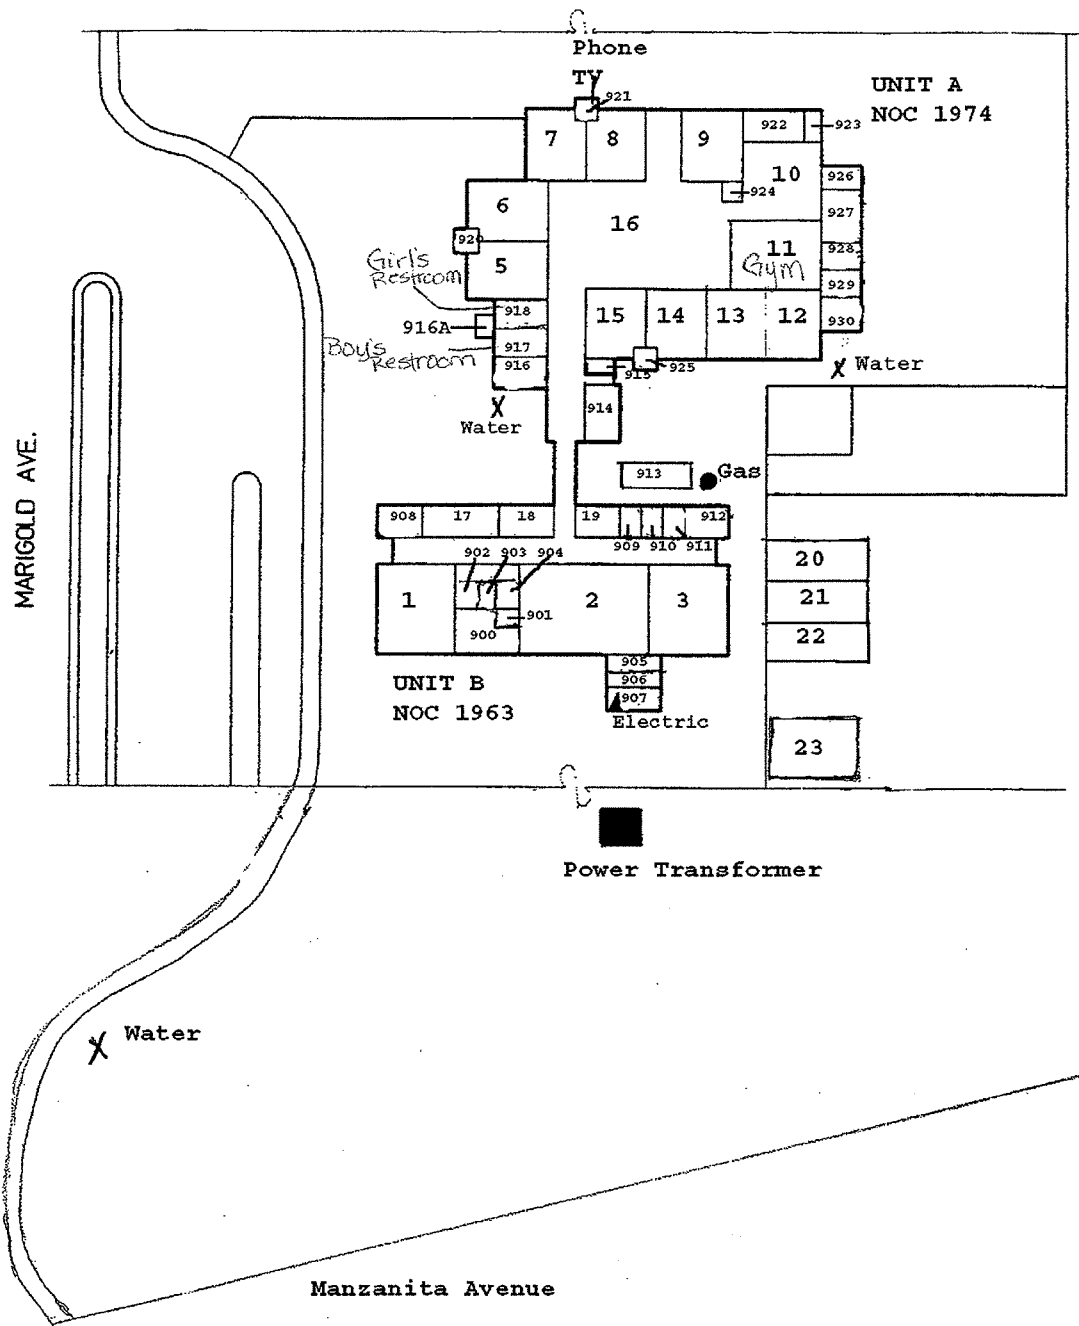
LOMA VISTA SCHOOL

Three-Year Reinspection
 Conducted By: William Esparza
 Entek Consulting Group, Inc.
 May 10, 2007
