**Bulk Material Analysis**  
Method: 40 CFR 763, Subpart F, Appendix A (AHERA)

P.O. Num:  
Job ID: 96-4623  
Site: Marigold - Units 1, 3 & 5

# Roofing Samples 5-6-96

## MARIGOLD SCHOOL, 1995-96

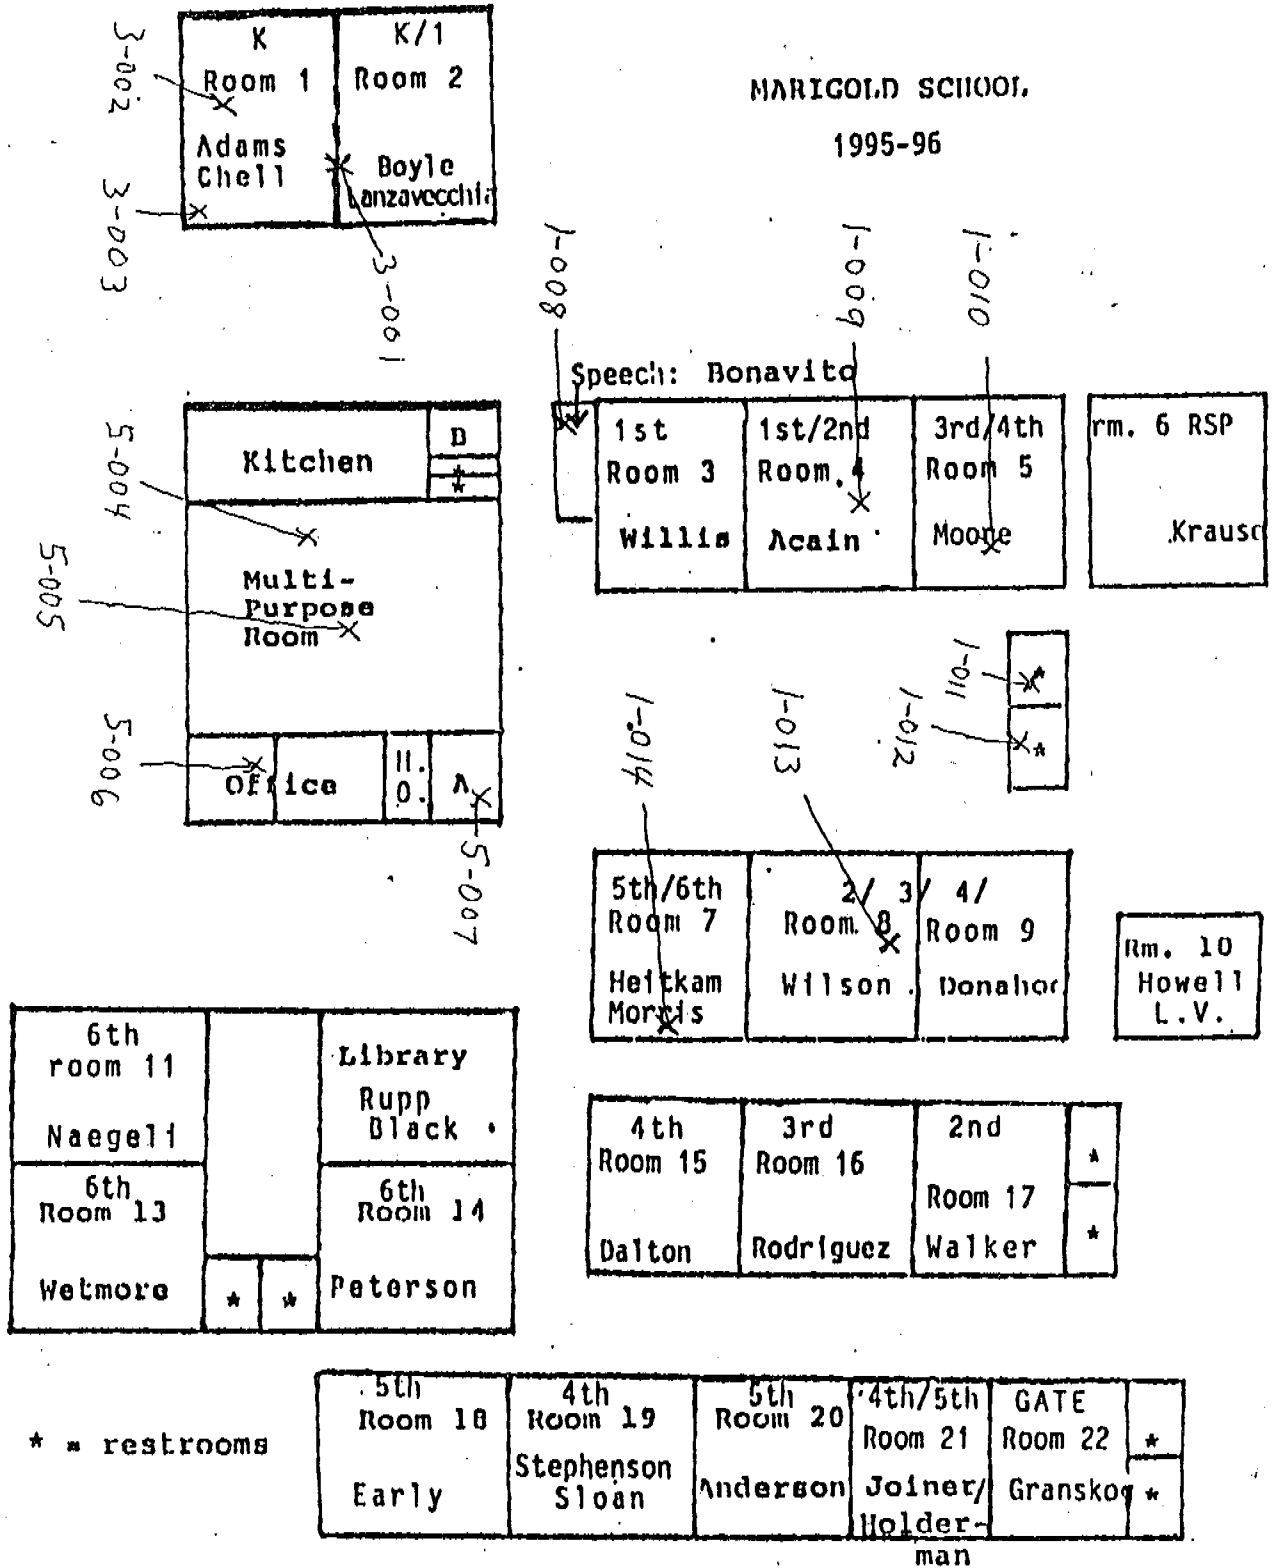
| SAMPLE NUMBER | DATE COLLECTED | SAMPLE LOCATION/DESCRIPTION |
|---|---|---|
| 1-008 | 5-6-96 | Roof over unit 1 - NW corner |
| 1-009 | " | Roof over Unit 1 - <sup>North</sup> Center by Ridge |
| 1-010 | " | Roof over Unit 1 - N.E. side |
| 1-011 | " | Roof over Unit 1 - by Restrooms |
| 1-012 | " | Roof over Unit 1 - by Restrooms |
| 1-013 | " | Roof over Unit 1 - South Ridge |
| 1-014 | " | Roof over Unit 1 - S.W. Side |

| SAMPLE NUMBER | DATE COLLECTED | SAMPLE LOCATION/DESCRIPTION |
|---|---|---|
| 3-001 | 5-6-96 | Roof over Unit 3-South Ridge |
| 3-002 | " | Roof over Unit 3-West side |
| 3-003 | " | Roof over Unit 3-S.W. Corner |
| 5-004 | " | Roof over Unit 5-North side |
| 5-005 | " | Roof over Unit 5-Center Ridge |
| 5-006 | " | Roof over Unit 5-Office Area |
| 5-007 | " | Roof over Unit 5-S.E. Corner |
