**Bulk Sample Analysis (PLM) Report for:**

## ADDITIONAL MANAGEMENT PLAN DATA

SIERRA VIEW ELEMENTARY SCHOOL  
CHICO UNIFIED SCHOOL DISTRICT  
CHICO, BUTTE CO., CALIFORNIA

## SIX-MONTH SURVEILLANCE

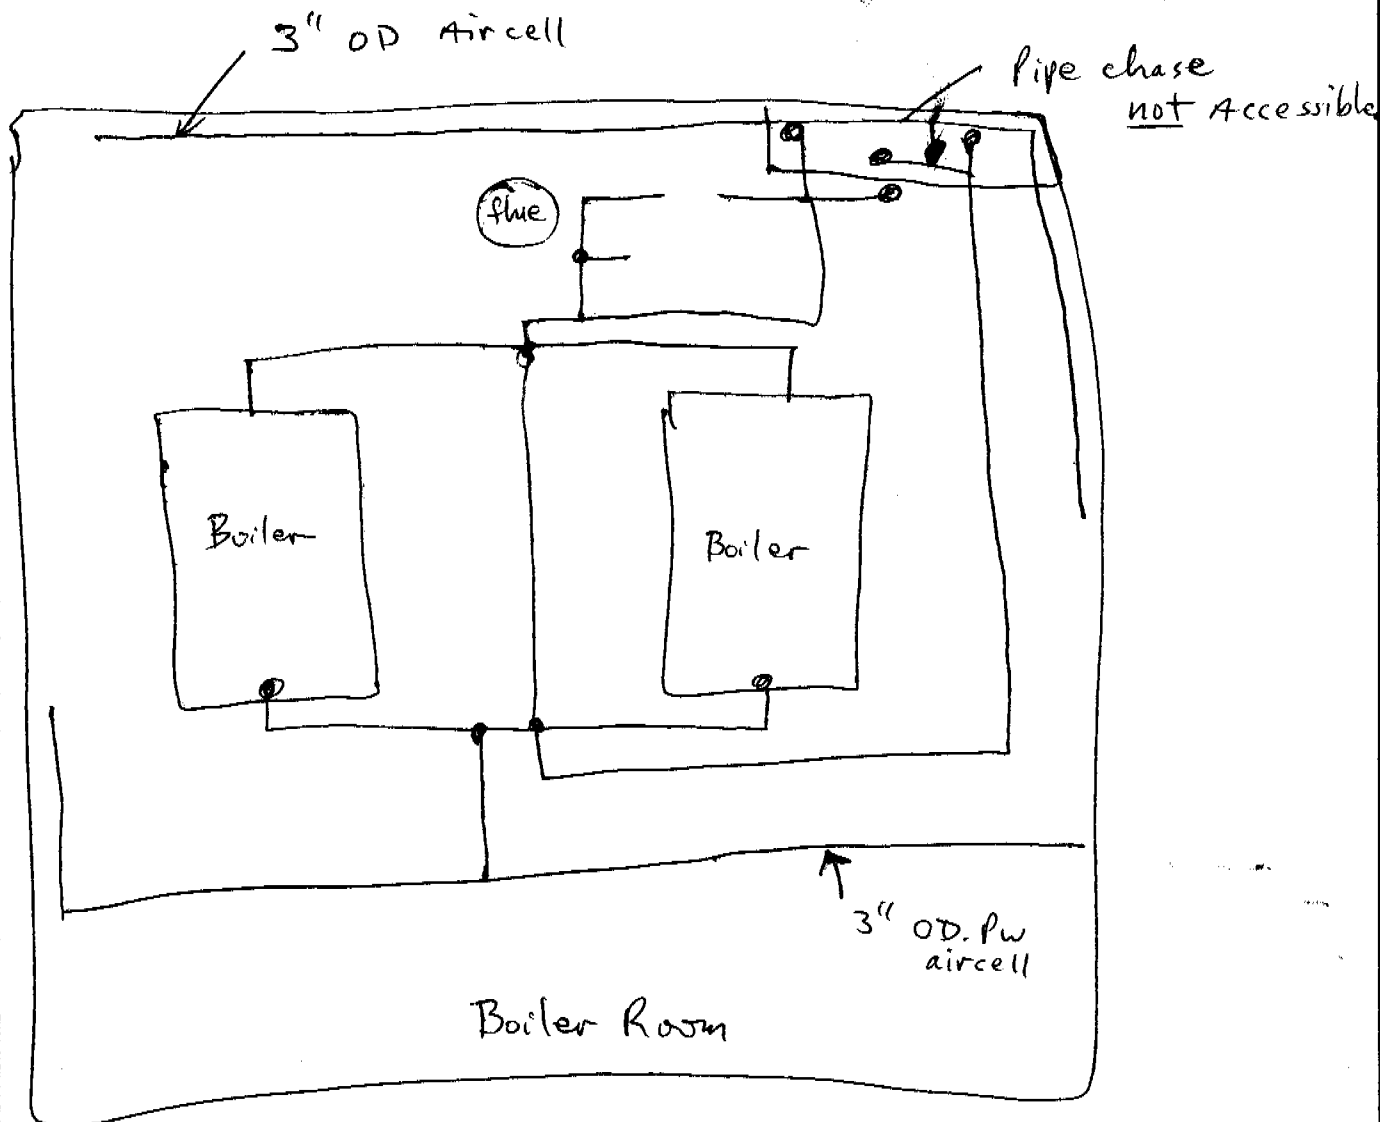
# Boiler Room Unit A

Approx 80' 6-8" OD pipewrap  
55' 3-4" OD pipewrap

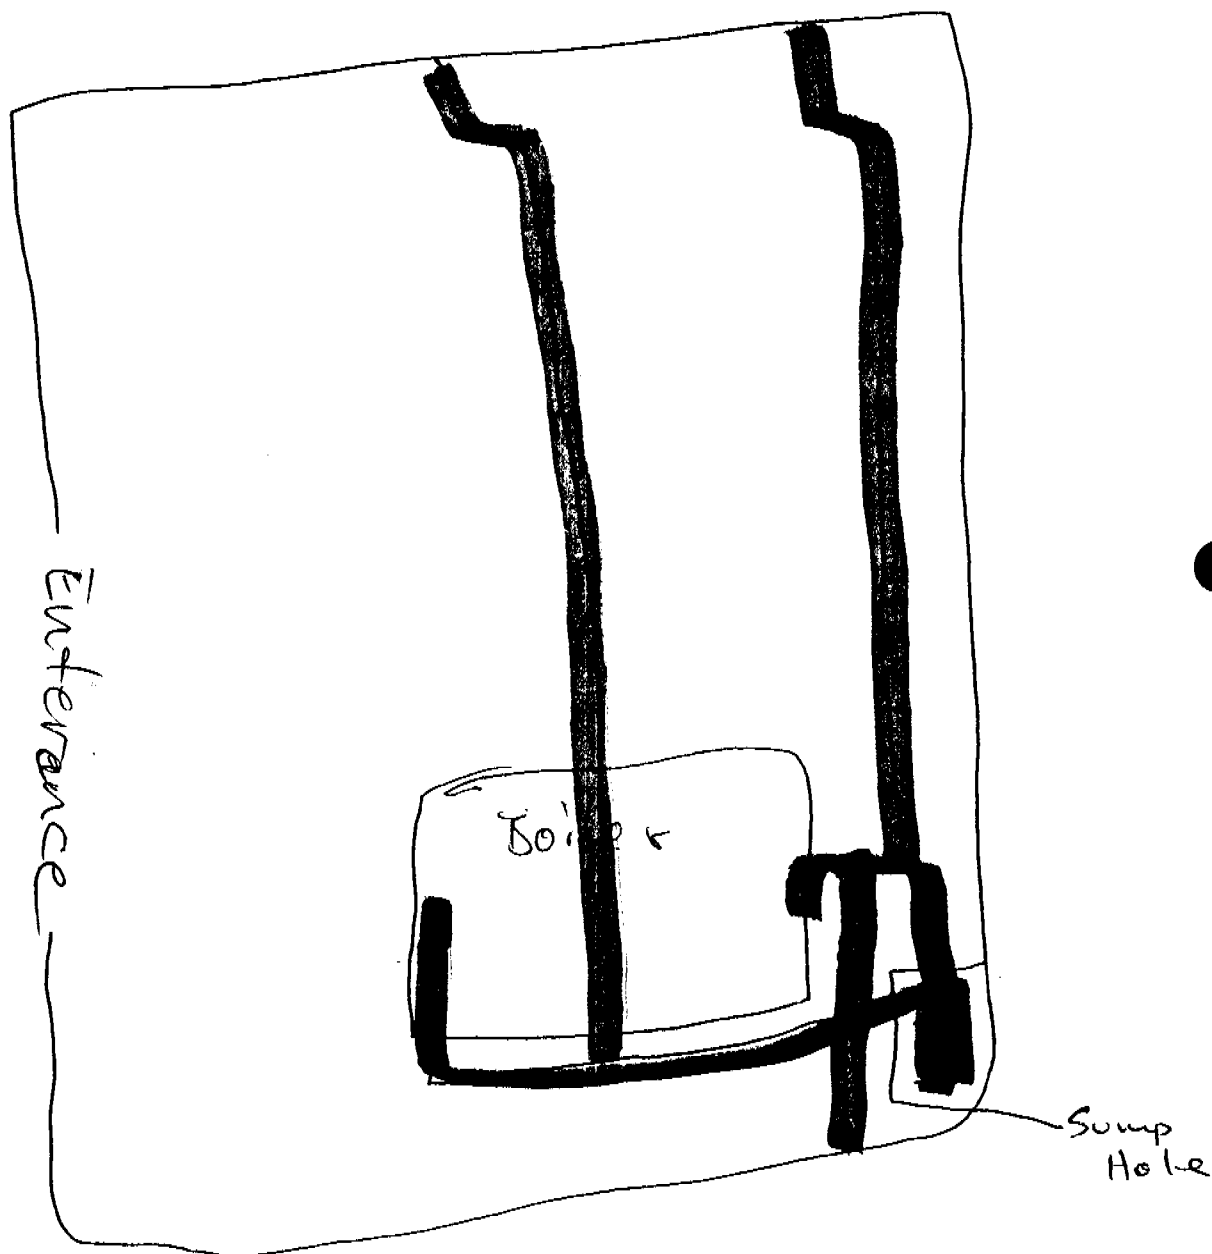
Unit E

Pipe Straights are F/6 (mostly)  
Joints are mudded  
Access is good in all Areas
