## SECTION 5. ELEMENTARY SCHOOLS

# CHAPMAN ELEMENTARY SCHOOL

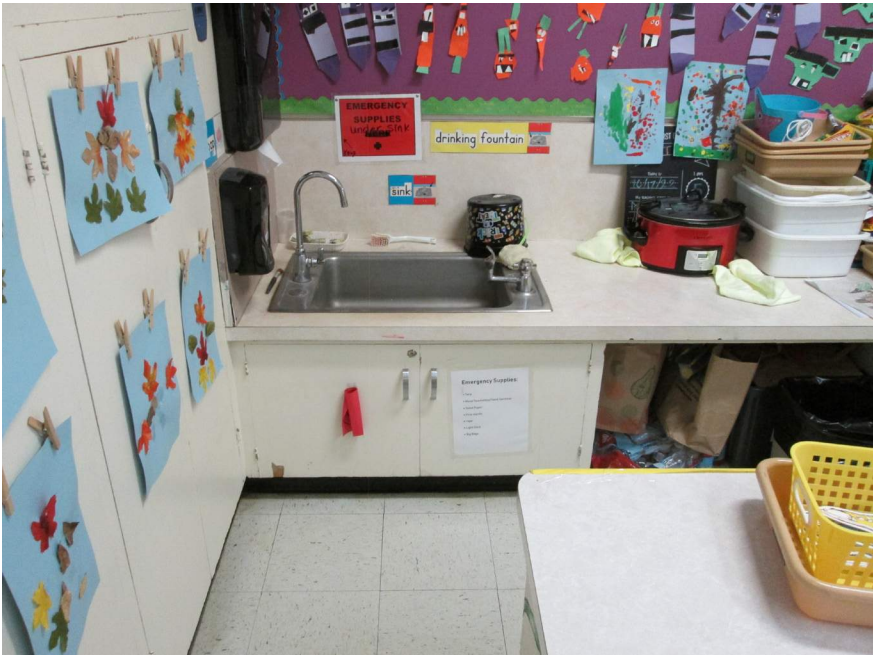
Accessibility upgrades required

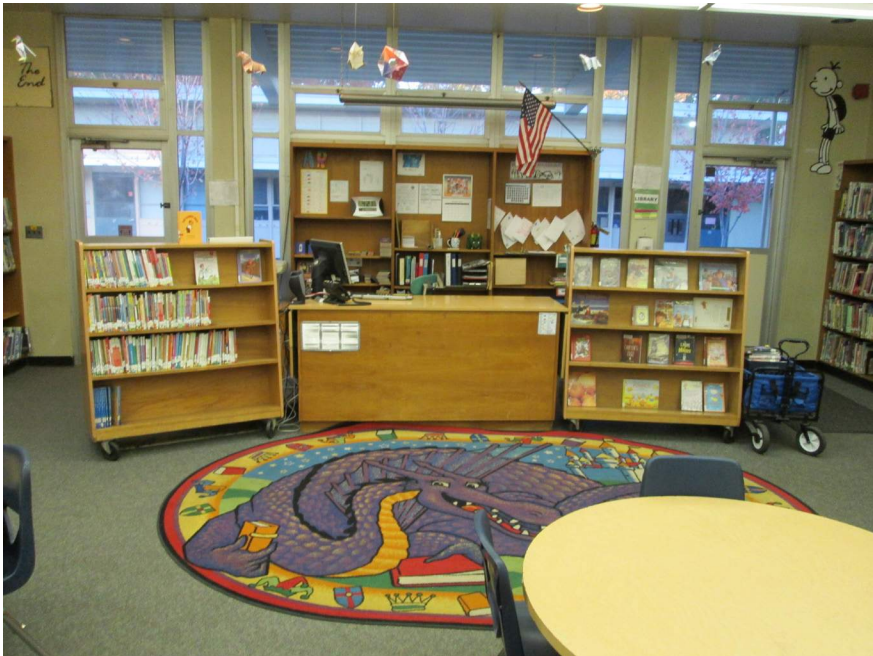
Aging casework and finishes

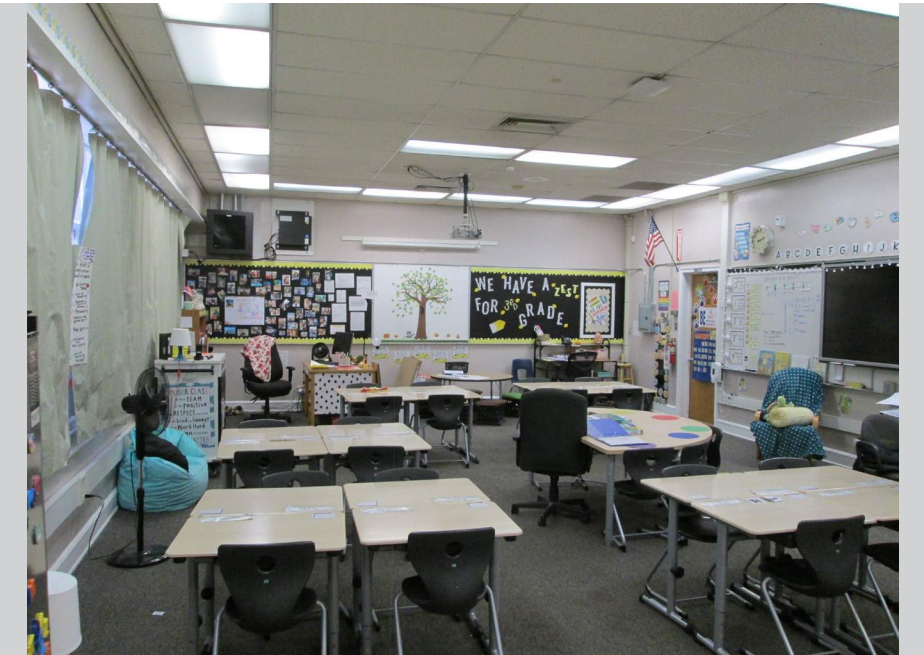
Classroom storage and full interior finishes renovation

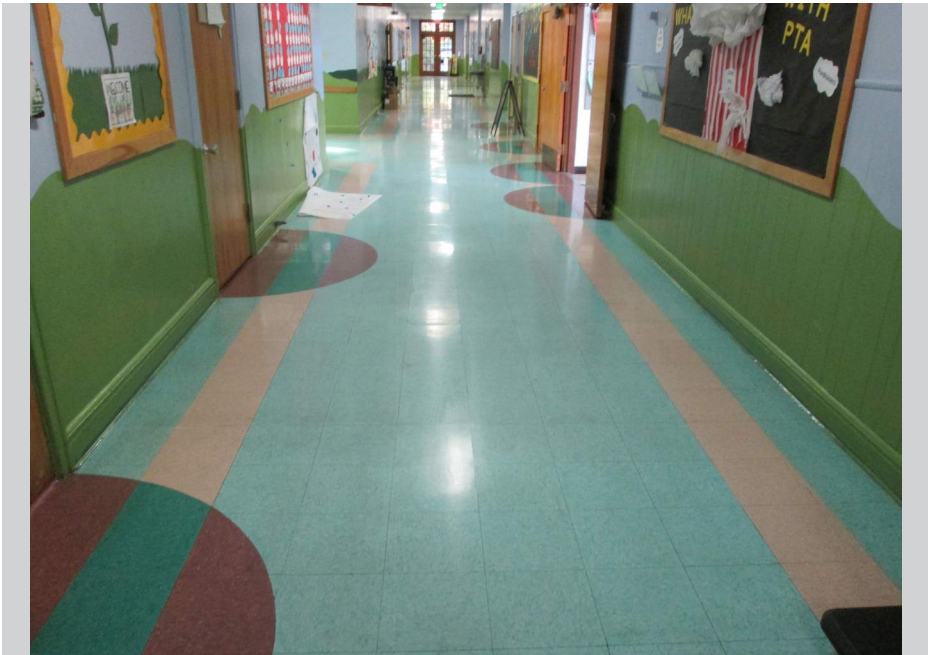
Interior finish upgrades and replacements

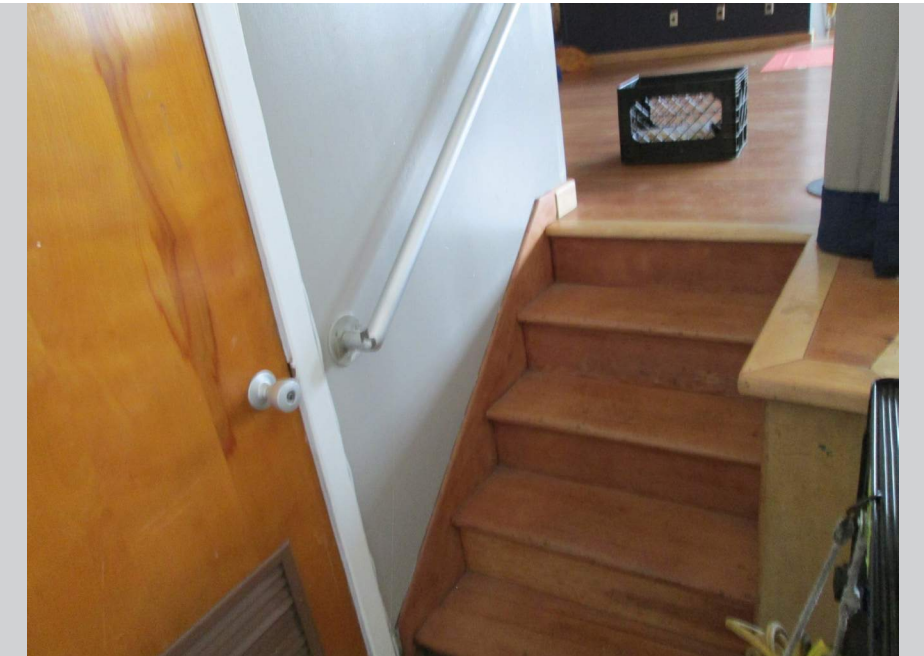
ADA compliance upgrades

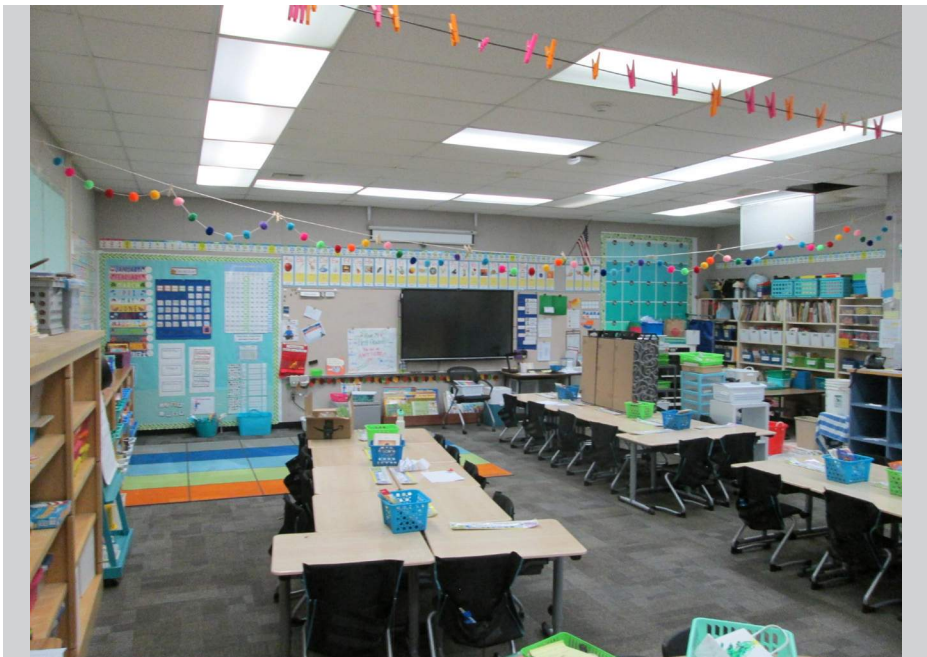
Classroom storage and interior finish upgrades

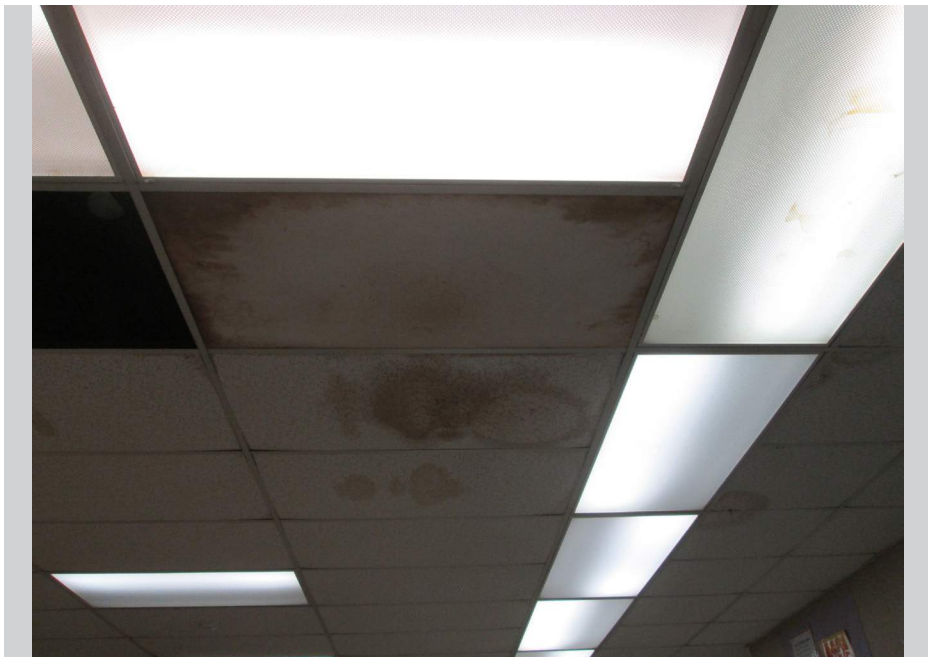
Acoustical Ceiling Tile replacement

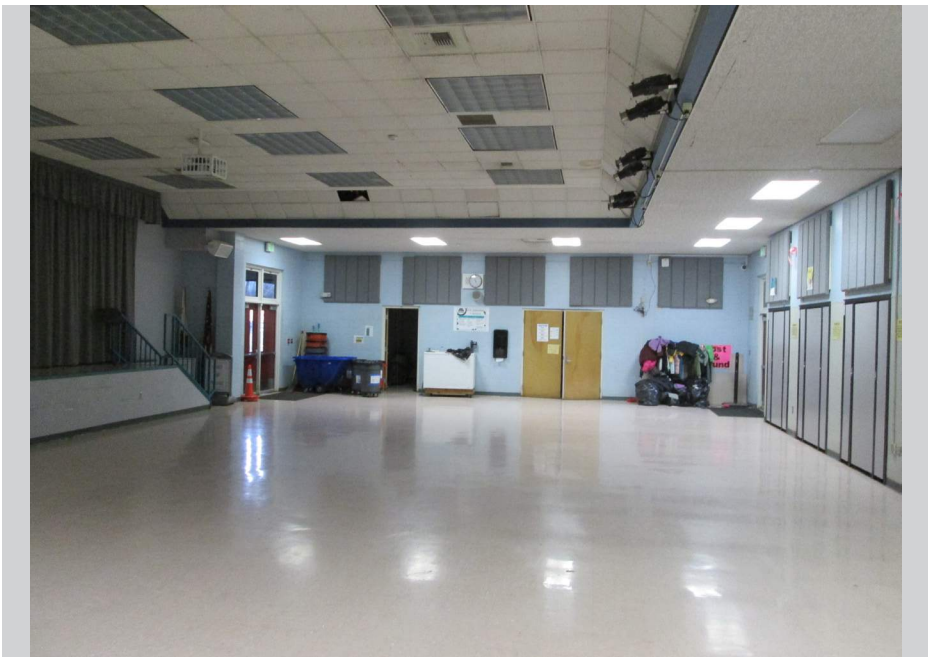
Multi-purpose daylighting improvements

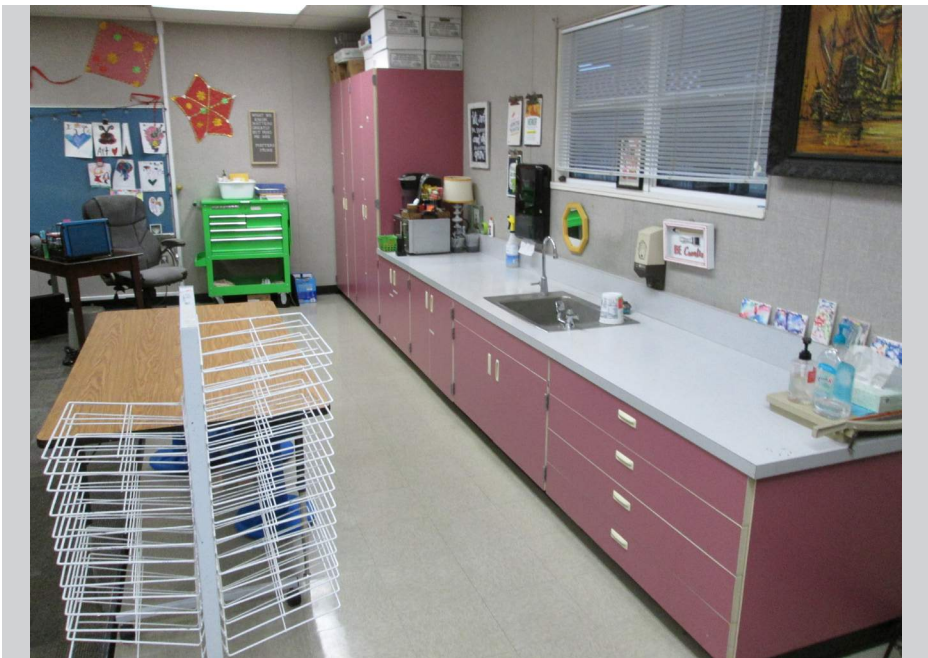
Casework and sink improvements for ADA compliance

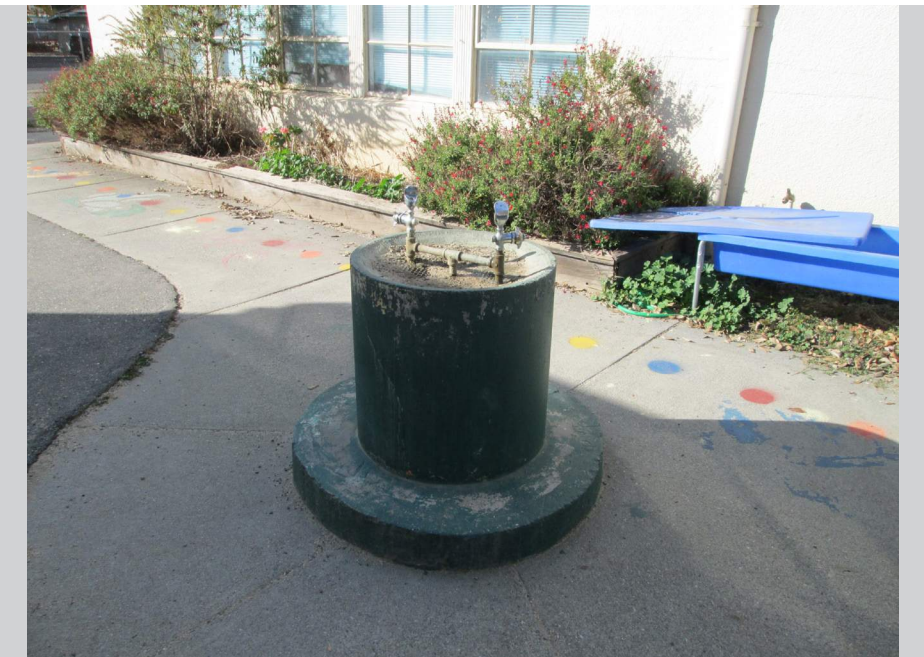
Exterior water fountain replacement

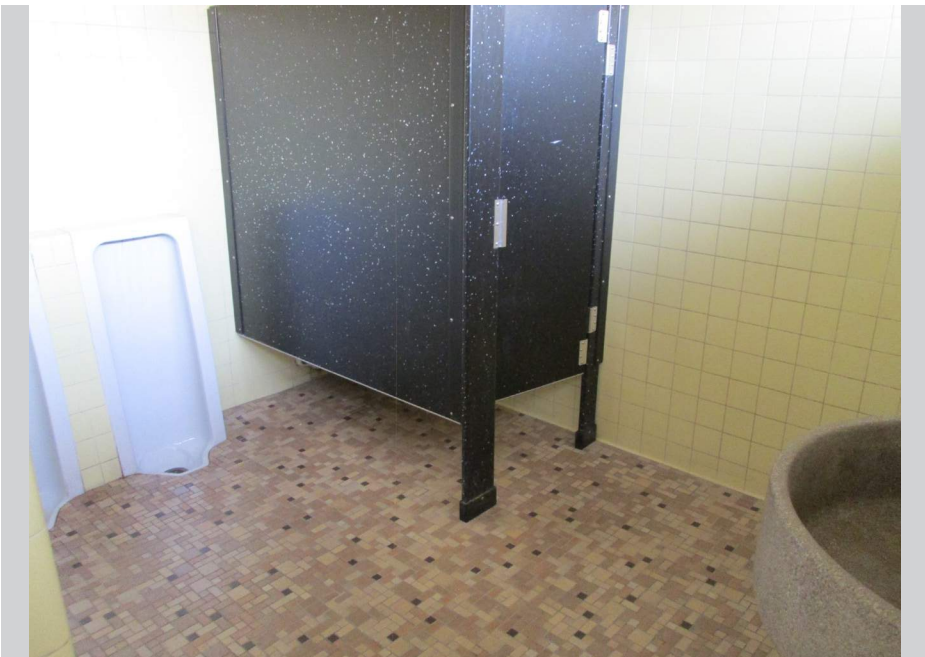
Student restroom ADA upgrades and renovations

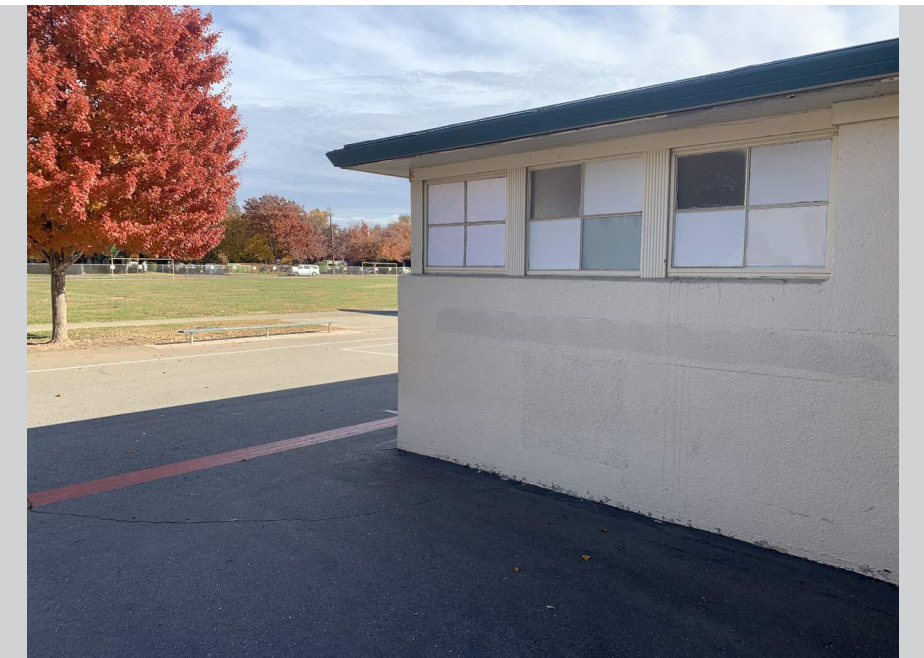
Exterior paint and window replacement needed

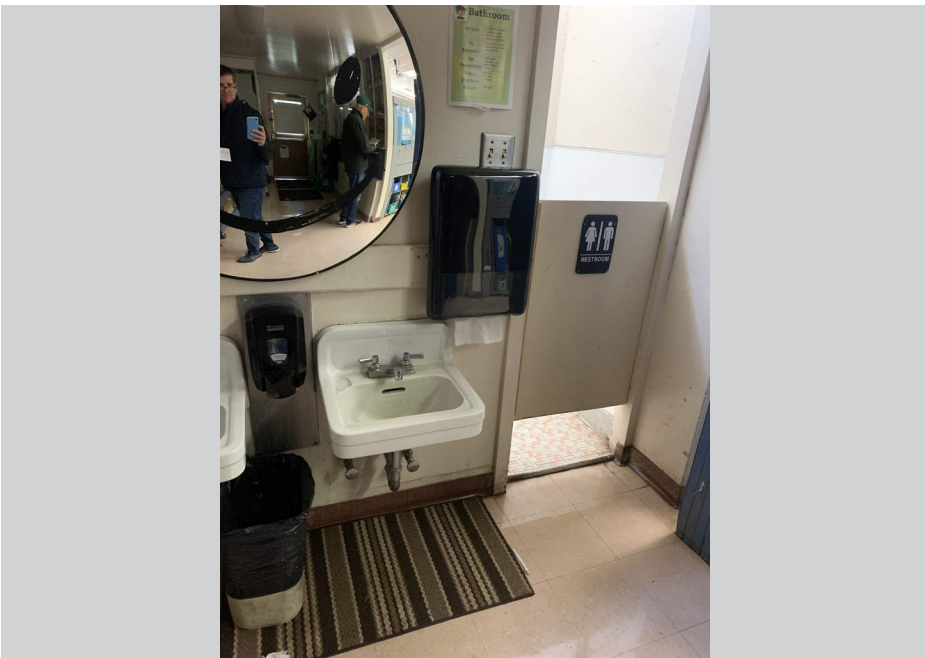
Restroom upgrades needed for ADA compliance

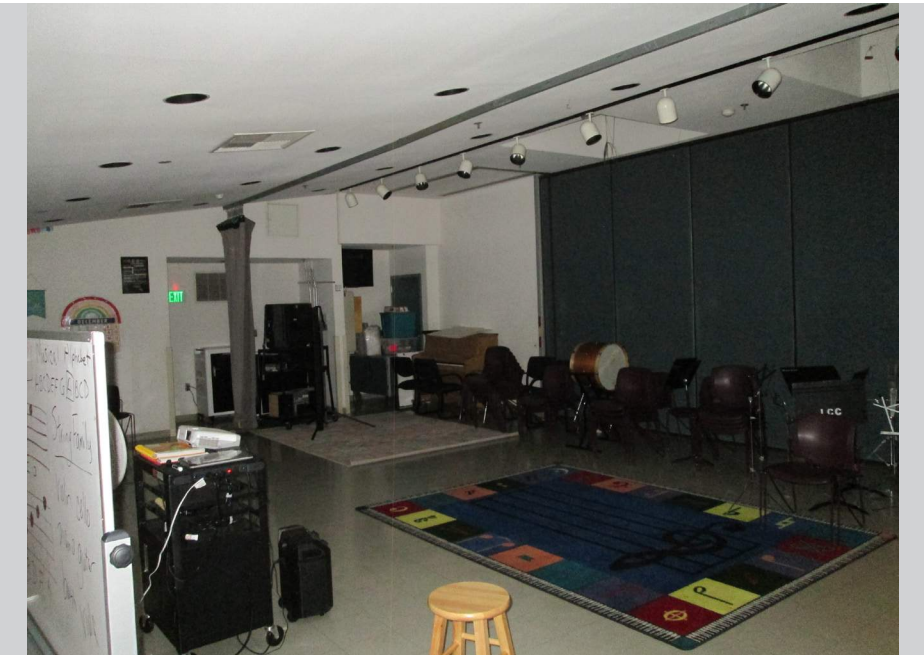
Interior lighting needs and upgrades

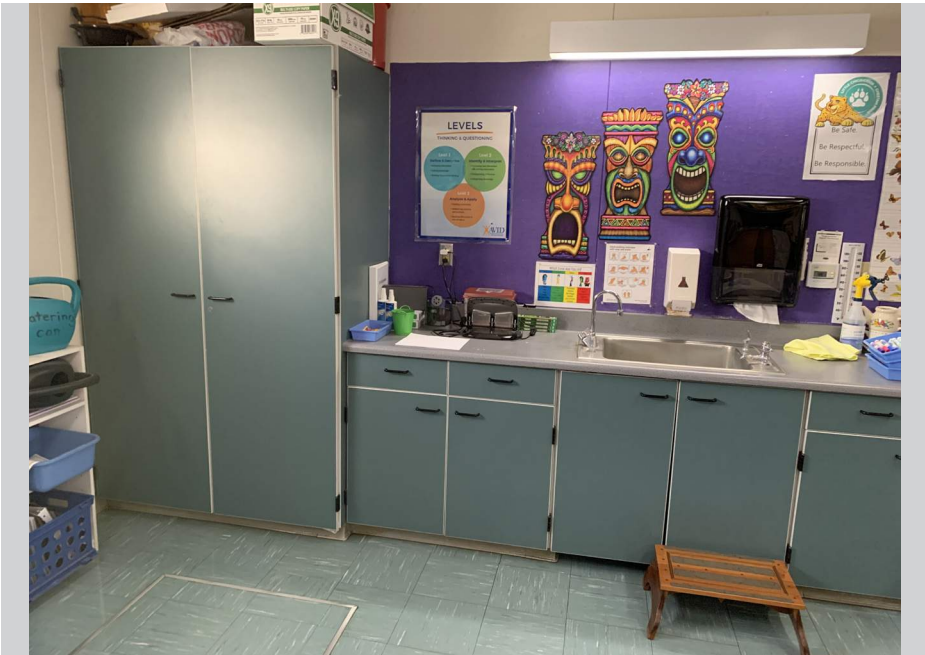
Casework and sink replacements for ADA compliance

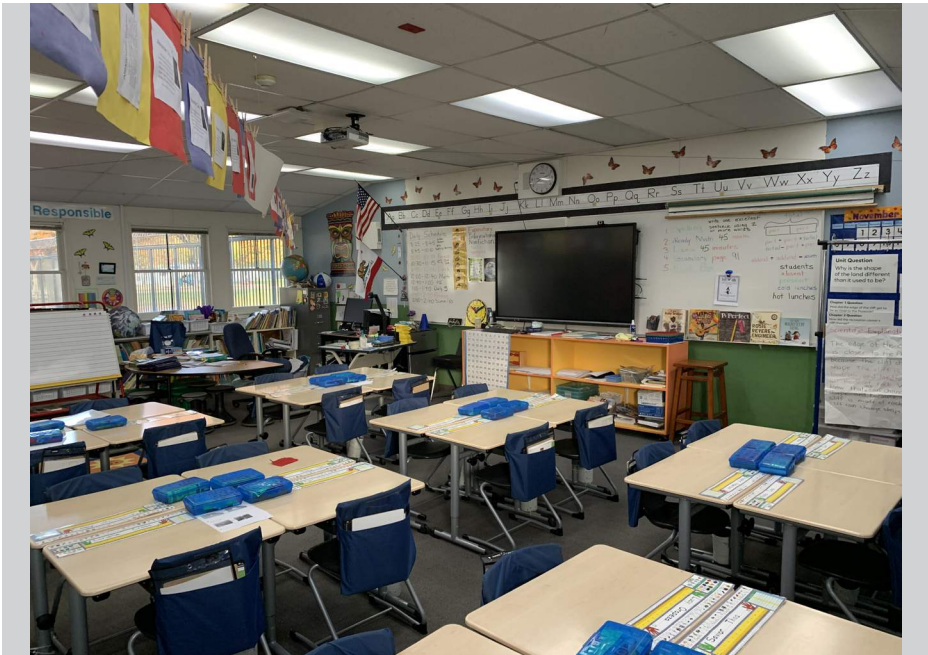
Typical classroom - storage needs

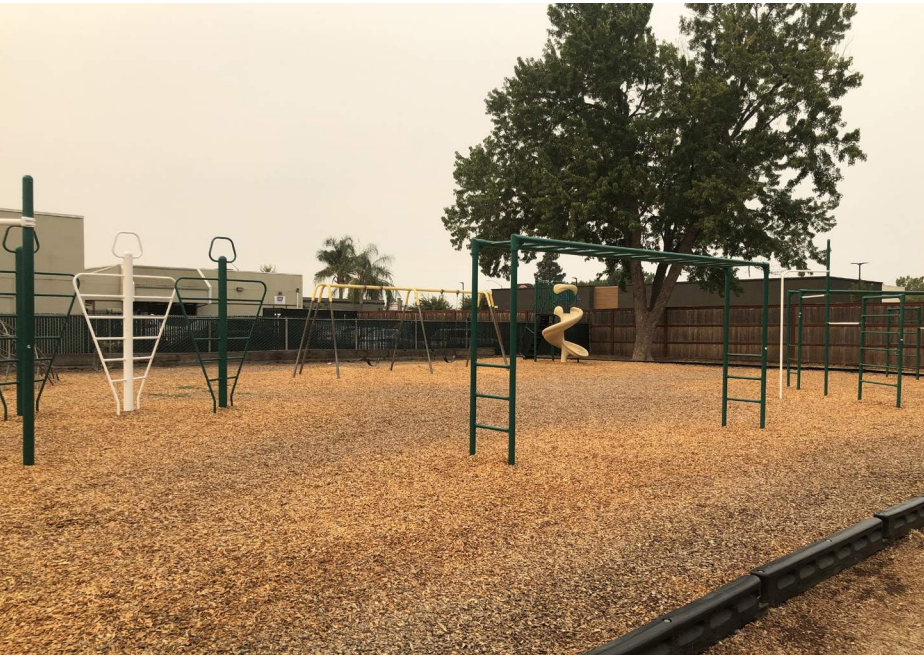
No shade structure over playground

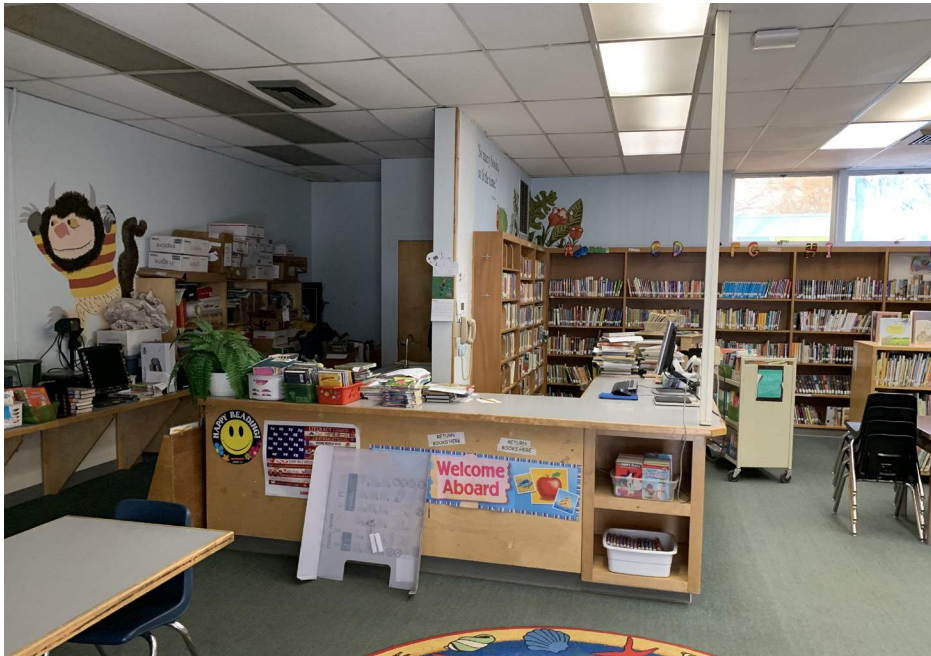
Library desk and casework replacement

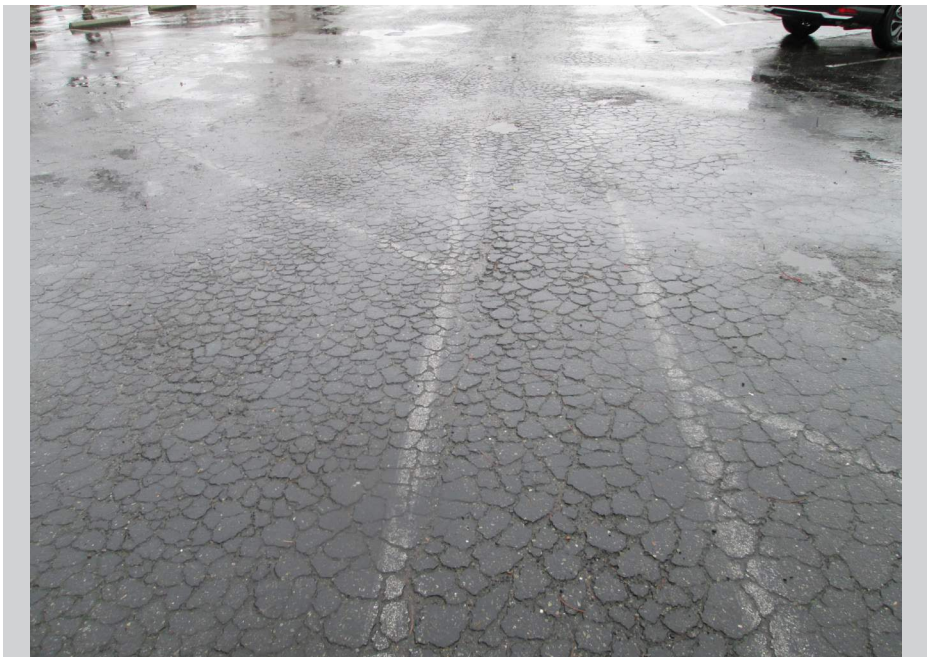
School needs a new parking lot

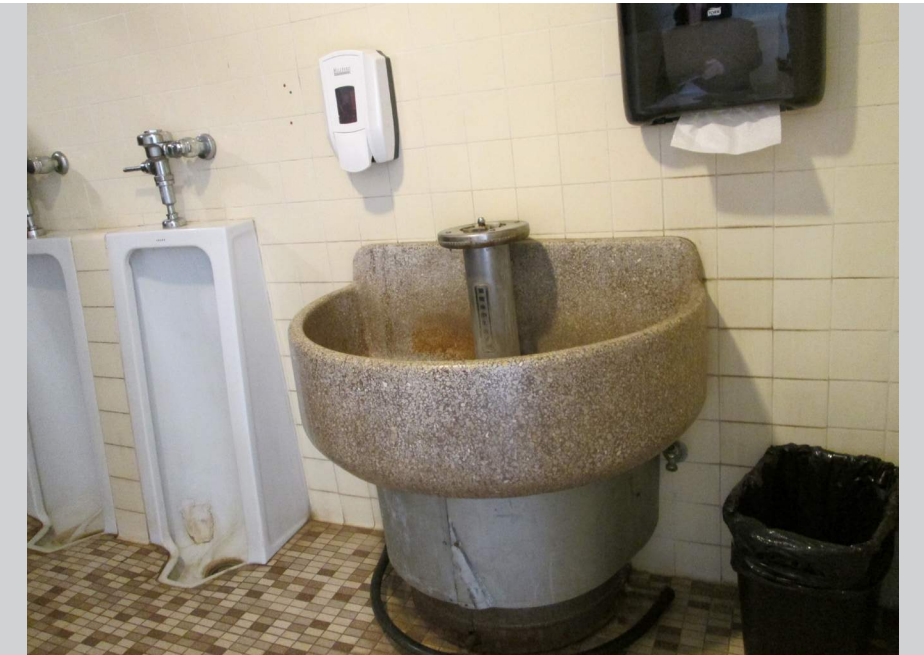
Restroom plumbing fixture replacement needs and ADA compliance

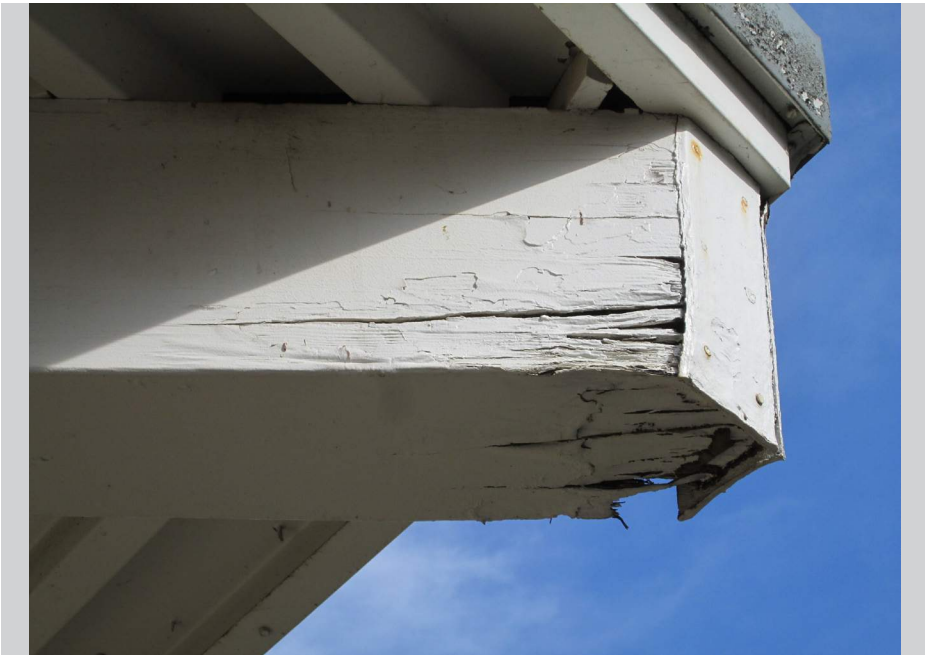
Exterior soffit and fascia replacement

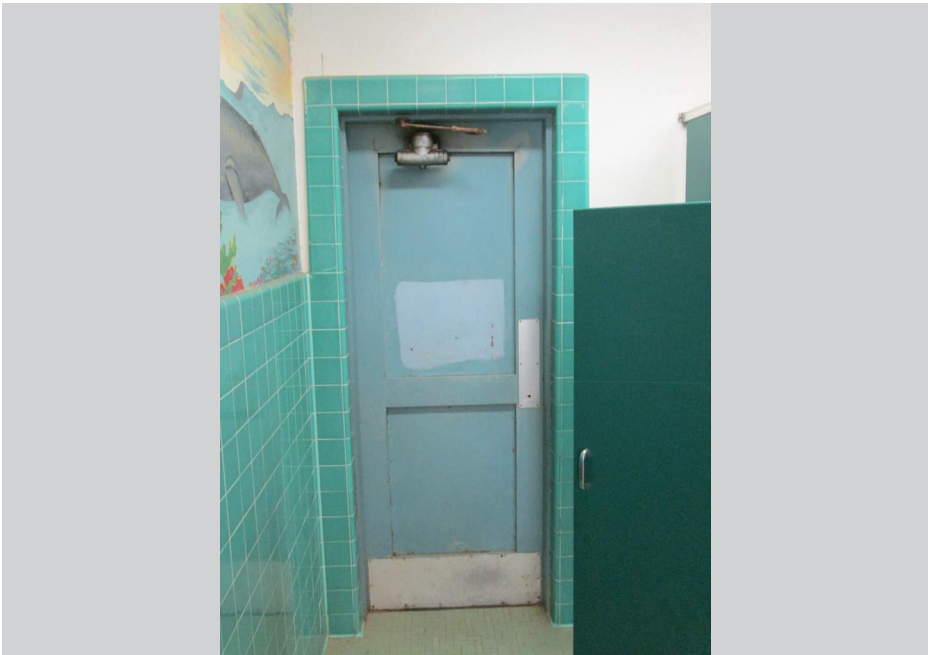
Door hardware upgrades and restroom renovations needed

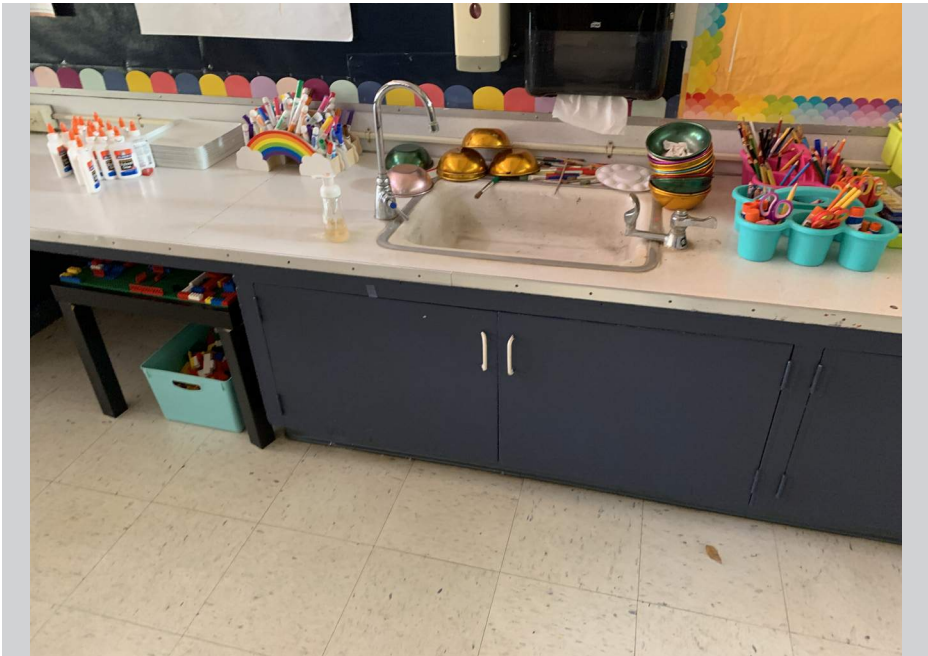
ADA compliant accessibility improvements to sink areas

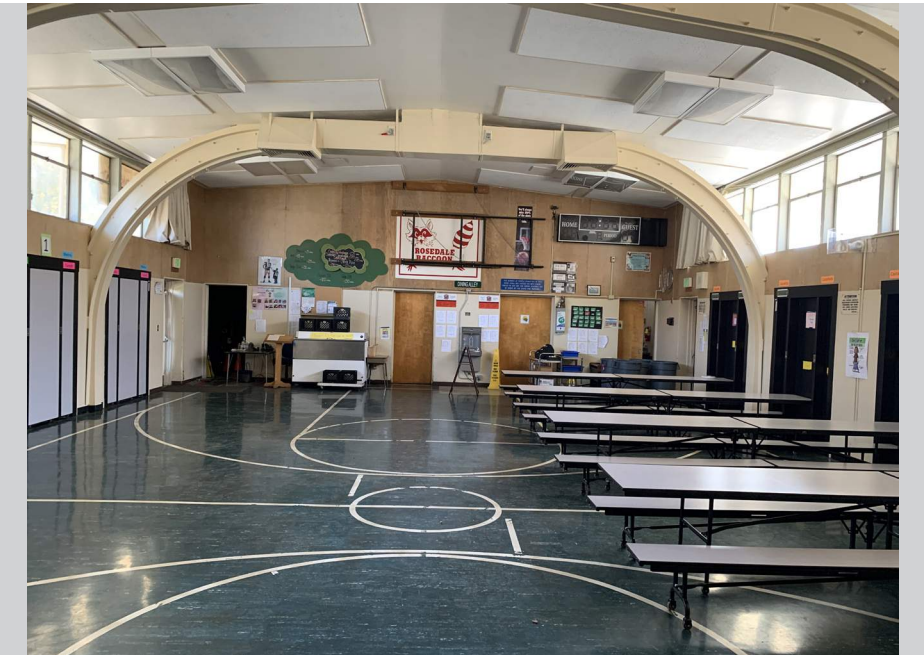
Multi-purpose interior finish renovations and storage improvements

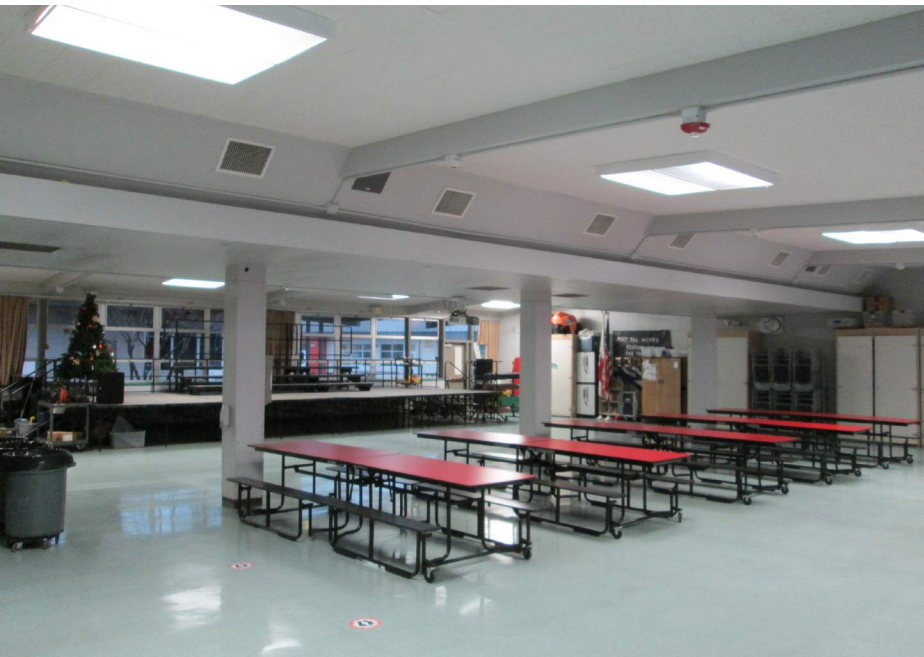
Daylighting and storage improvements

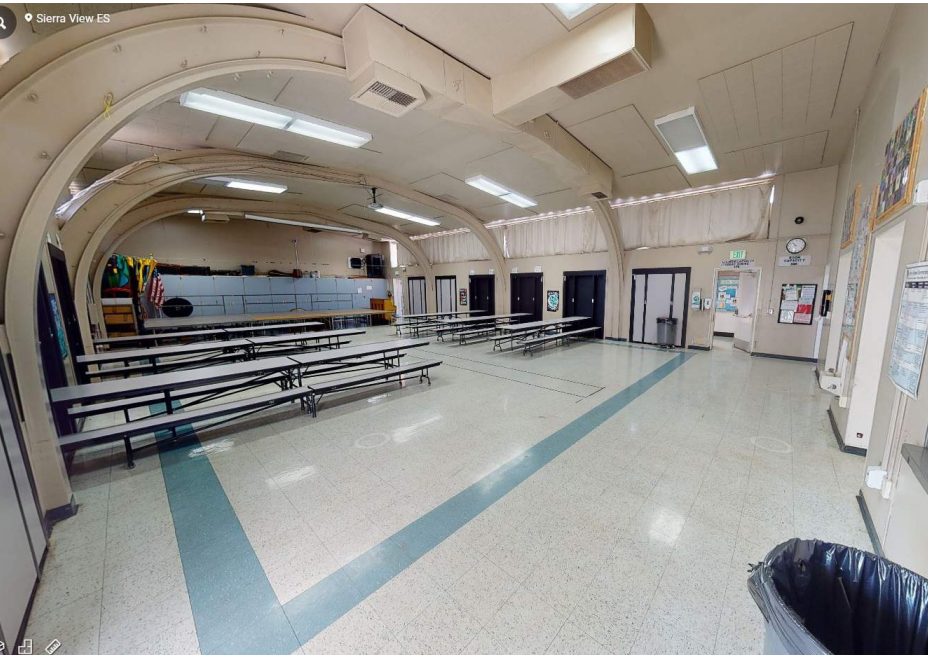
Multi-purpose room upgrades needed

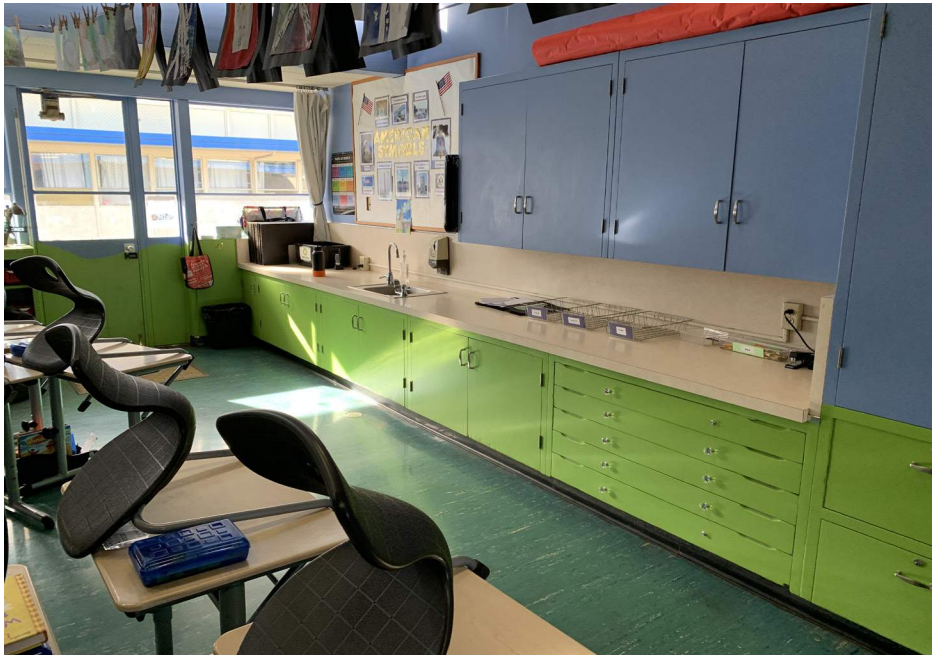
Casework replacement and ADA upgrades

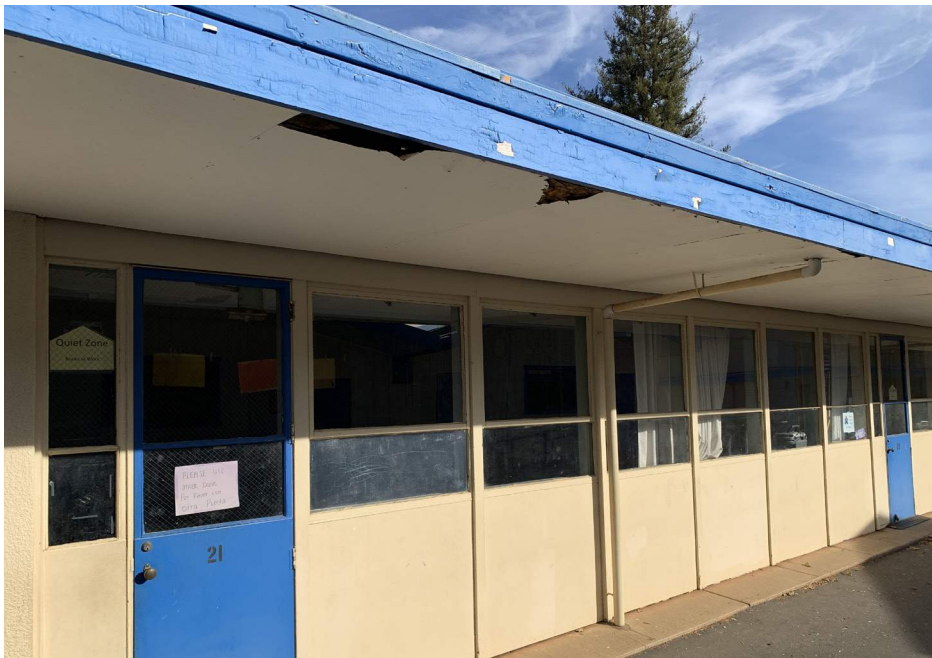
Exterior finishes need repair or replacement

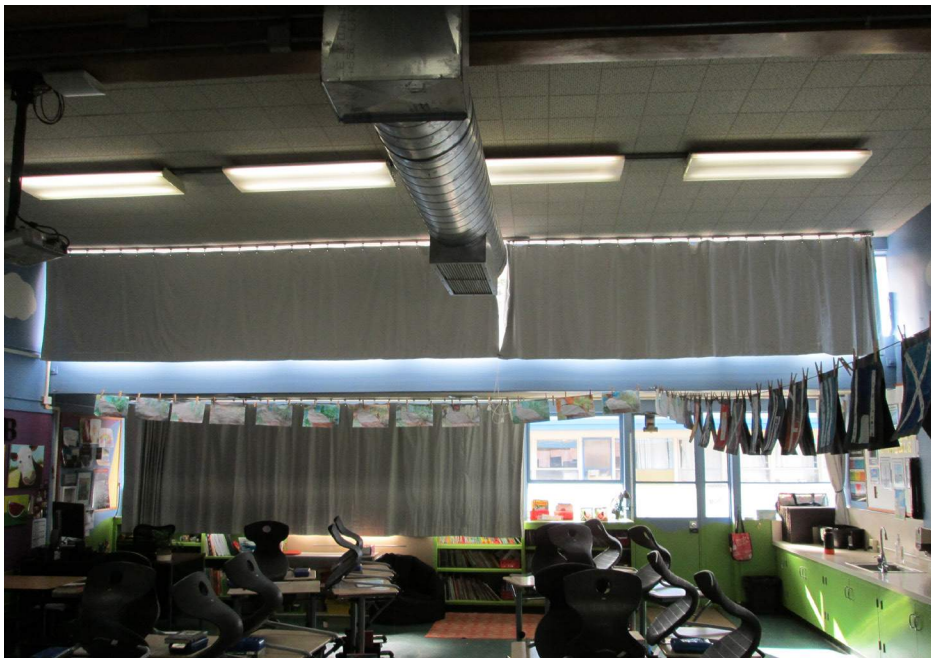
Classroom clerestory and window treatment upgrades
