06-133 Chico USD
Community Day School
Chico, CA

BULK ASBESTOS ANALYSIS REPORT

BULK ASBESTOS MATERIAL Analysis Request Form for Entek Consulting Group, Inc.

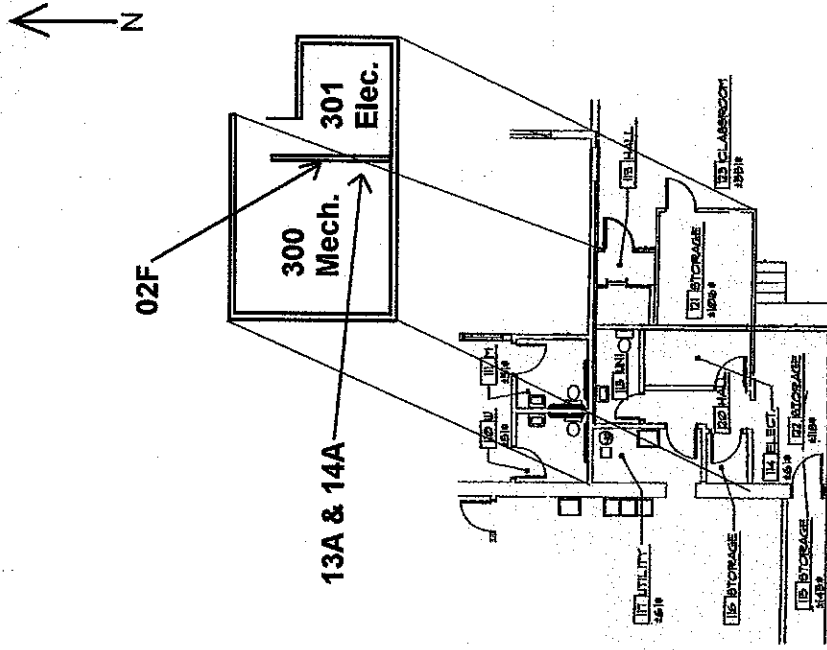
MECHANICAL MEZZANINE

Approximate locations of bulk
samples collected by Richard A
Beall of Entek Consulting Group,
Inc. on March 29, 2006
