## SECTION 5. ELEMENTARY SCHOOLS

# CHAPMAN ELEMENTARY SCHOOL

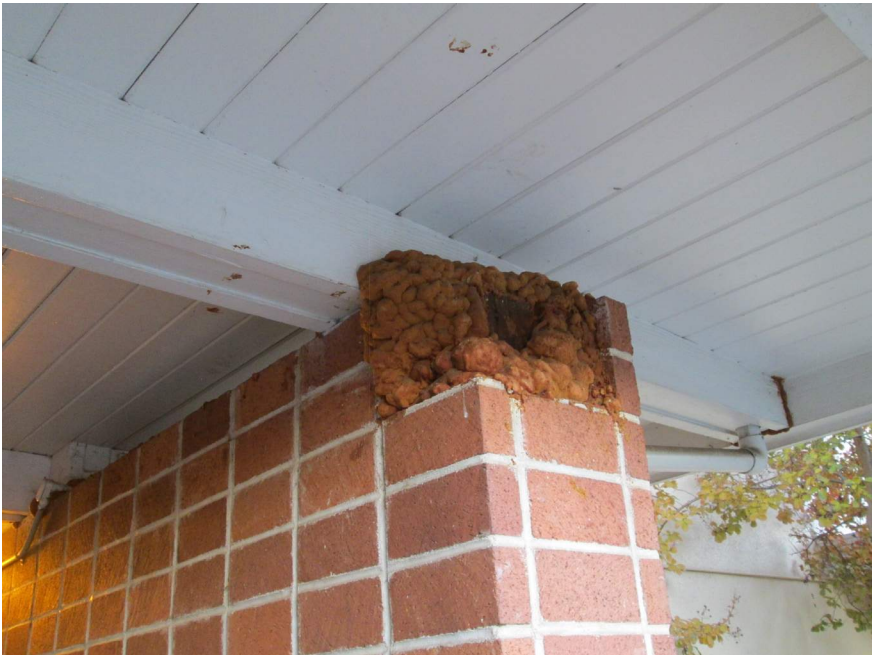
Ongoing deferred maintenance

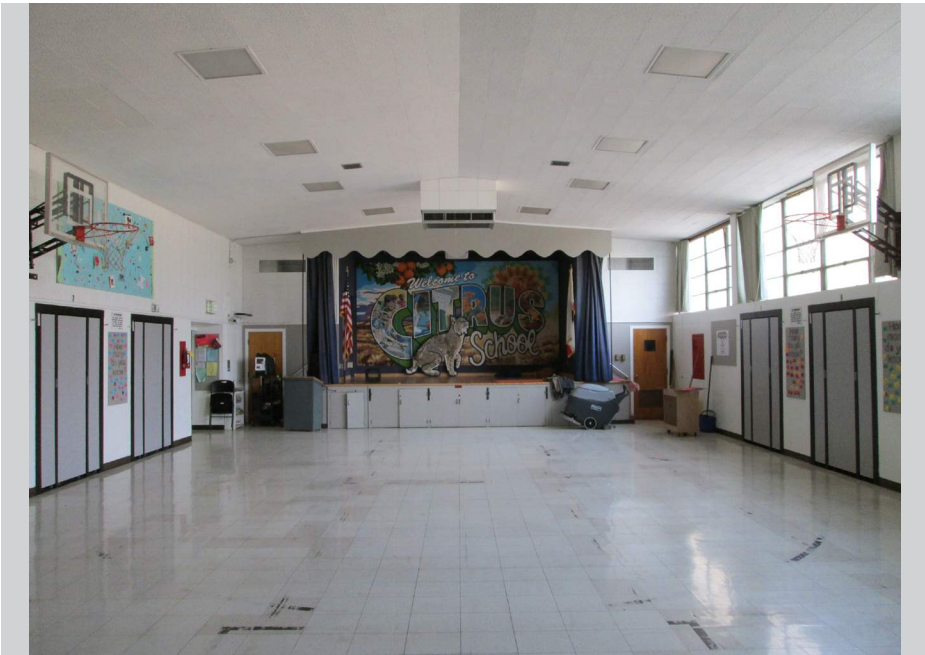
Multi-purpose room renovation and storage improvements

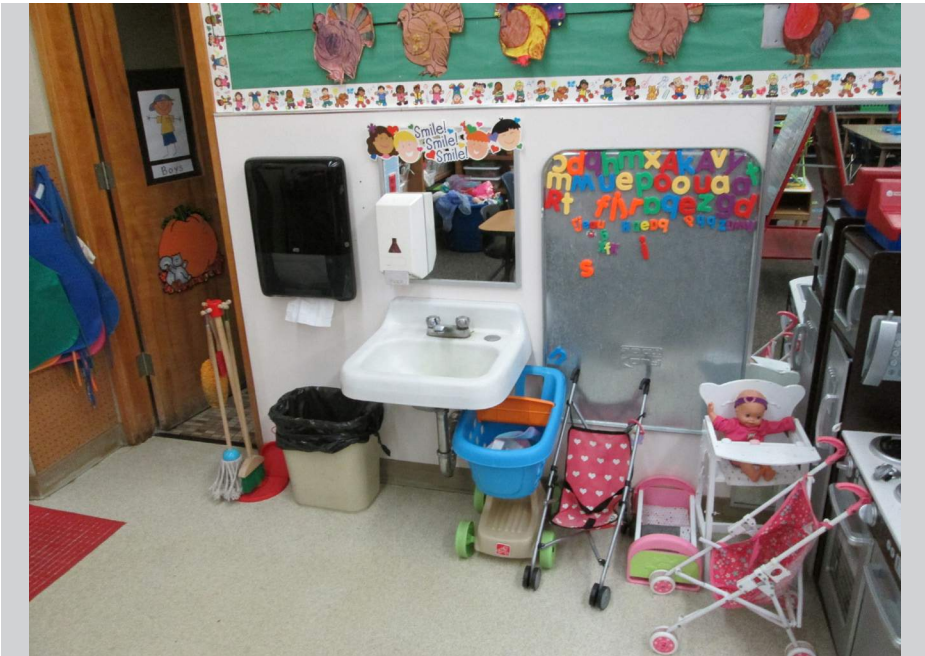
Sink area improvement for ADA accessibility

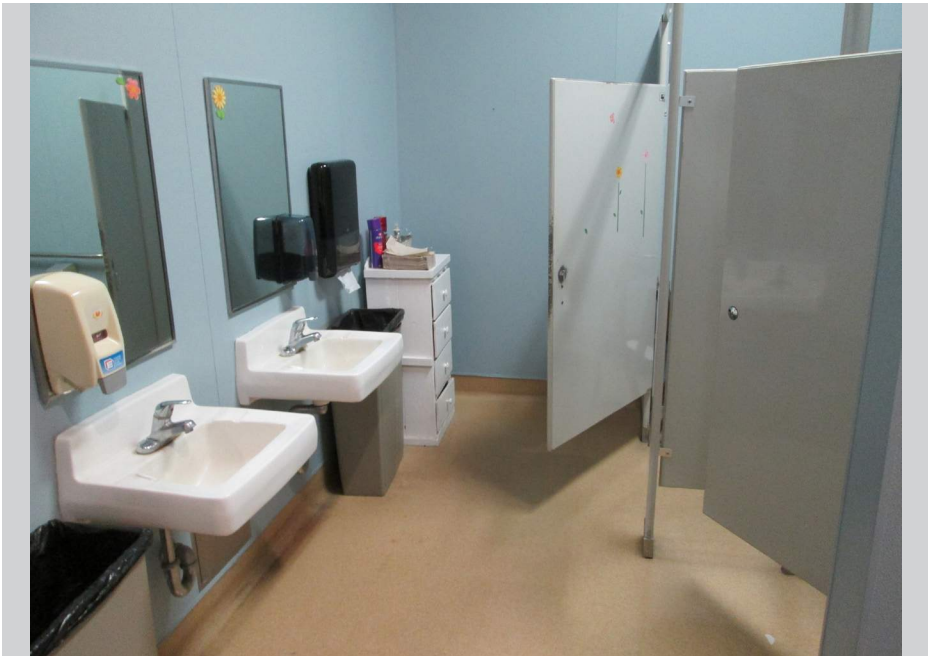
Student restroom upgrades

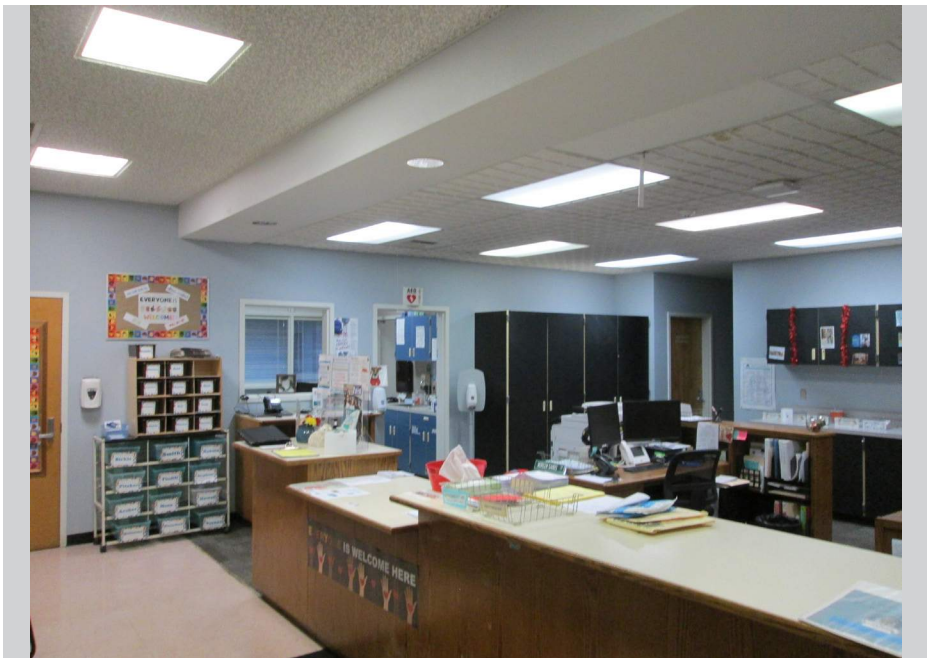
Admin reception desk renovations and interior finishes upgrades

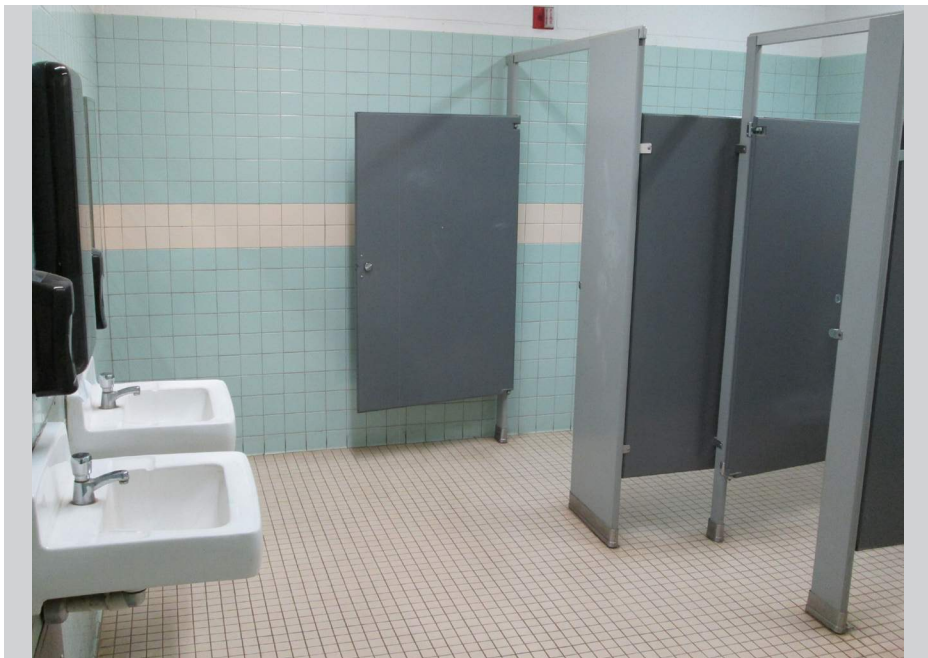
Student restroom upgrades

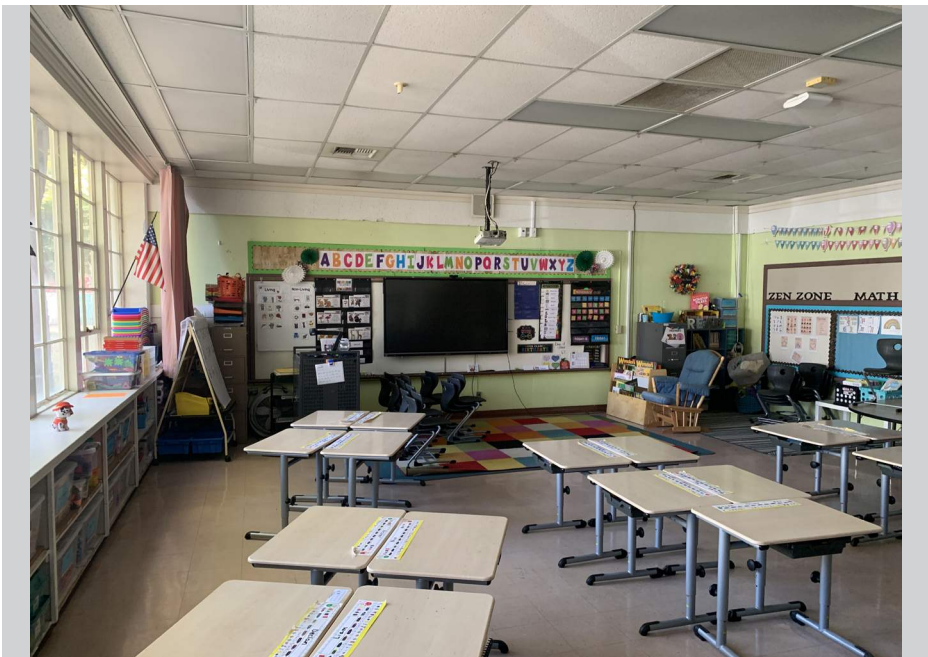
Classroom interior finish improvements and upgrades

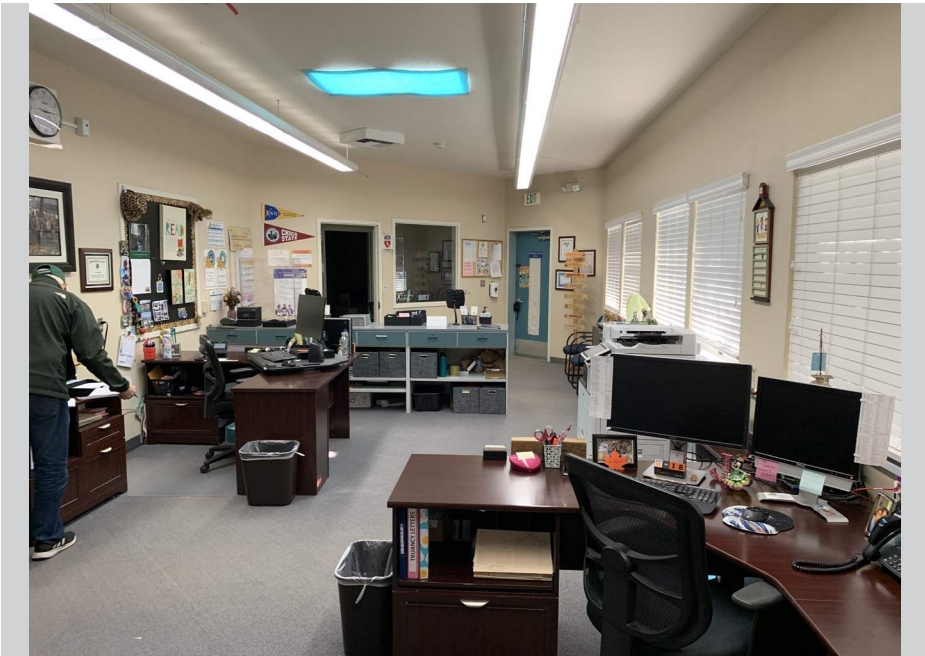
Administration work stations

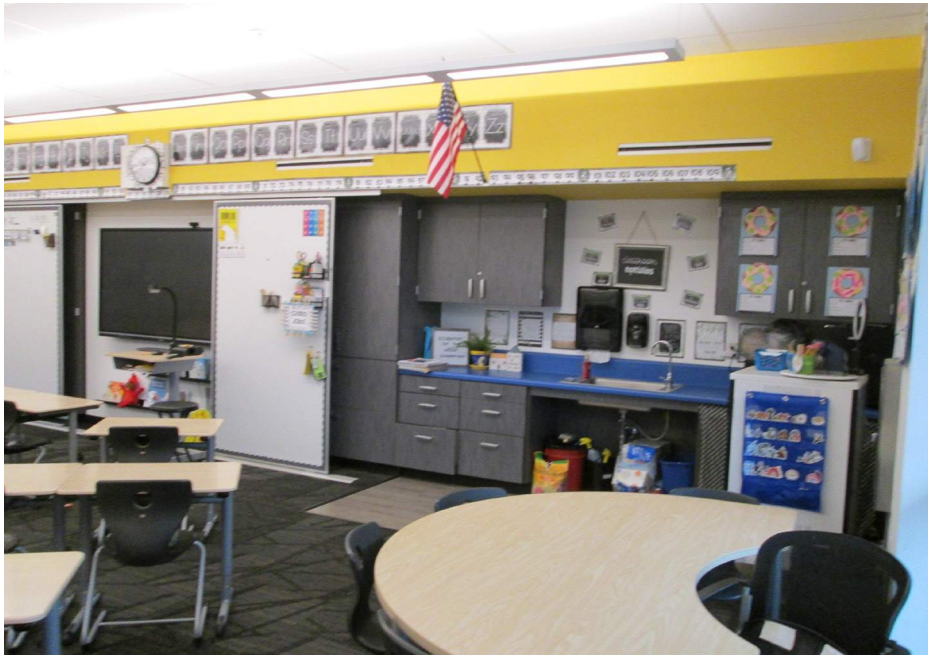
Classroom casework and sink areas

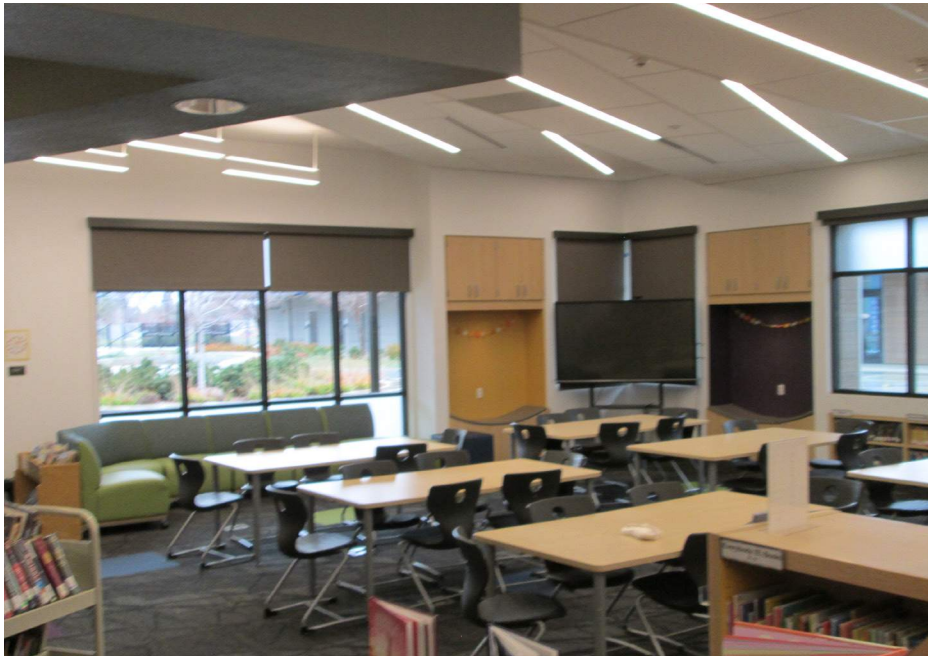
Campus Library interior

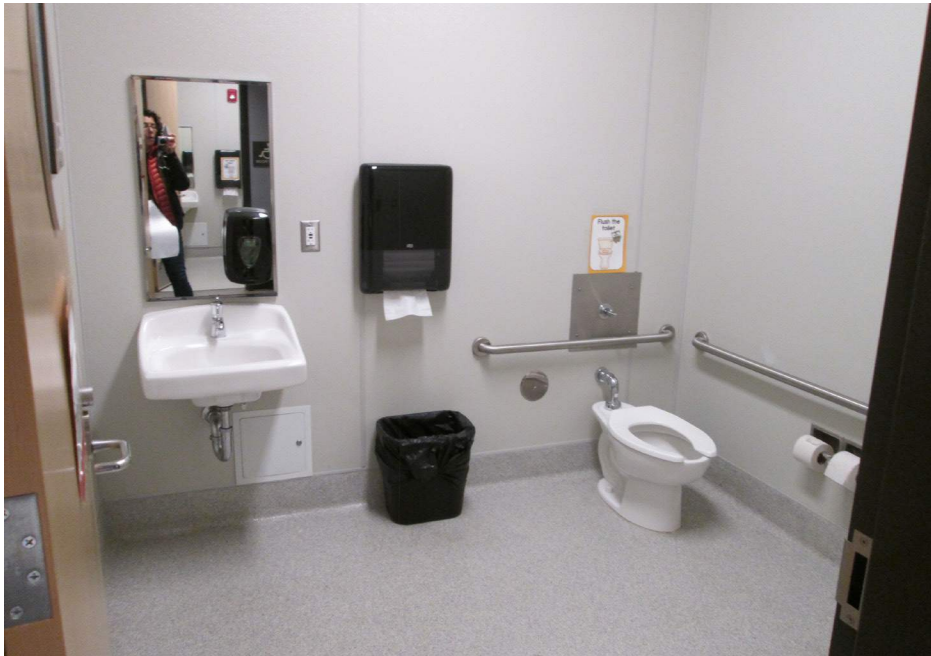
Restroom finishes and fixtures

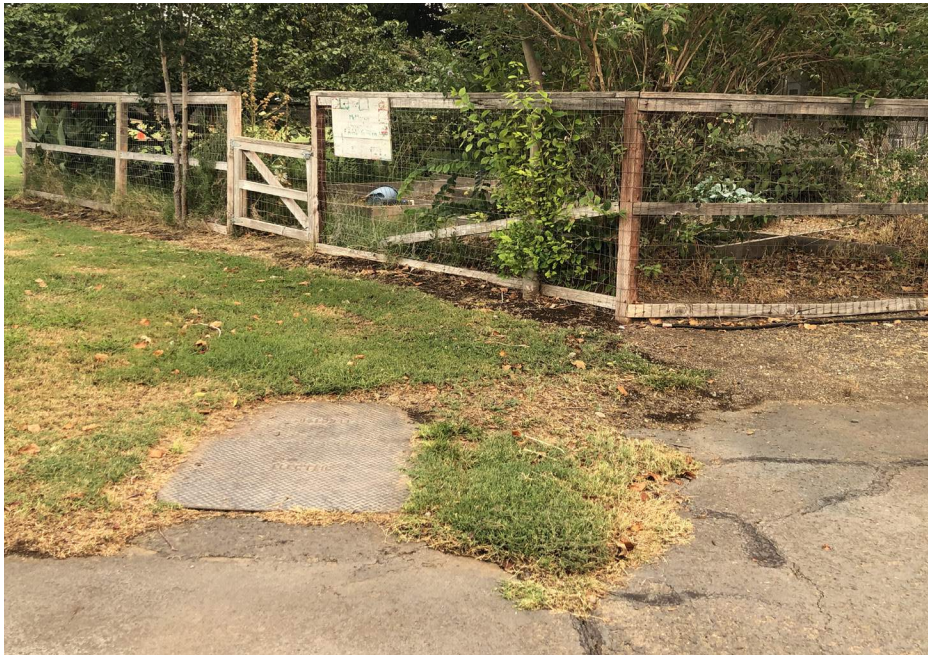
ADA path of travel improvements to pavement and landscape

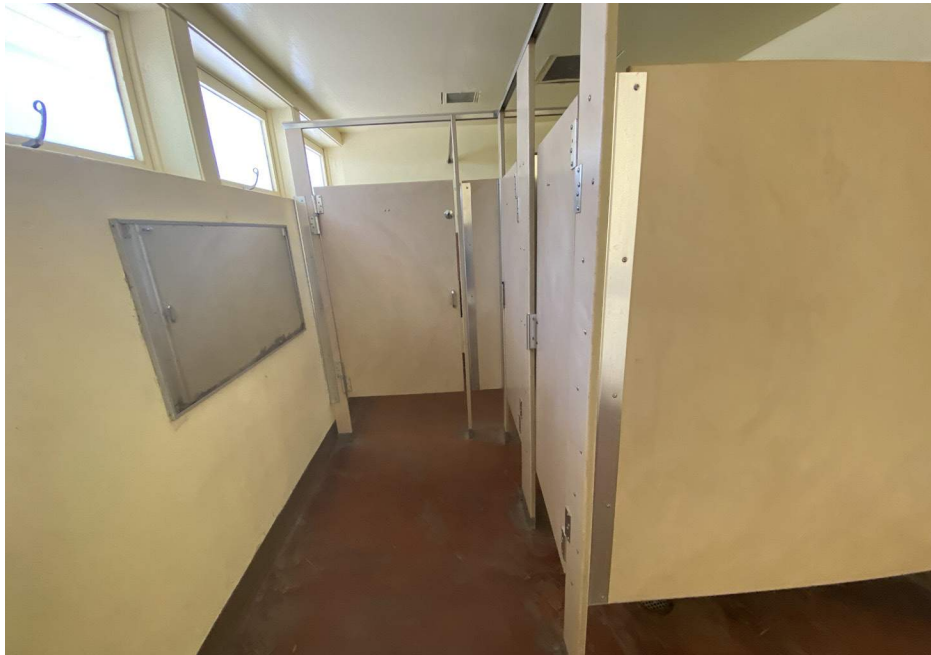
Core restroom ADA compliance upgrades

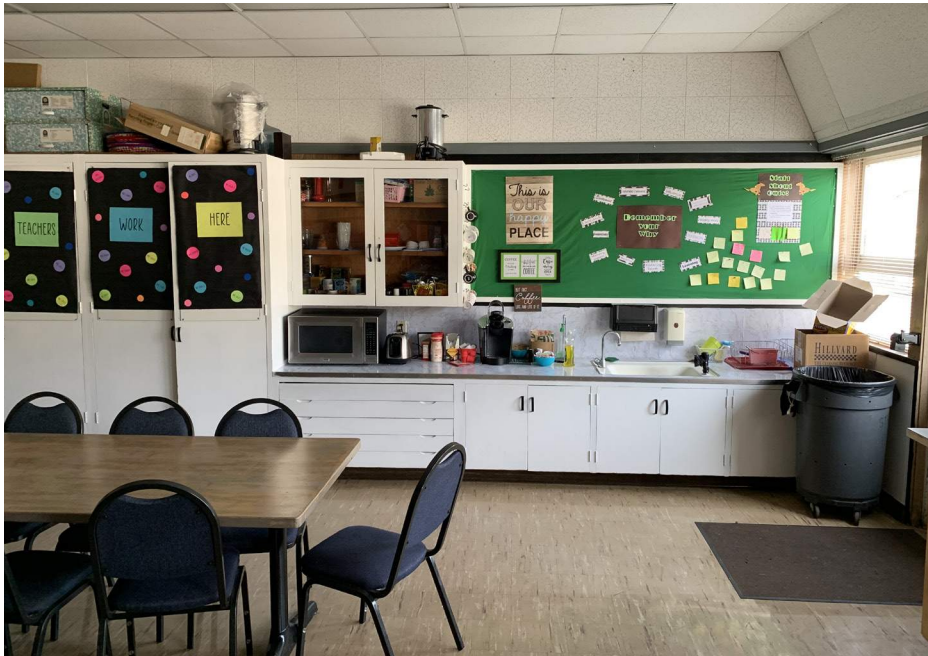
ADA-compliant improvements to sink areas

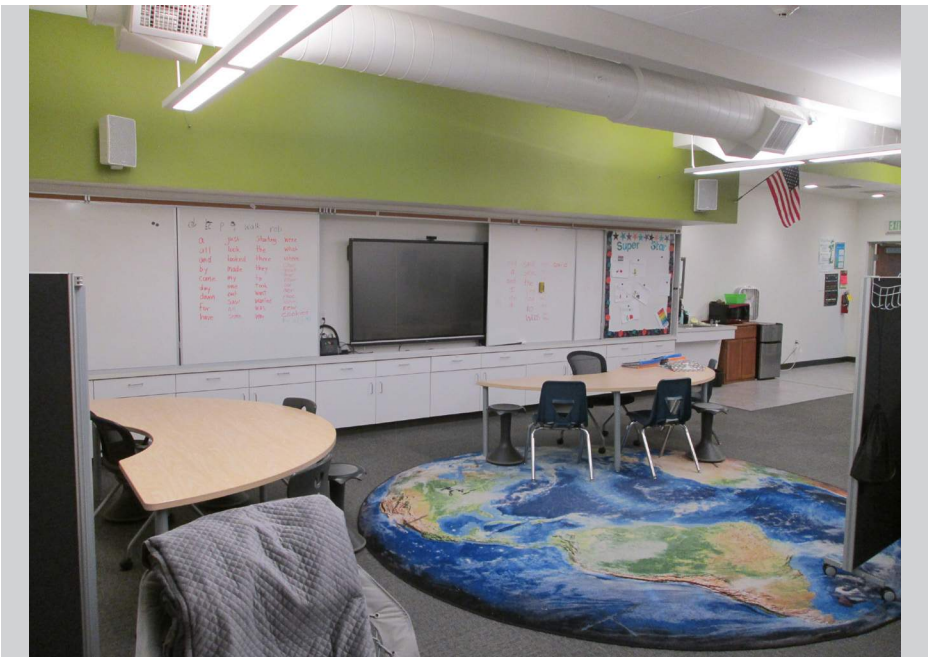
Typical classroom teaching wall and interior finishes

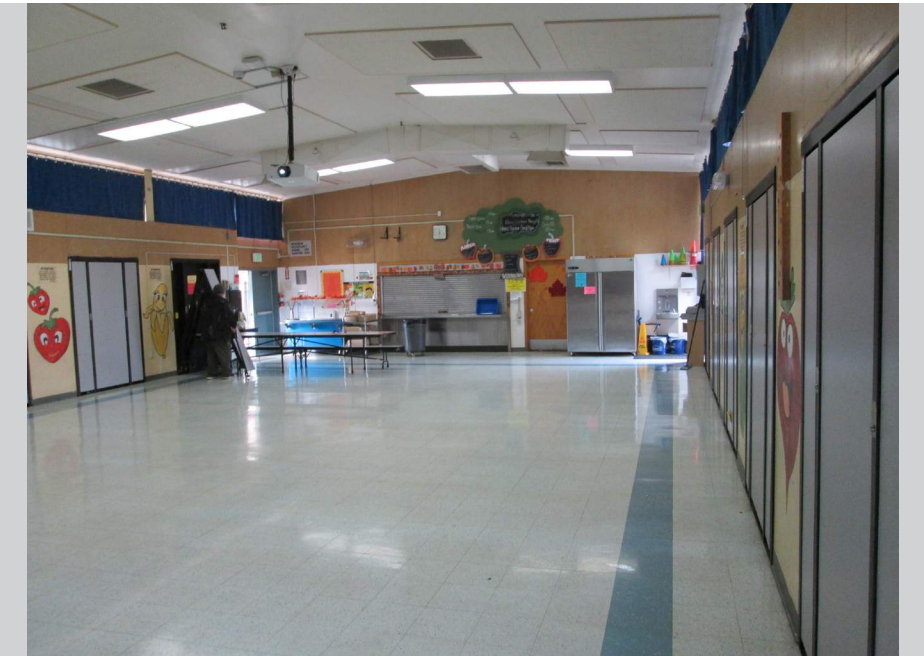
Multi-purpose room interior finish upgrades

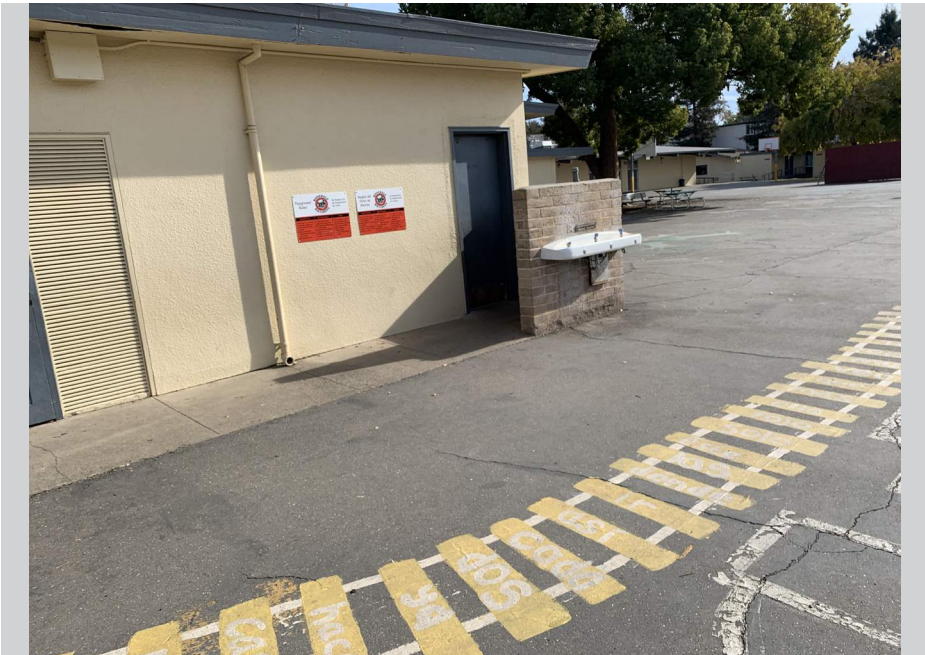
Water fountain upgrades

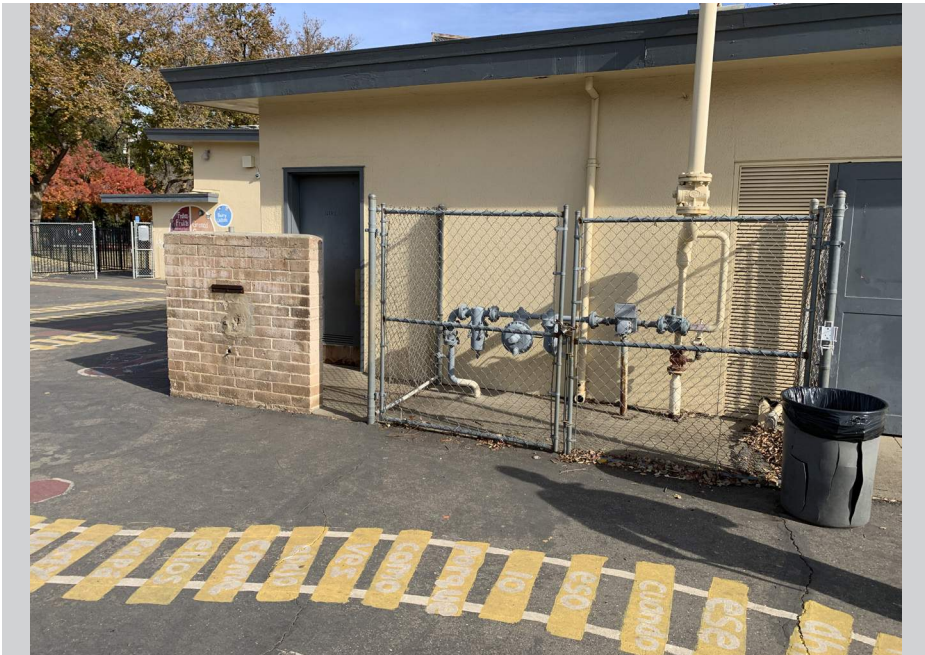
ADA accessibility improvements

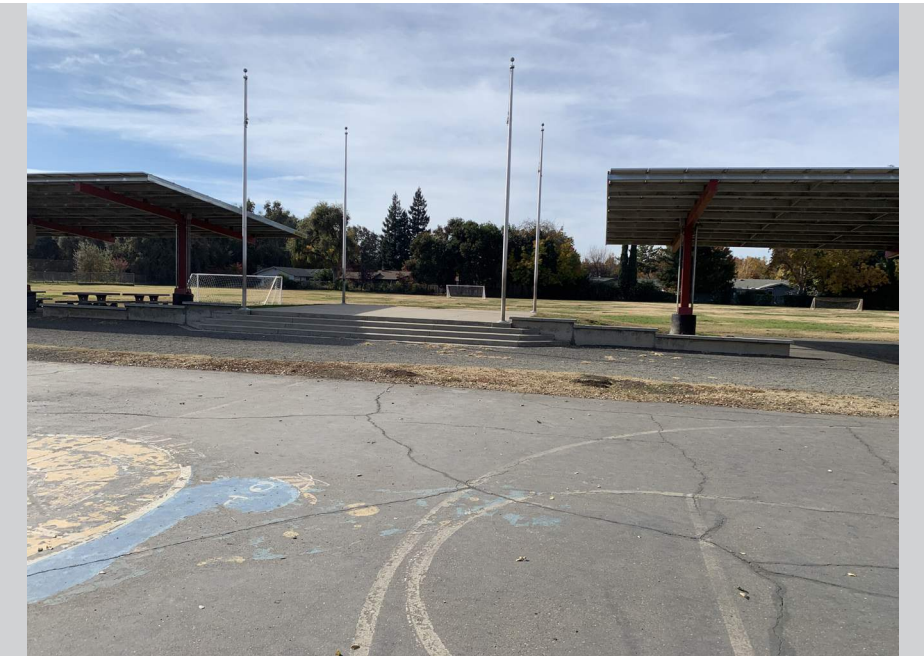
Landscape improvements and hardcourt repavement

| KEY FINDINGS | | |
|---|---|---|
| 2. Site - Other | | <ul style="list-style-type: none"><li>A/C paving in poor condition throughout parking lot</li><li>Hardcourt paving is in poor condition.</li><li>Bike rack is not fenced in - open to campus</li></ul> |

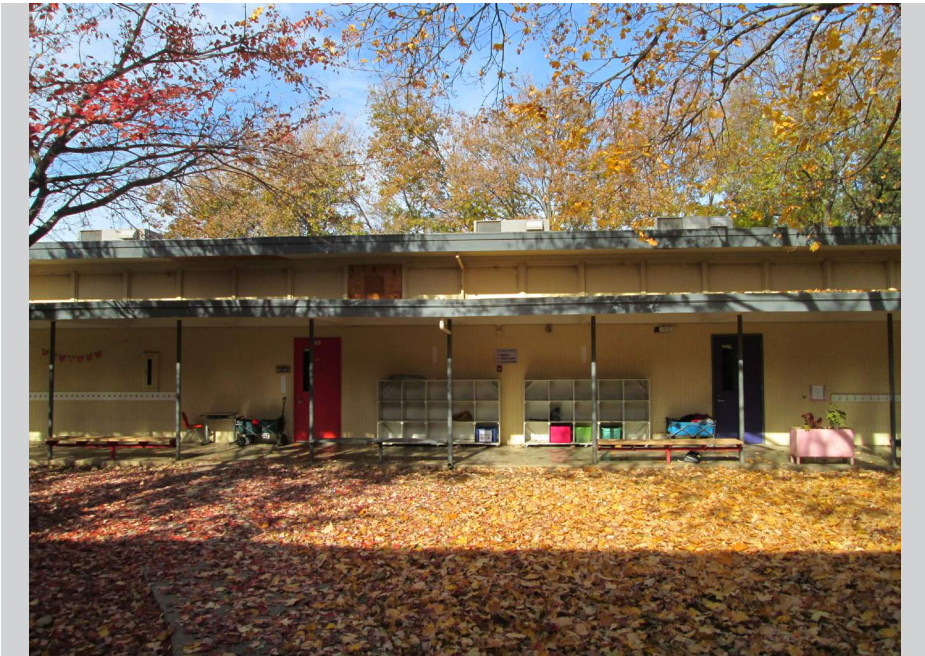
ADA path of travel upgrades to pavement and thin metal doors

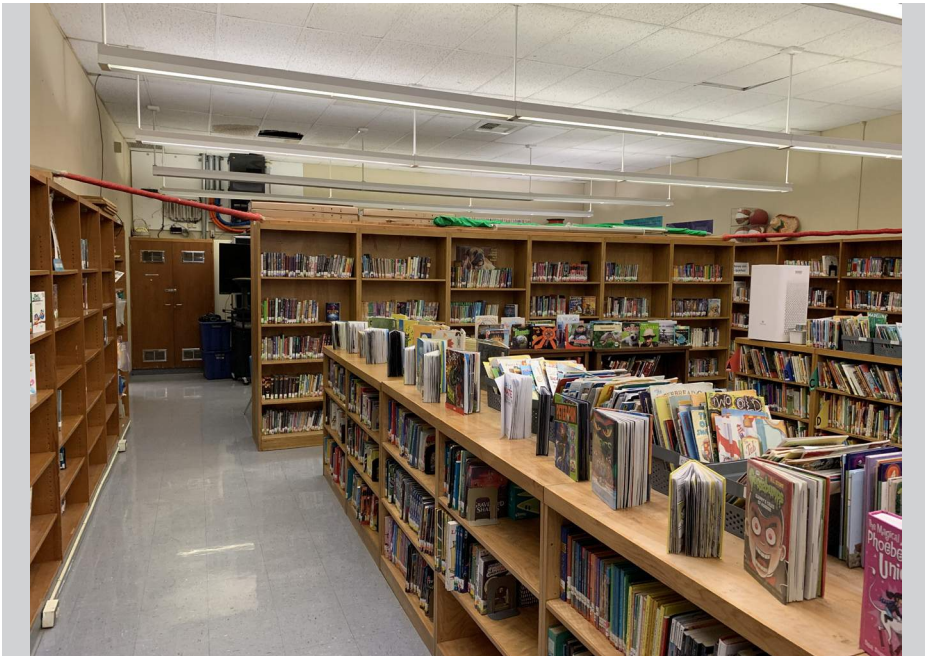
Campus library electrical improvements

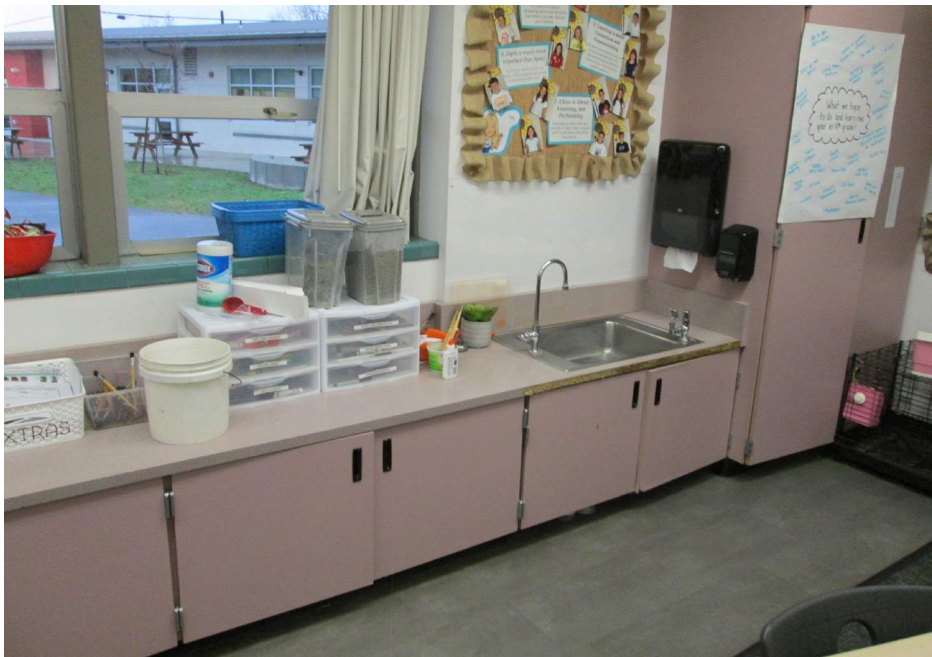
ADA and casework upgrades in classrooms

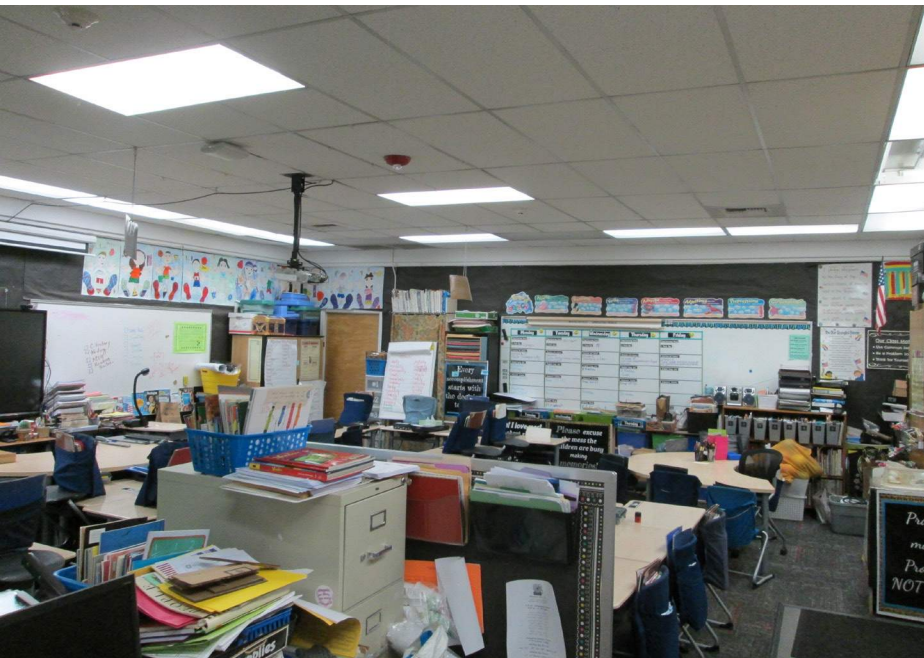
Classroom storage improvements

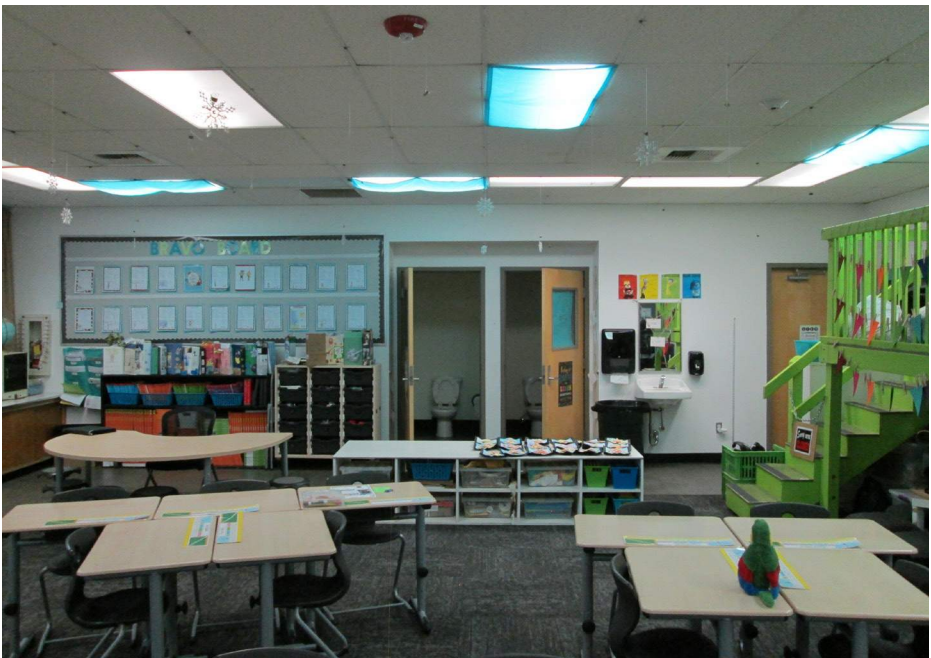
Kindergarten classroom interior upgrades

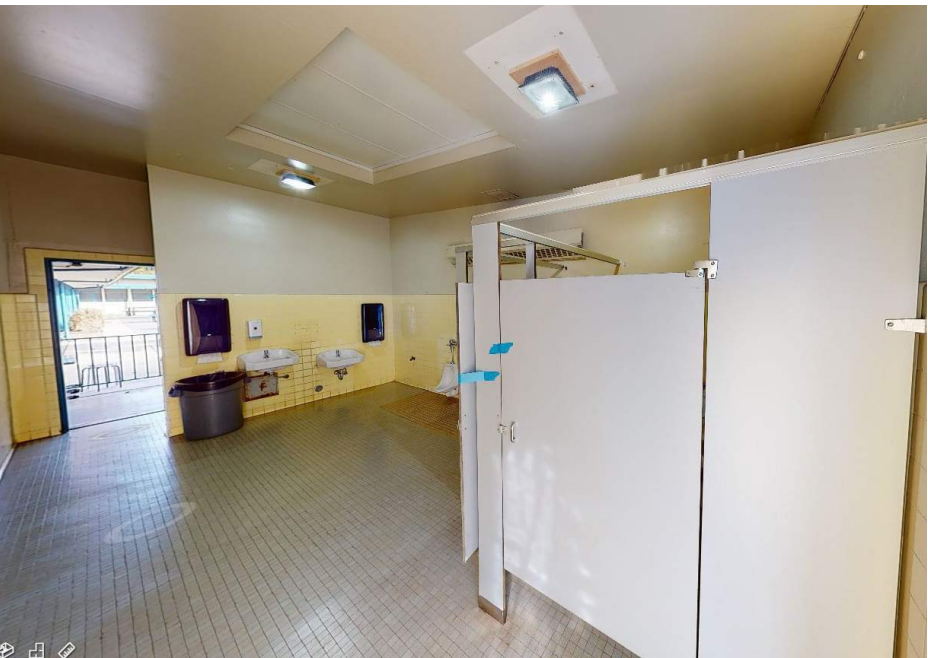
Student restroom interior finish upgrades
