## SECTION 5. ELEMENTARY SCHOOLS

# CHAPMAN ELEMENTARY SCHOOL

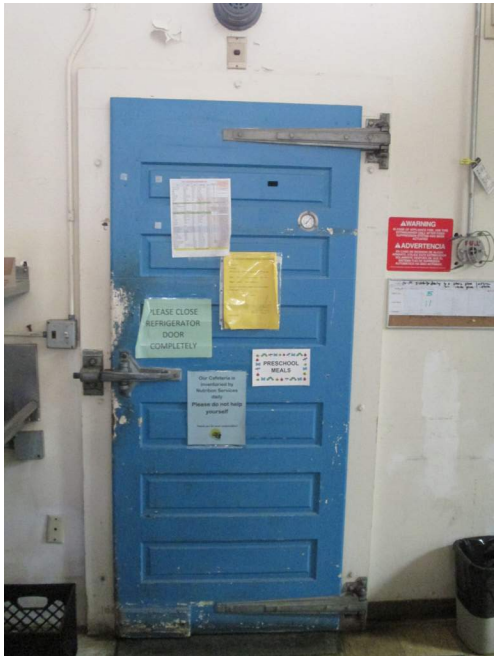
Aging food service facilities

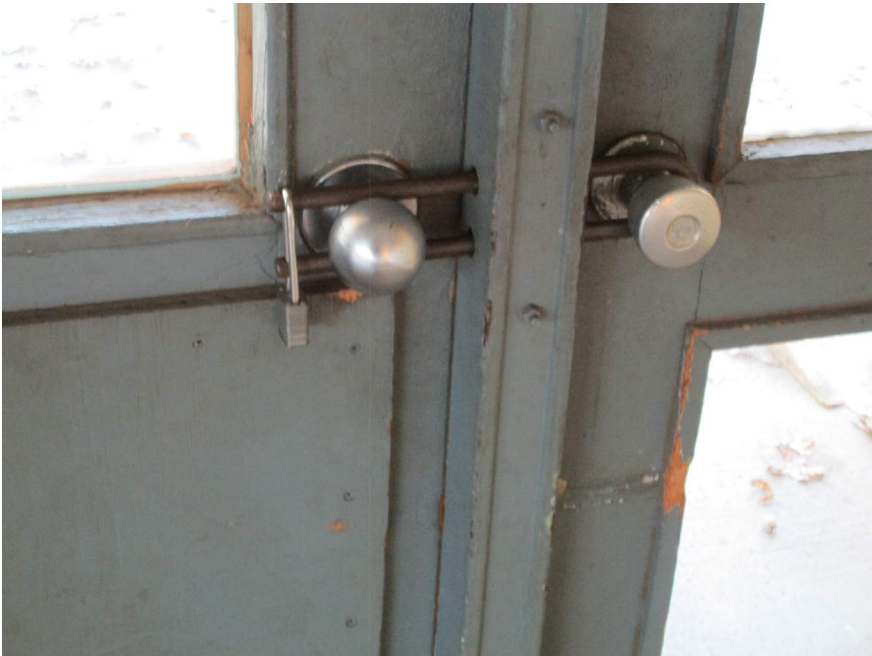
Door hardware for accessibility

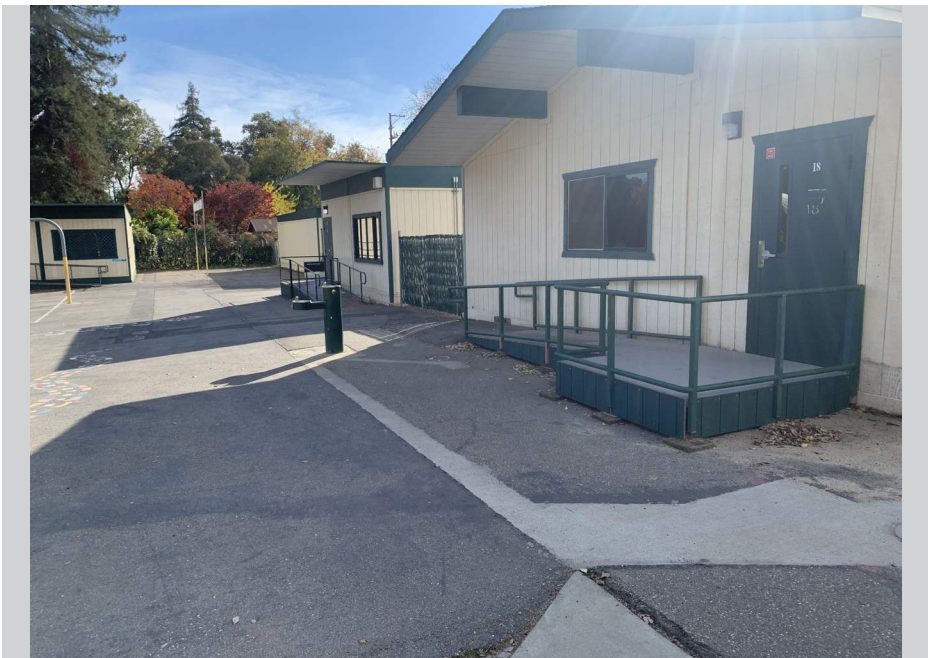
Campus portable classrooms

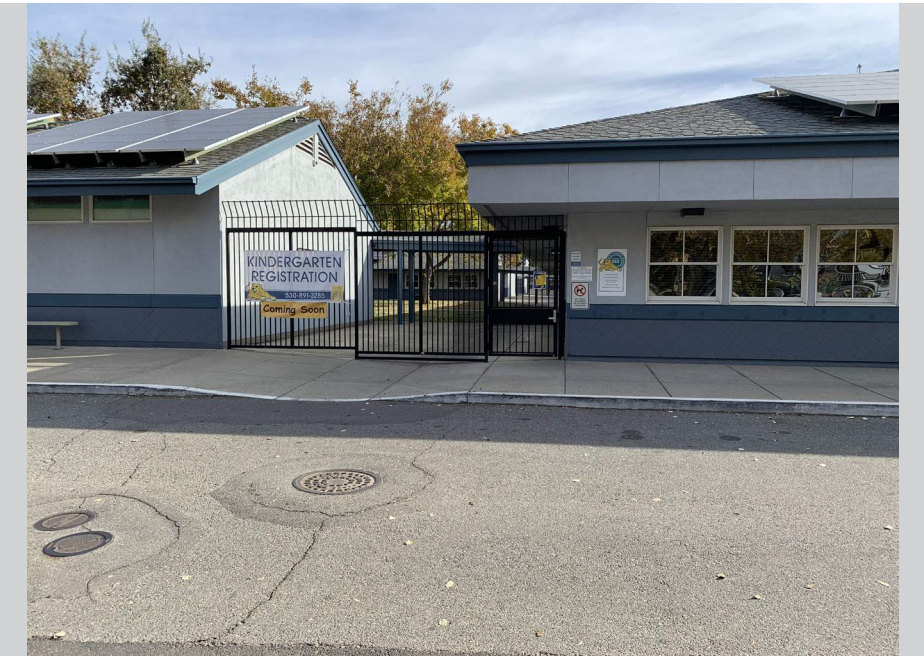
Student drop-off asphalt upgrades

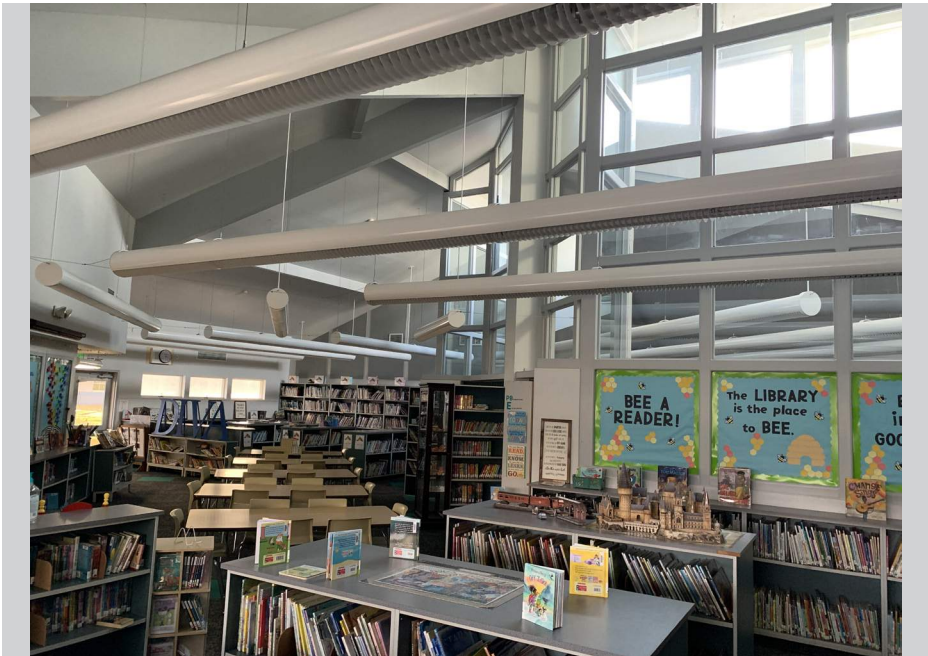
Current campus Library condition

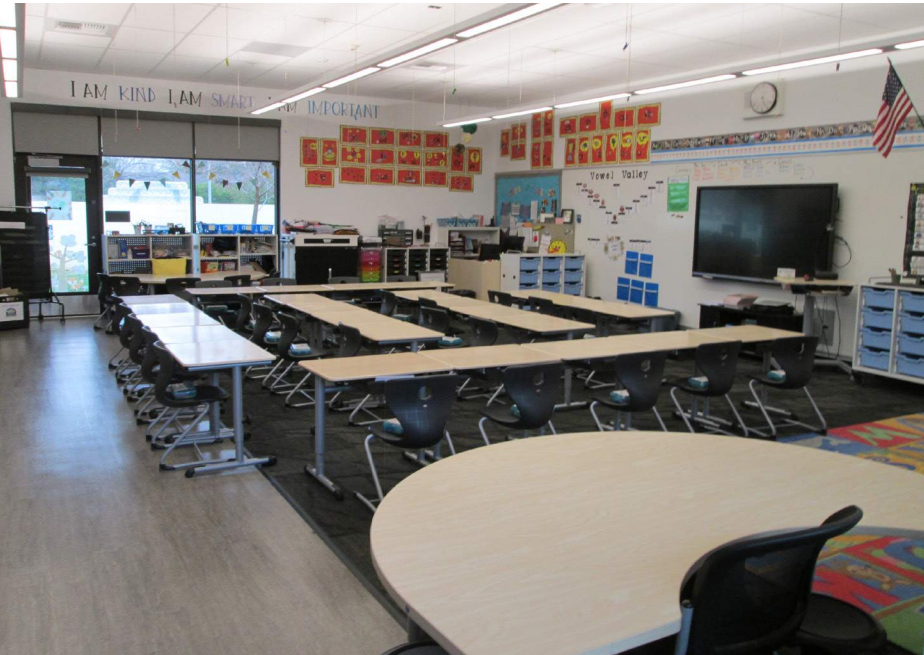
Typical classroom interior

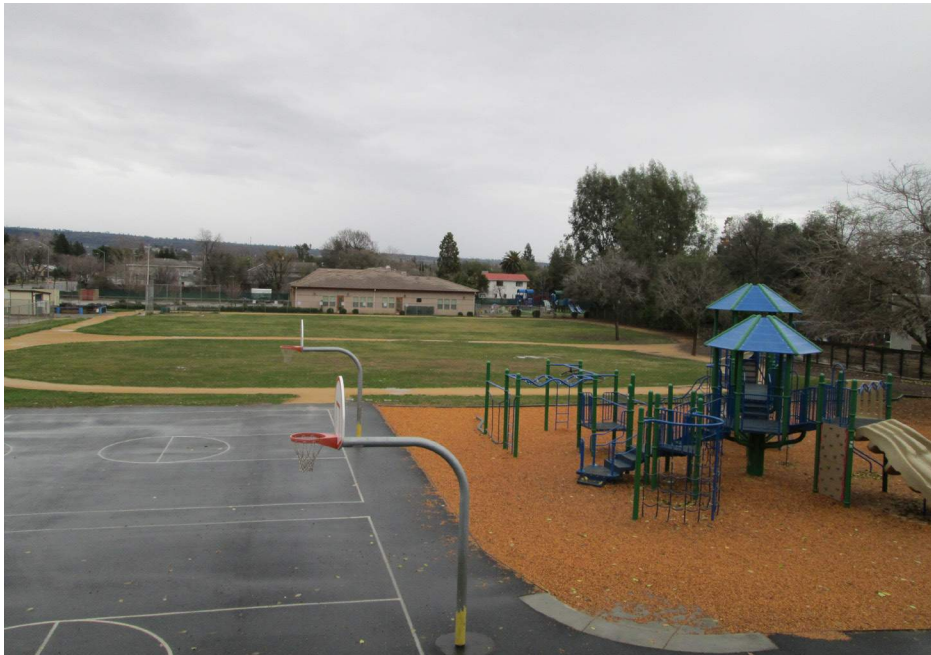
Hardscape courts and playground

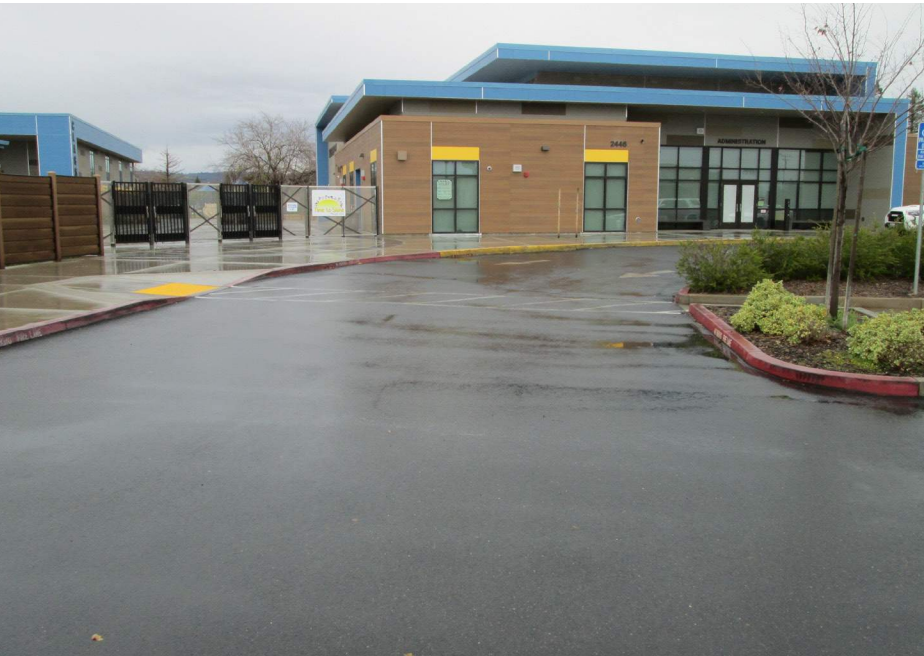
Student drop-off/pick-up & entry point

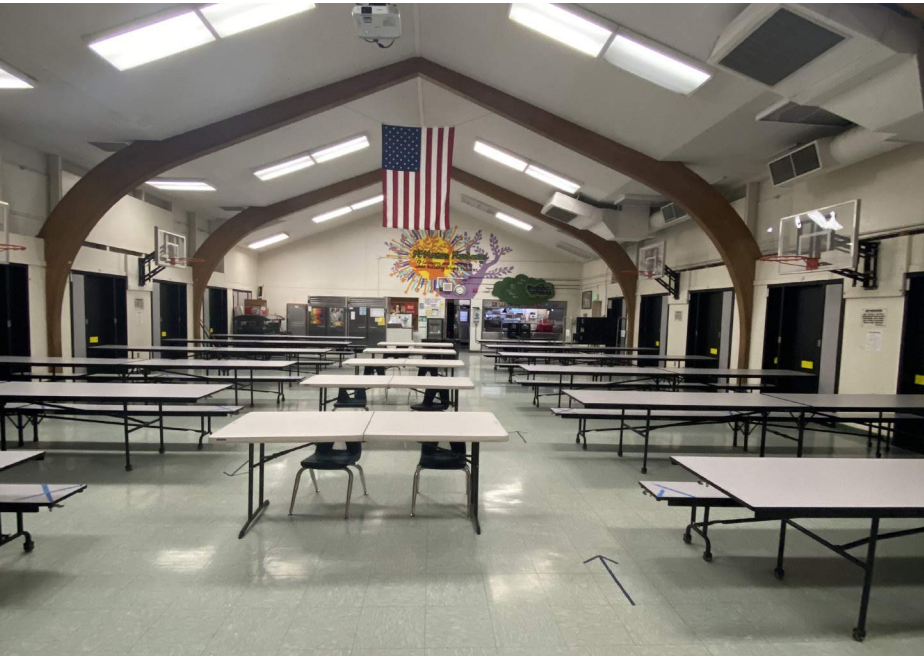
Multi-purpose room expansion and storage needs

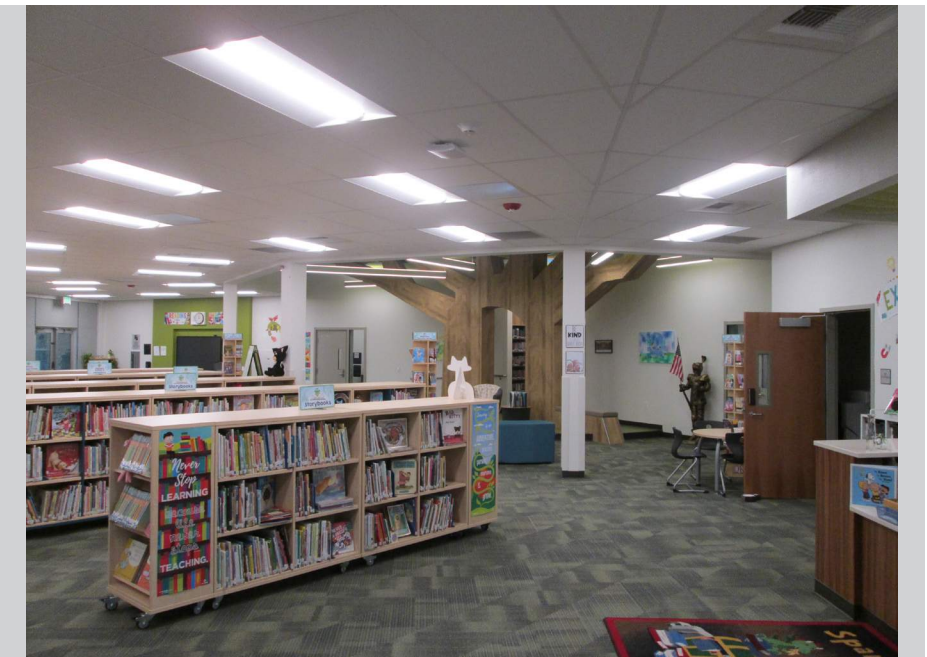
Library interior

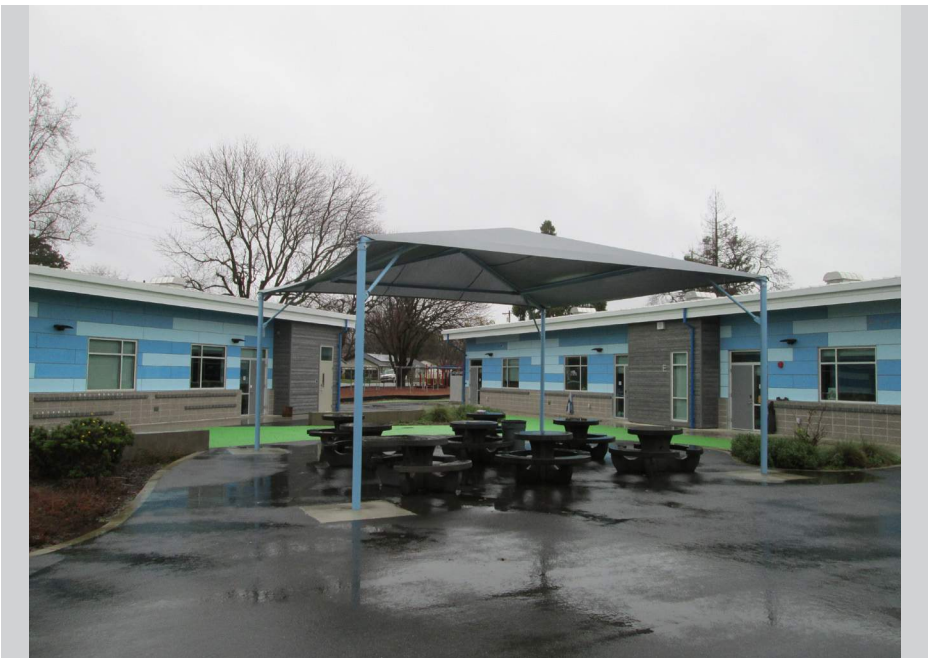
Campus quad shaded structure

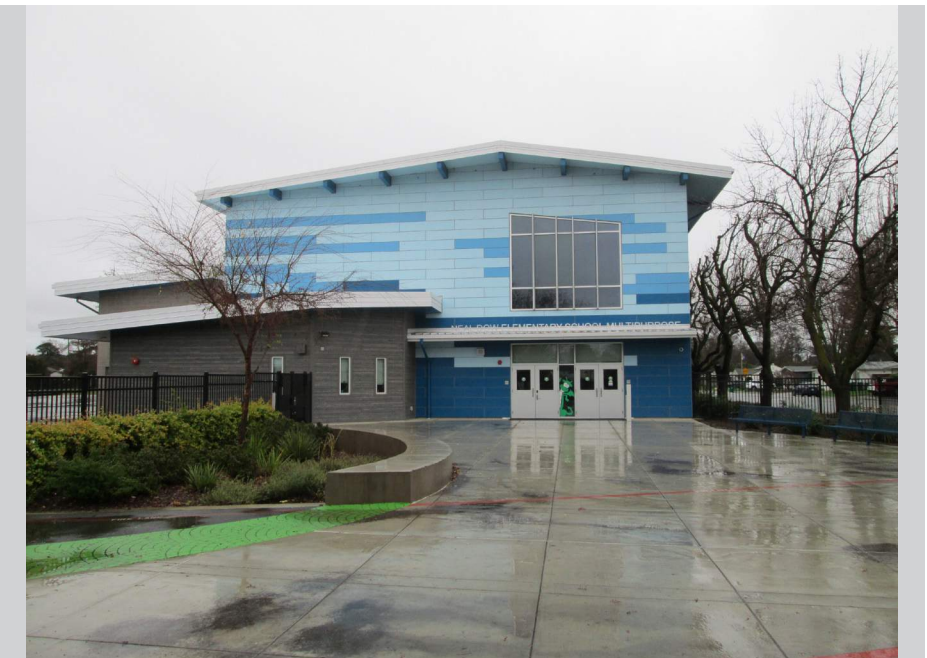
Multi-purpose exterior

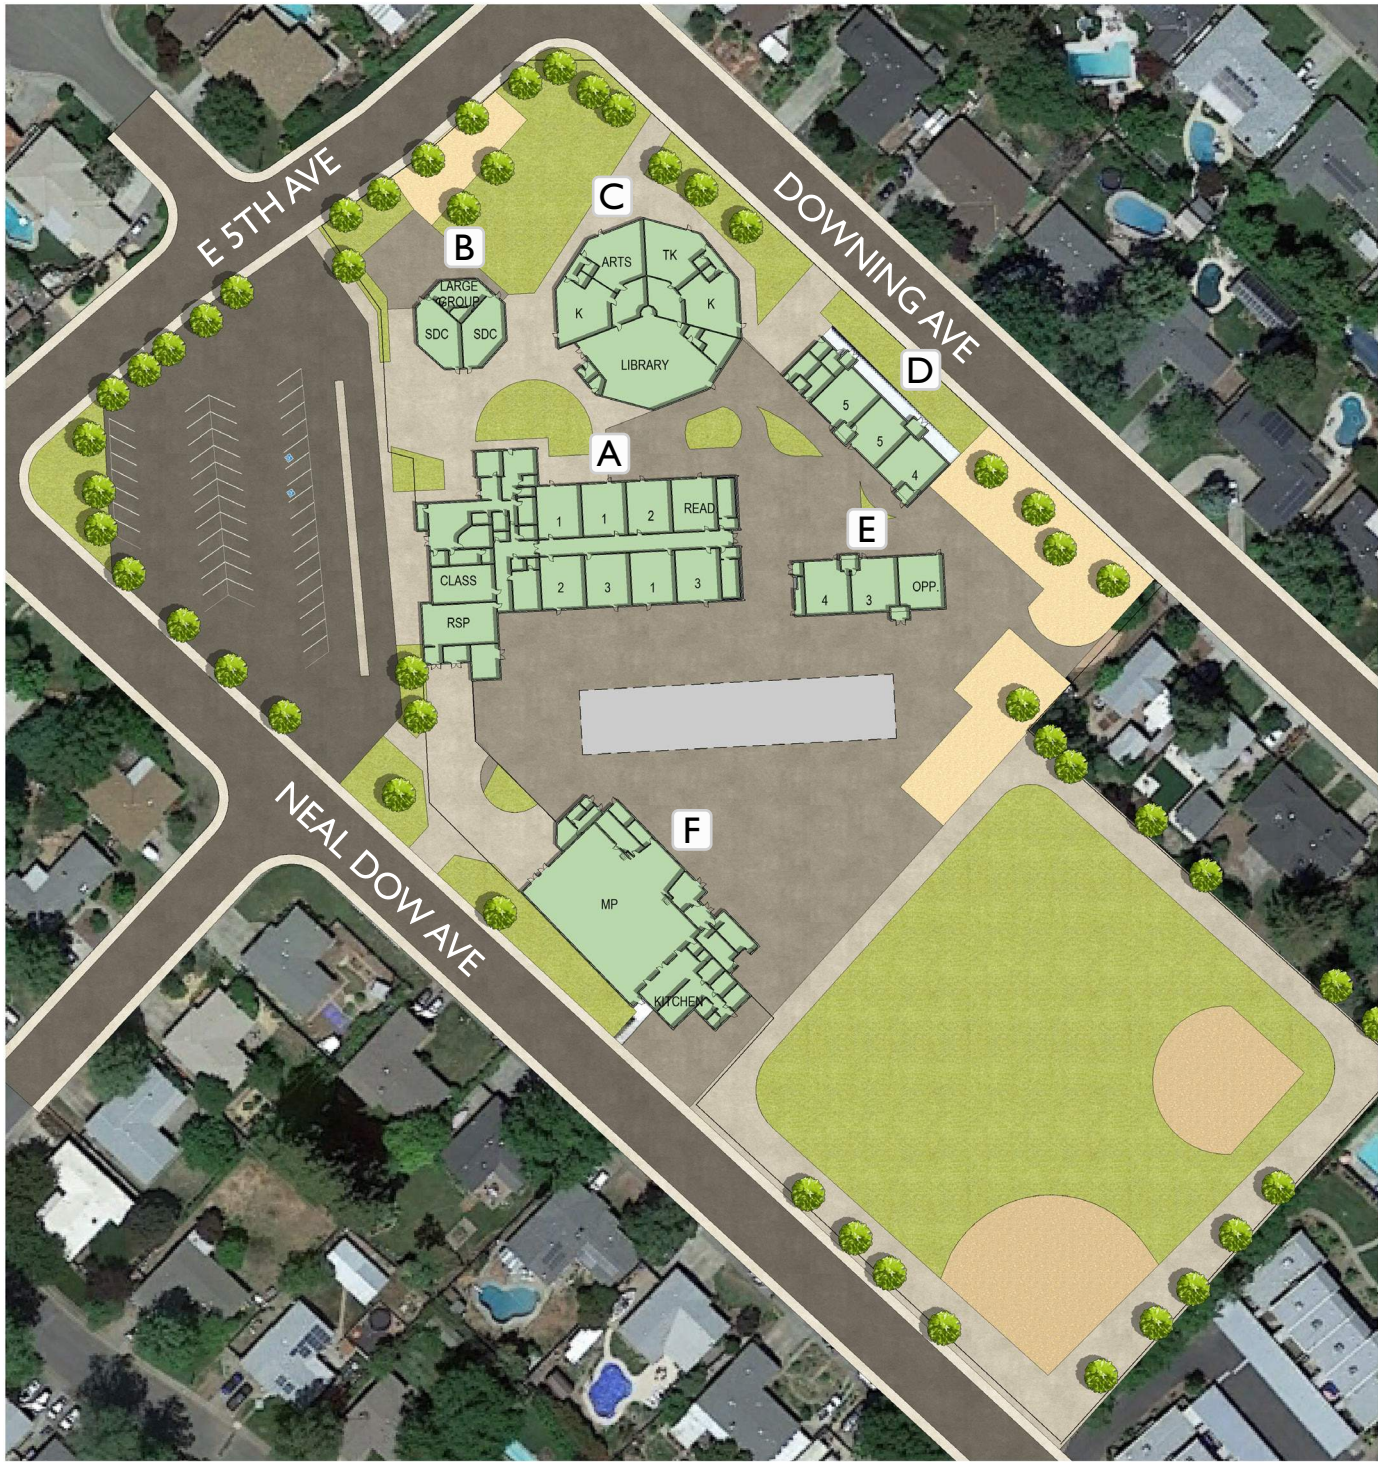
CONDITION ASSESSMENT

| KEY FINDINGS | | |
|---|---|---|
| 2. Site - Other | | <ul style="list-style-type: none"><li>Drop off and parking area needs replacement</li></ul> |
| 6. Fire Alarm | | <ul style="list-style-type: none"><li>Renovated campus - system is up to standard</li><li>No automatic fire sprinkler system found in Library and Kinder classrooms</li></ul> |
| 10. Plumbing/Restrooms | | <ul style="list-style-type: none"><li>Original water heater needs replacement</li></ul> |

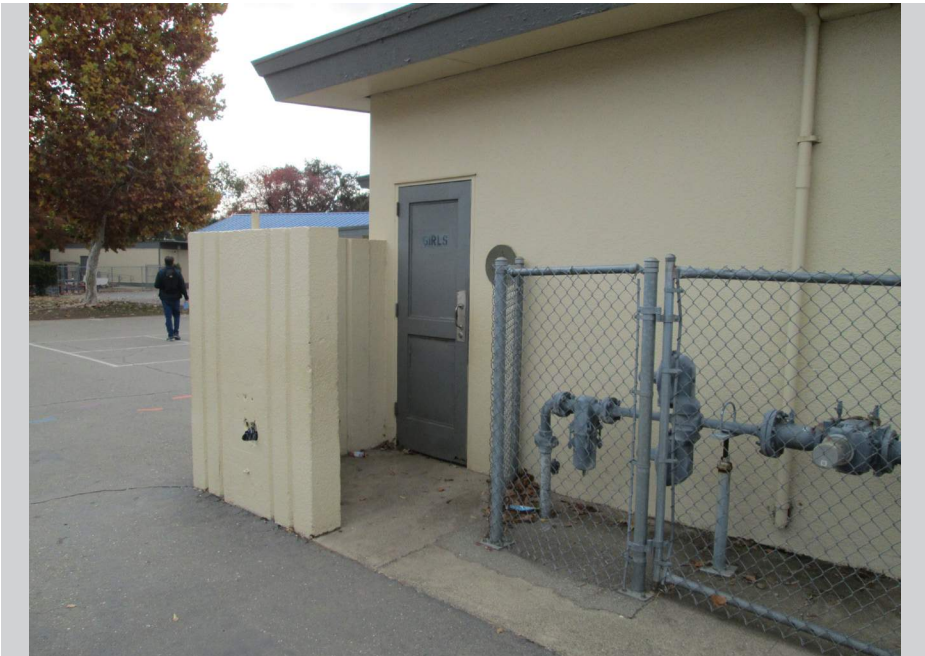
ADA path of travel improvements

| KEY FINDINGS | | |
|---|---|---|
| 2. Site - Other | | <ul style="list-style-type: none"><li>Hardcourts are in poor condition.</li><li>Playground equipment new but does not have shade structures.</li><li>Inner campus has non-compliant path of travel cross-slope conditions, door landings and thresholds - remove and replace.</li></ul> |

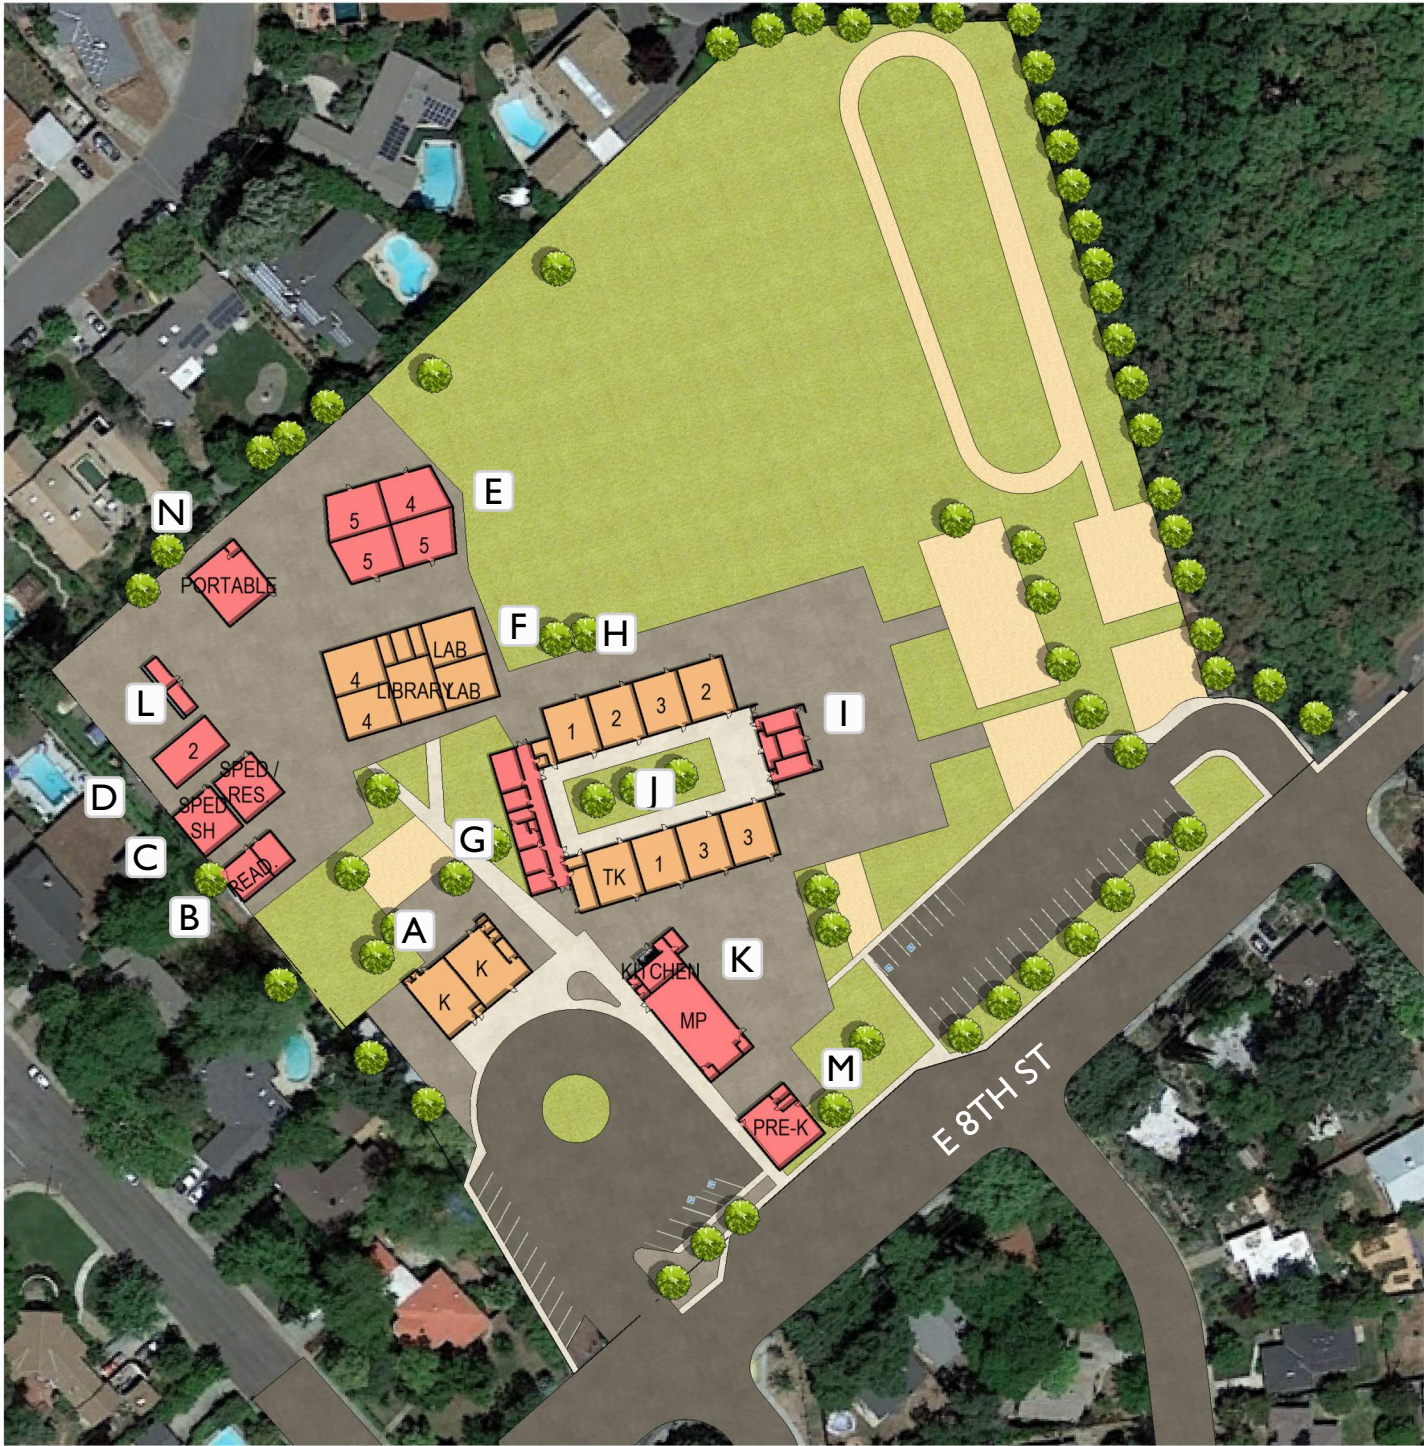
CONDITION ASSESSMENT

| KEY FINDINGS | | |
|---|---|---|
| 4. Building - Exterior | | <ul style="list-style-type: none"><li>Soffits &amp; Fascias have dry-rot and in poor condition - needs replacement</li><li>Most roofs do not have proper draining and downspouts</li></ul> |
| 5. Building - Interior | | <ul style="list-style-type: none"><li>Door hardware are non-ADA compliant</li><li>Damaged 2x4 Acoustic Ceiling Tile system</li><li>Interior finishes need replacement</li></ul> |
| 7. Electrical | | <ul style="list-style-type: none"><li>Most existing panels on campus are older but in servicable condition.</li><li>Surface raceways in classrooms.</li></ul> |
| 9. Mechanical | | <ul style="list-style-type: none"><li>Ceiling Exhaust Fans are original and in need of replacement.</li><li>Existing Gas Fired AC-Units are at the end of life and need to be replaced</li></ul> |
| 10. Plumbing/Restrooms | | <ul style="list-style-type: none"><li>Original Plumbing Fixtures need replacement</li><li>Sinks are not ADA-complaint</li></ul> |

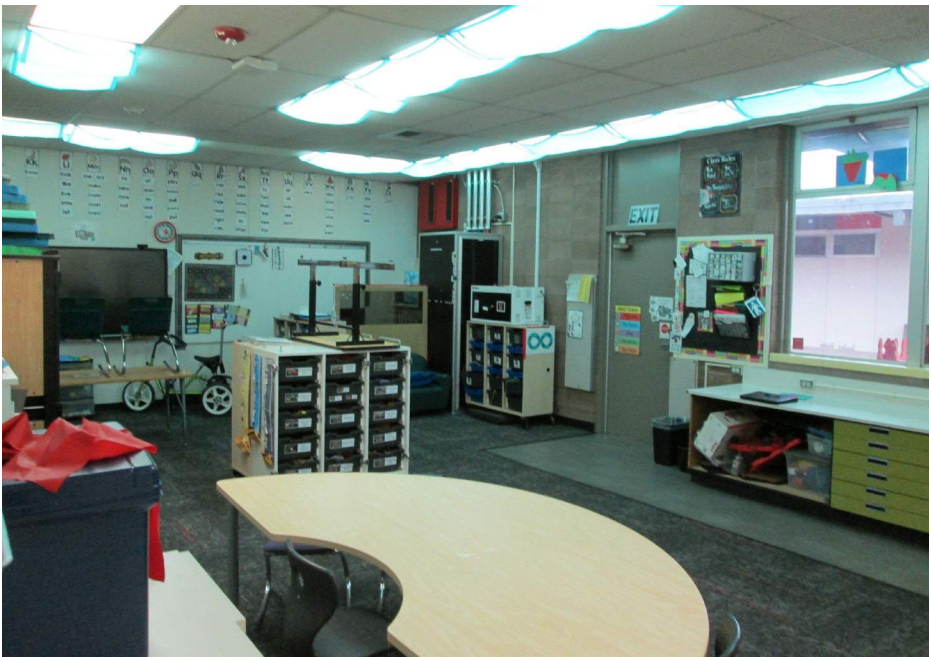
Window treatment needs for security purposes
